AMENDED BLIGHT STUDY

WEST BOTTOMS STUDY AREA

FORESTER VIADUCT/BLUFF ROAD/W 12TH STREET/HICKORY STREET
KANSAS CITY, MISSOURI

NOVEMBER 17, 2023
RECORD No. 1800

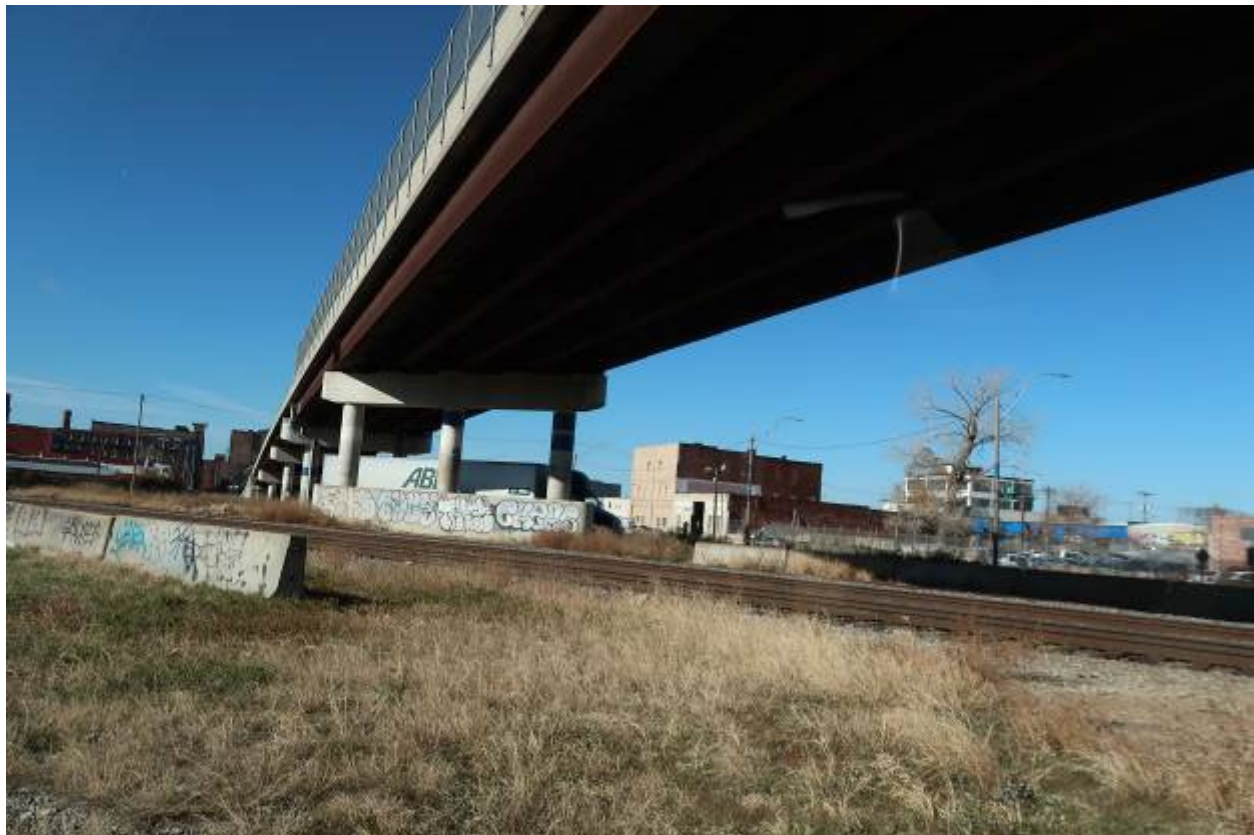
Looking Northwest Across 912 Santa Fe Street

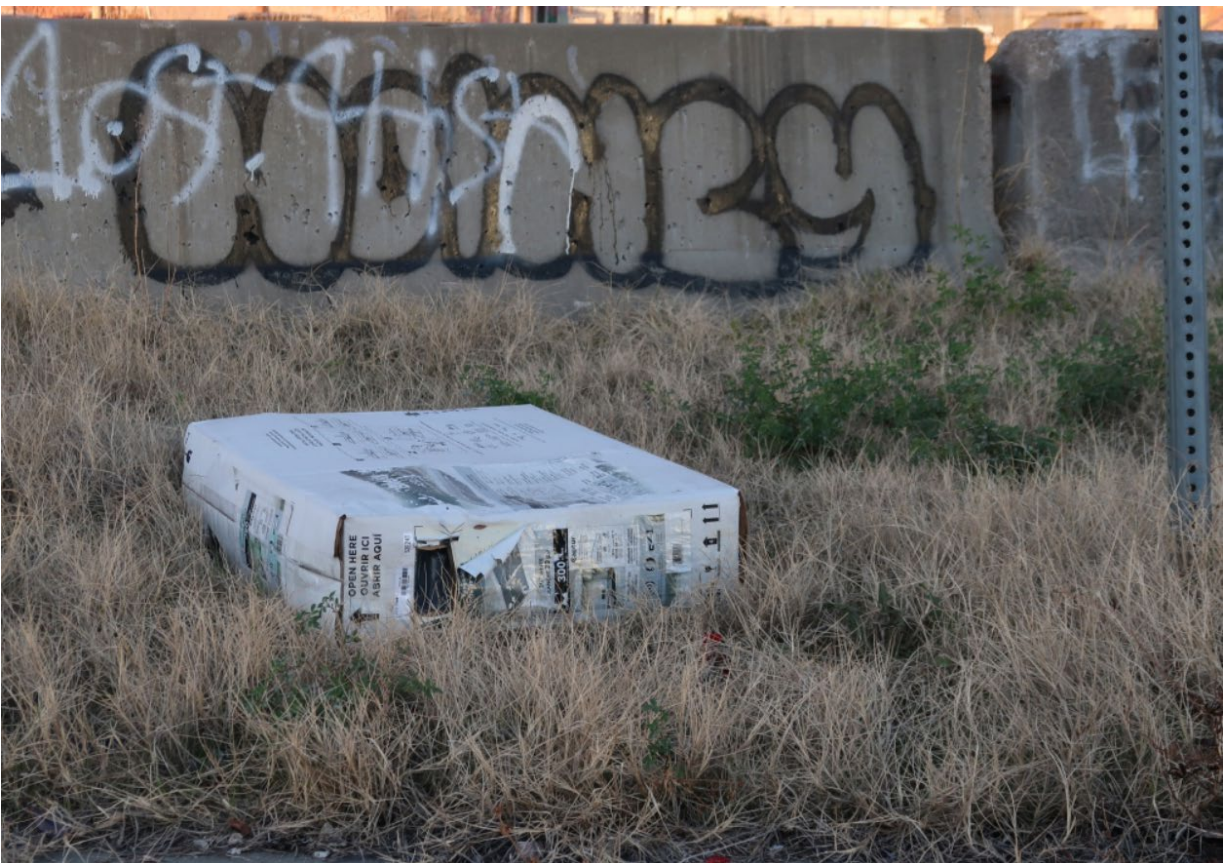
Blight issues involving Insanitary Or Unsafe Conditions observed at the subject tax parcel include trash and illegal dumping as well as the presence of the active railroad tracks bisecting the tax parcel.

Trash & Illegal Dumping

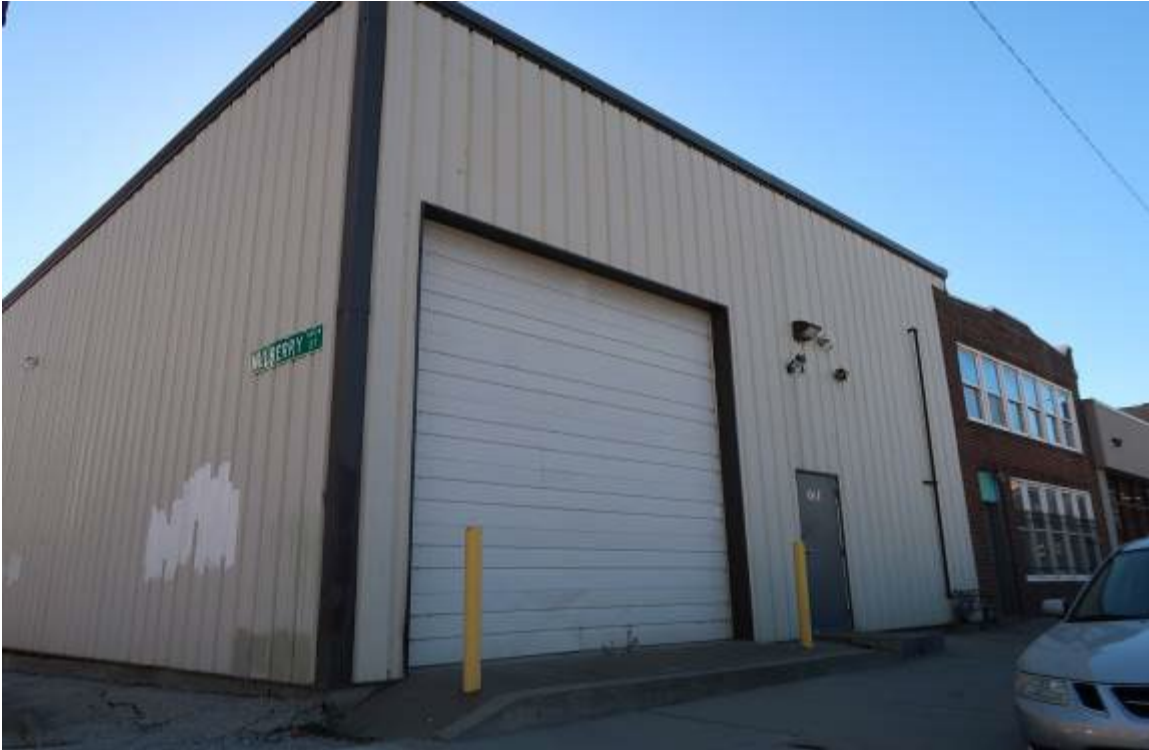
Blight issues involving Insanitary Or Unsafe Conditions observed at the subject tax parcel include loading over an adjoining pedestrian sidewalk. Access to the rear overhead door likely requires use of the adjoining property to the south as the adjoining alleyway is only 10 feet wide. The tenant's trash dumpster sits in the alleyway behind the building and trash is strewn around the dumpster. The roof drains onto the pedestrian sidewalk along the east side of the subject building. Significant settling has occurred along the easterly adjoining sidewalk and the east elevation of the building. The owner indicated a significant expenditure was needed to stabilize the foundation of the building. A building of this age should be free from environmental hazards.

Loading Over Adjoining Pedestrian Sidewalk

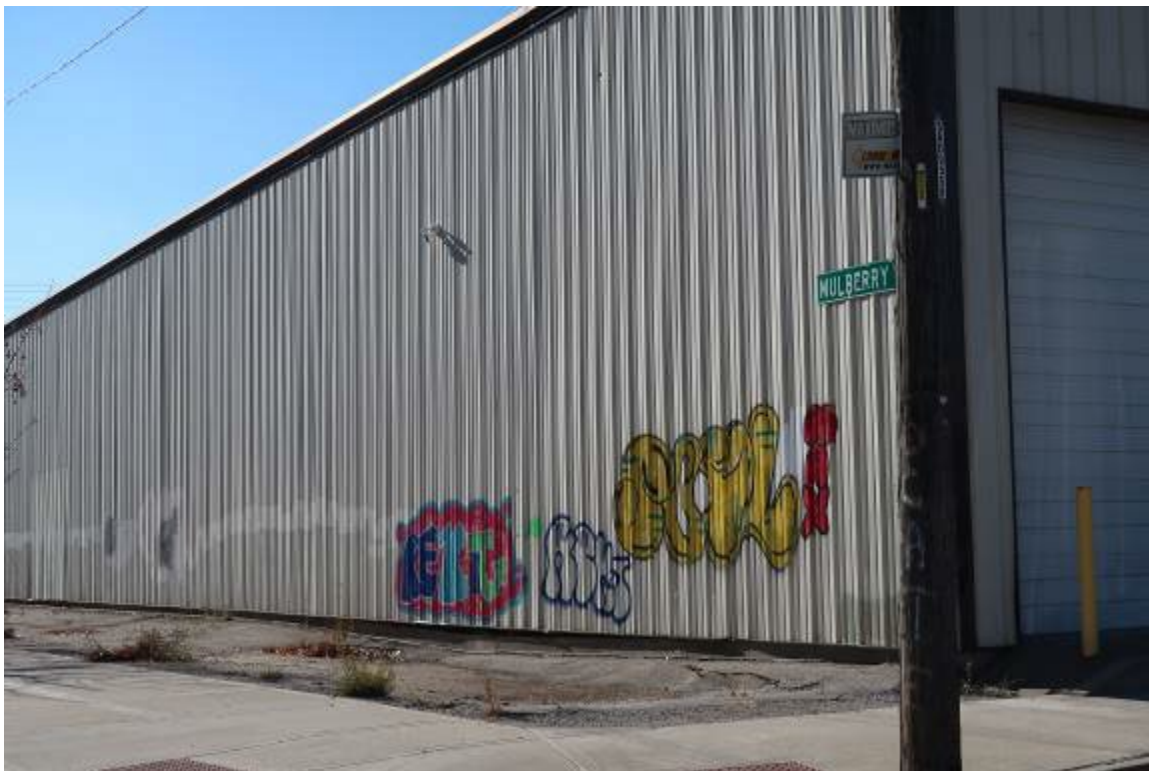
Graffiti Along The East Elevation Facing Mulberry Street

Graffiti Was Not Present At The Initial Re-Inspection (11/7) But Was During Second Re-Inspection (12/5)

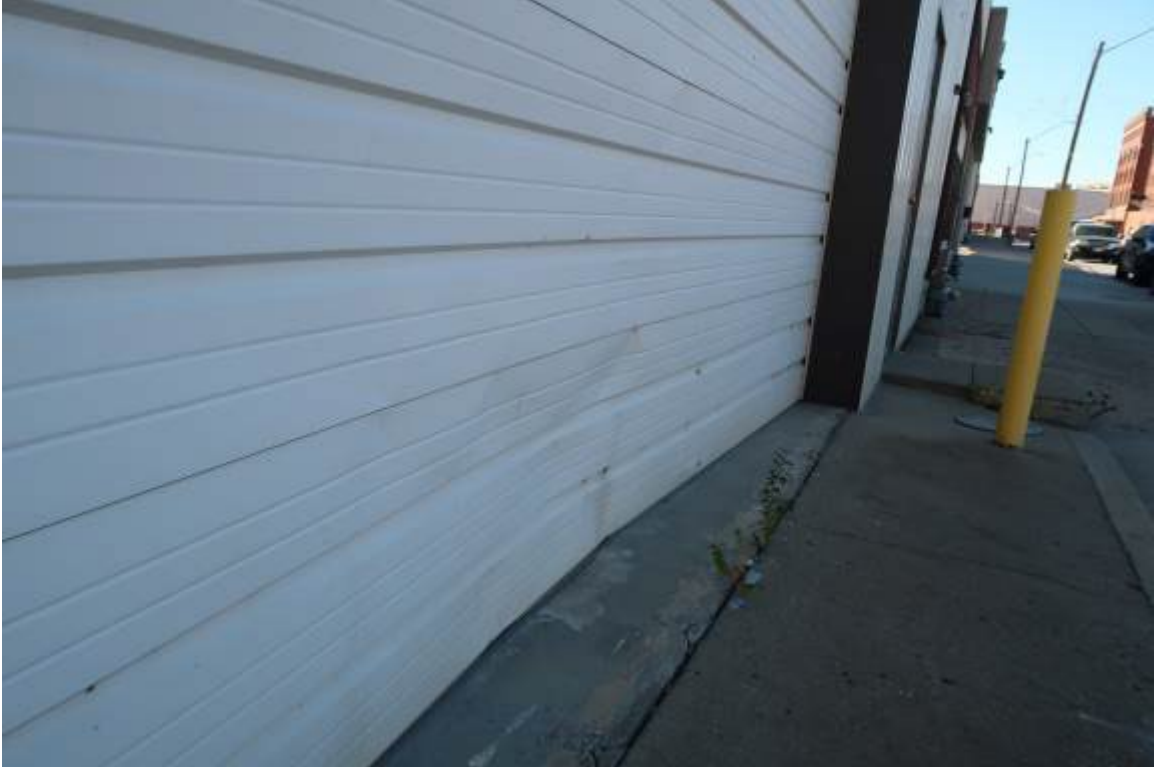
Damaged Loading Door Along Union Avenue Pedestrian Sidewalk

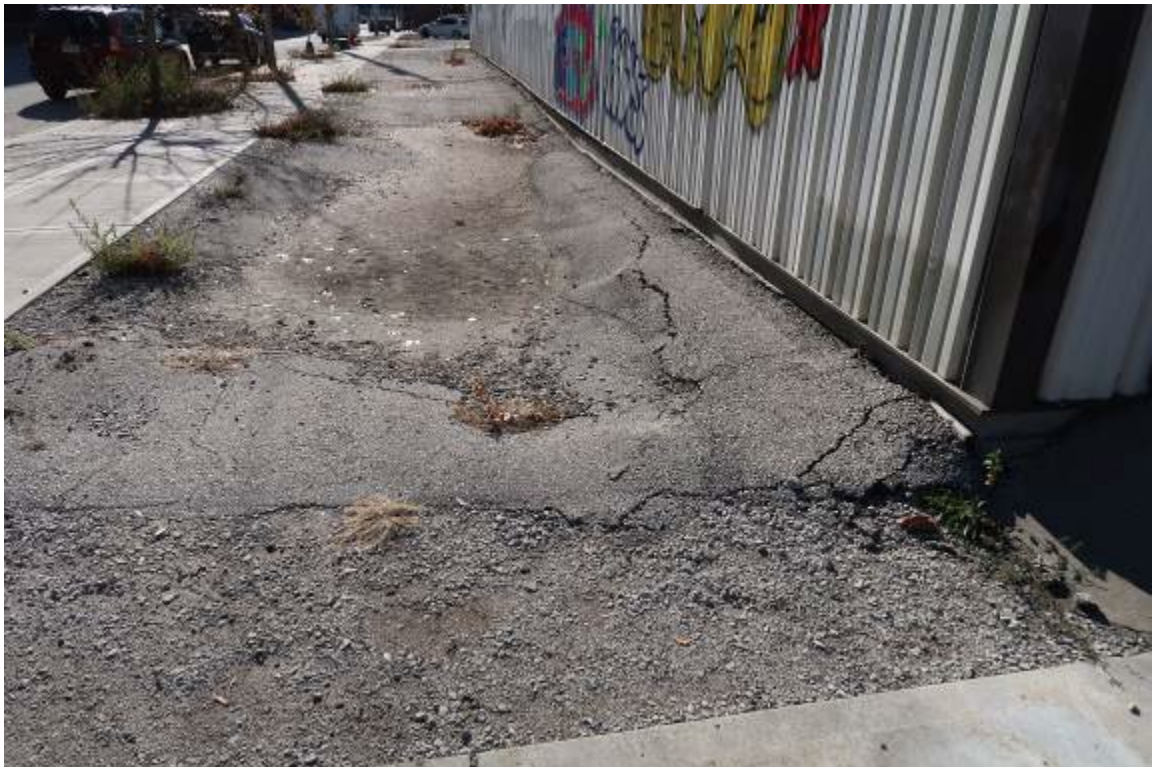
Blight issues involving Endangerment By Fire Or Other Causes observed at the subject tax parcel include crime (graffiti and loitering), the settling along the adjoining pedestrian sidewalk to the east, the roof draining onto the easterly adjoining sidewalk, and the trash dumpster blocking the alleyway.

Settling In The Easterly Adjoining Pedestrian Right-Of Way (Along Mulberry St.)

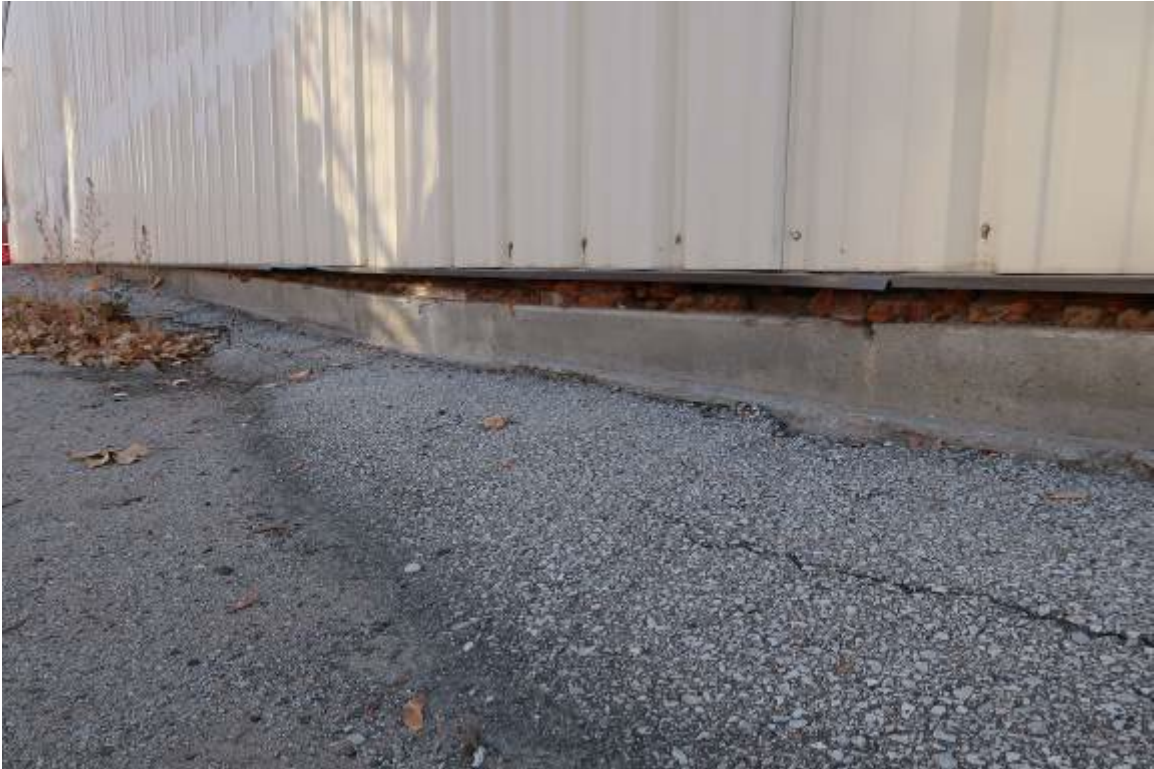
The exterior is in poor to fair condition. The foundation below the east elevation and the adjoining sidewalk are settling noticeably. The exterior walls have dents and have graffiti or whited out graffiti areas. The roof is newer. The structure lacks windows. Finished space is minimal. Elongated buildings are less functional. The structure would be a poor candidate for residential or commercial conversion.

Settling Beneath The East Foundation

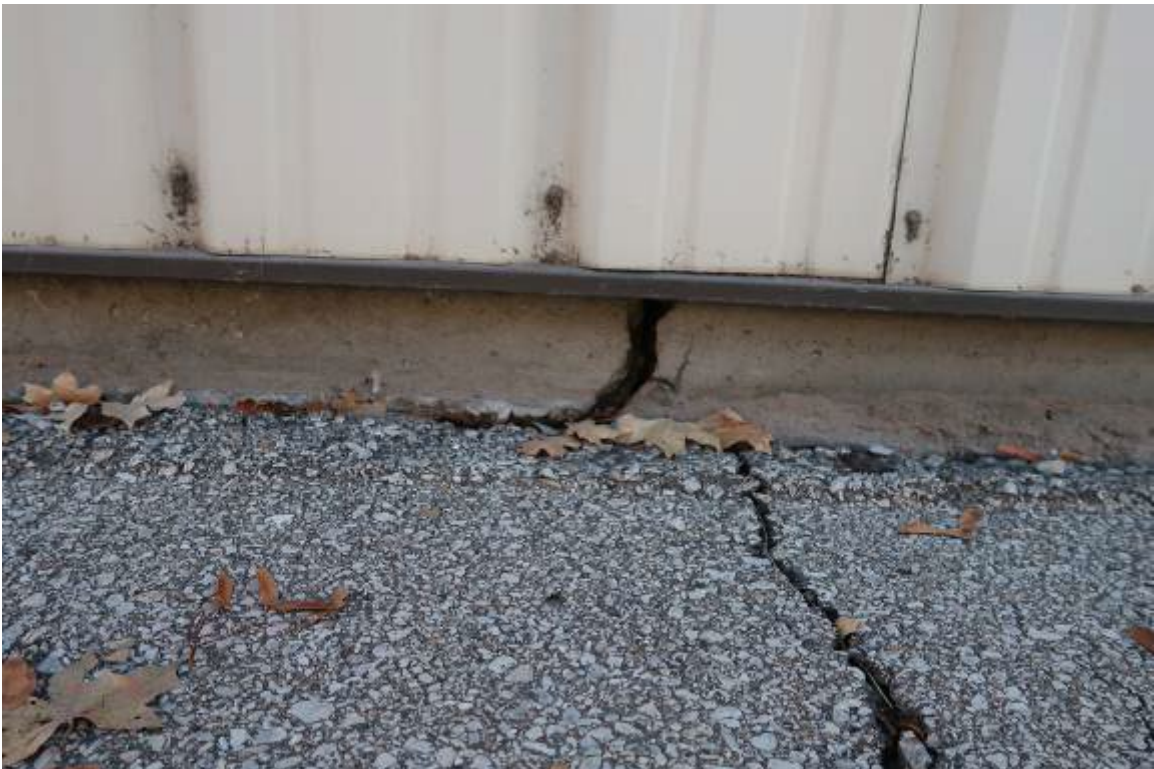
Settling Beneath The East Foundation

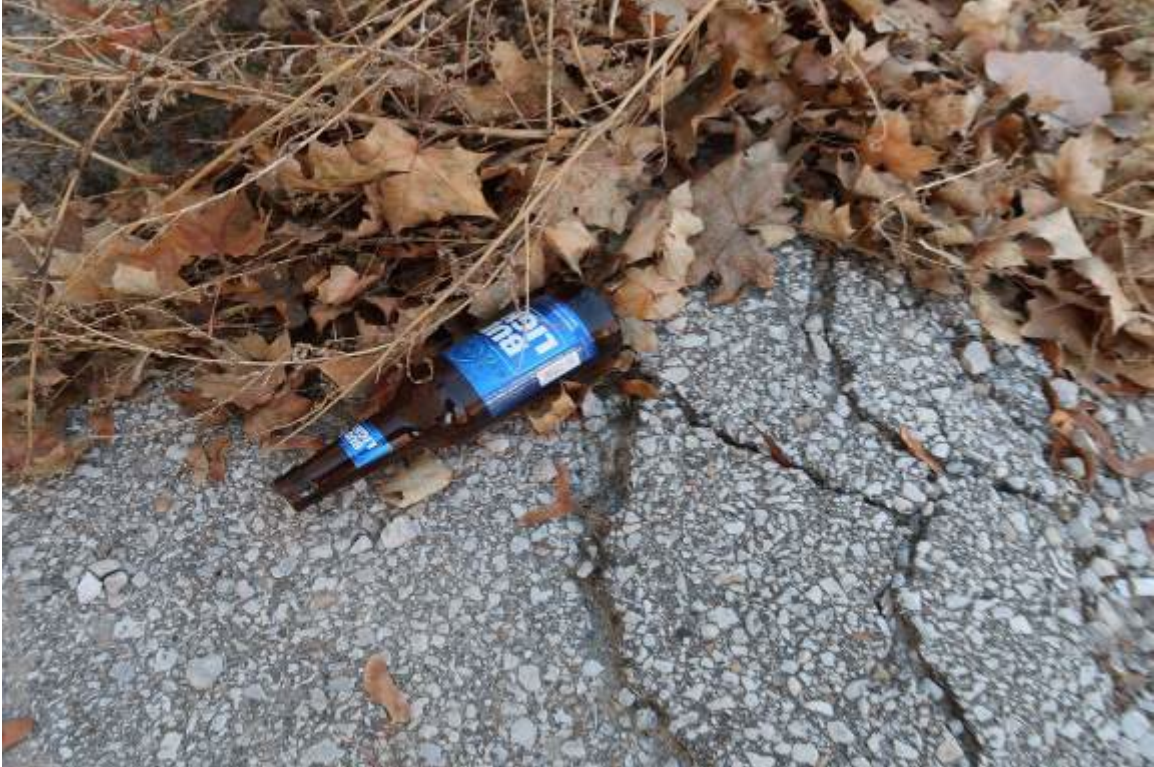
Crime – Loitering & Trash Along The East Foundation

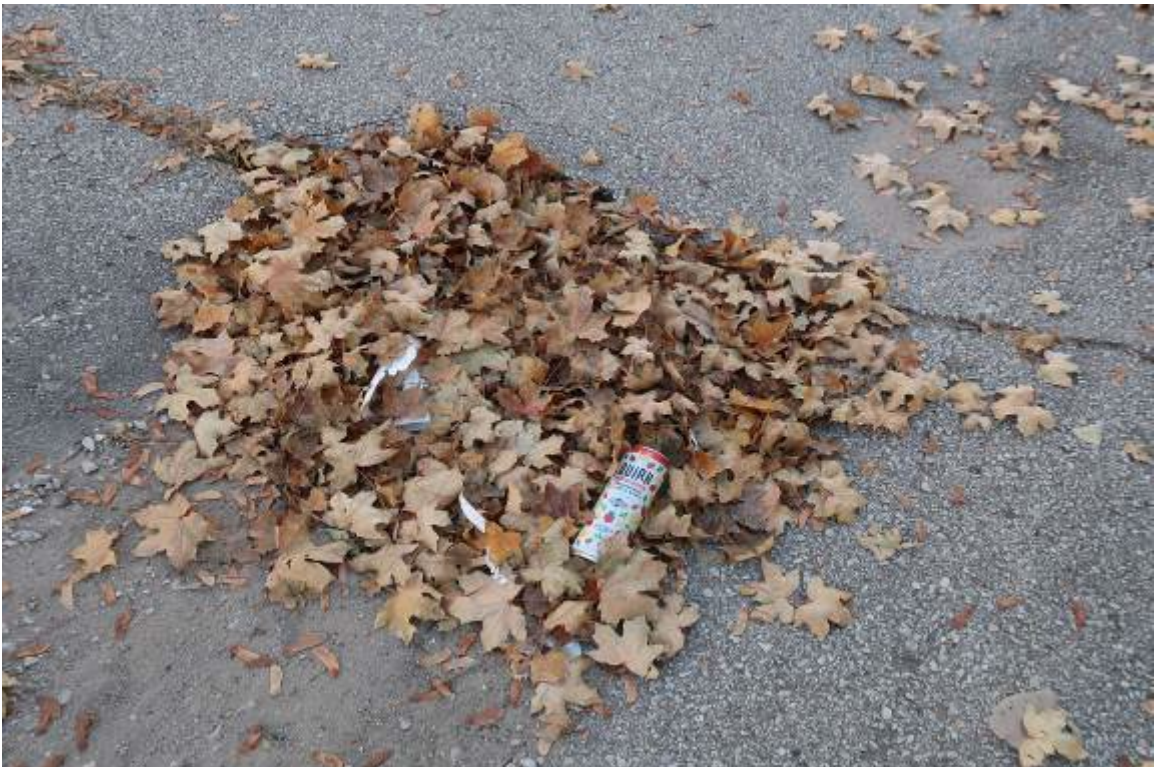
Crime – Loitering & Trash Along The East Foundation

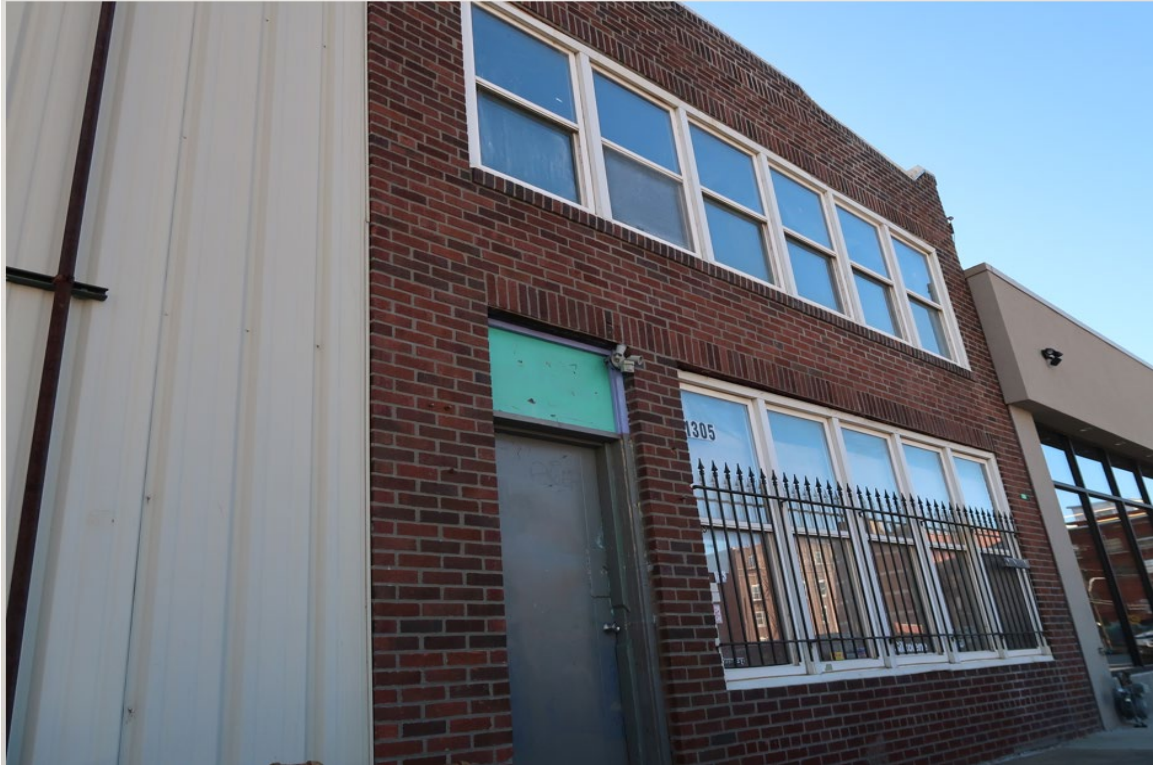
Security Bars Over The Front Windows

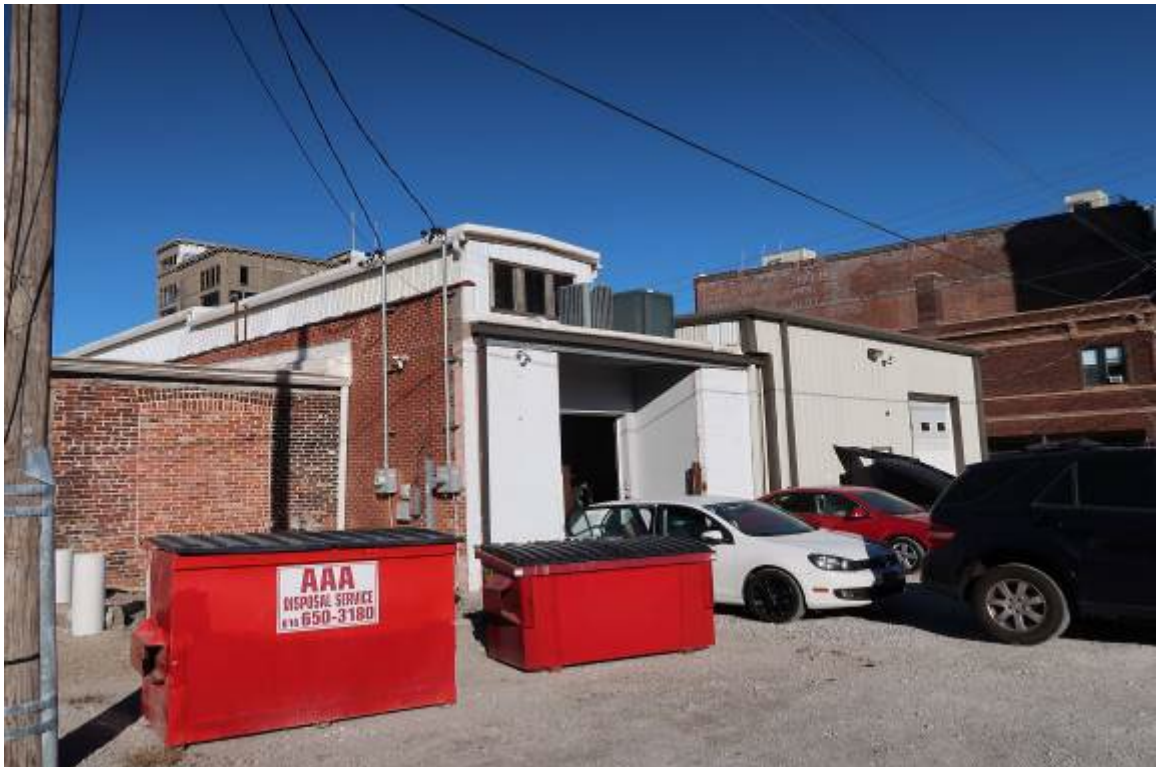
Trash Dumpsters & Tenant Vehicles Blocking The Adjoining Unpaved Alleyway

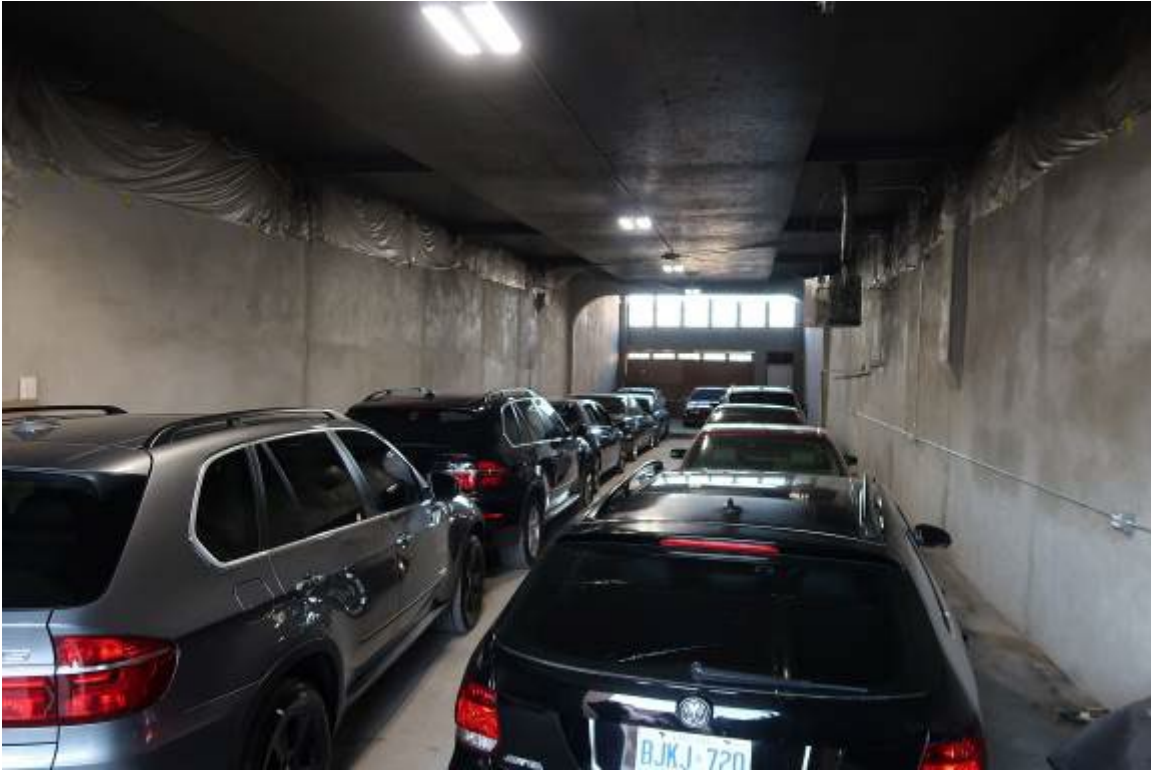
Concrete Interior Lacking Finish

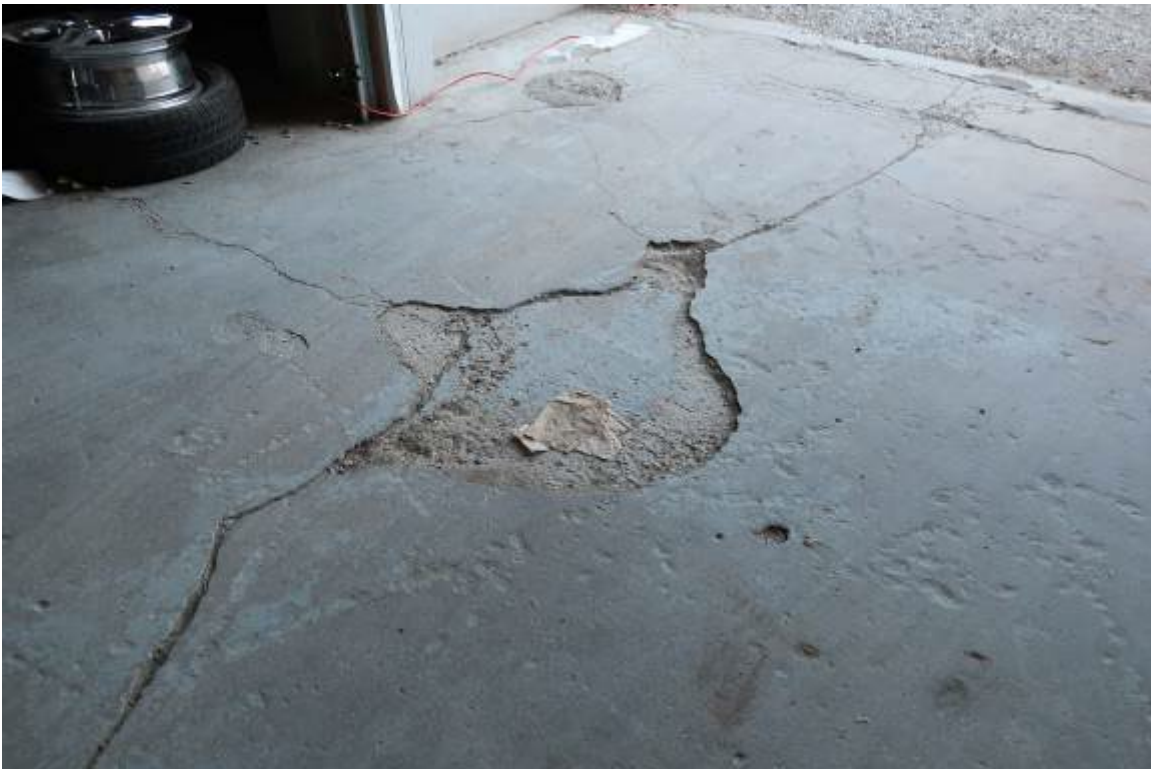
Damaged Flooring

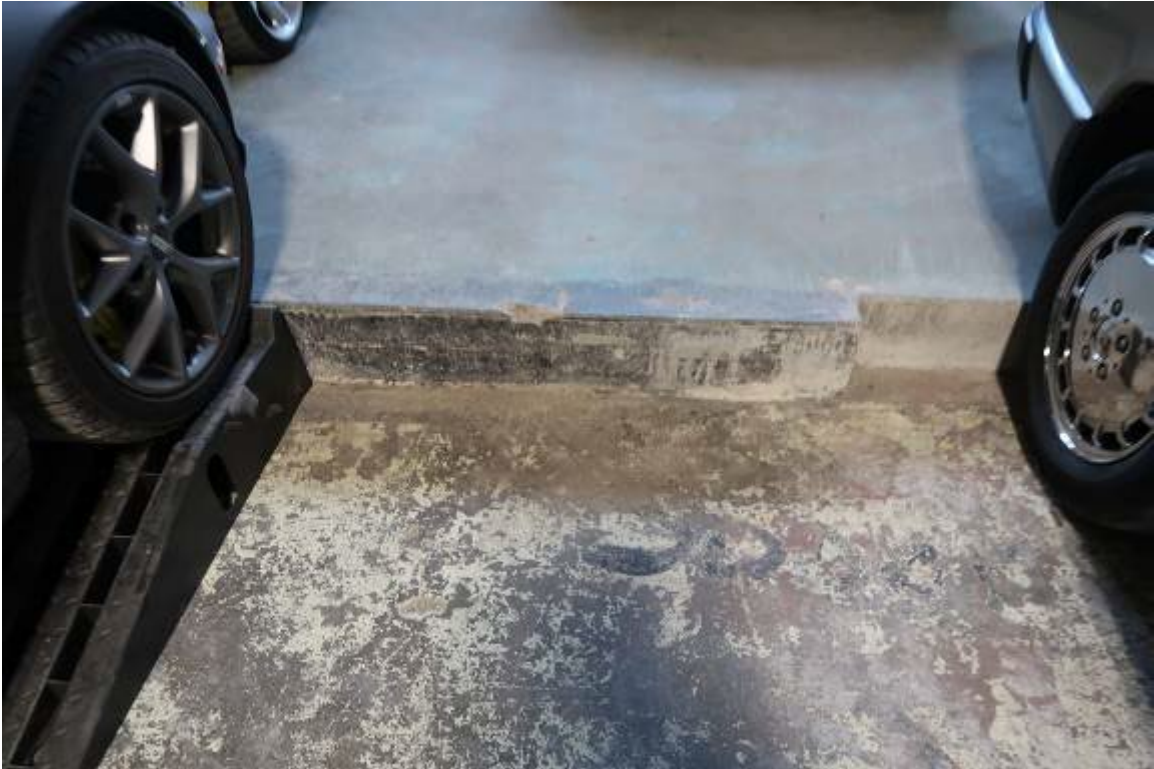
Varying Floor Levels

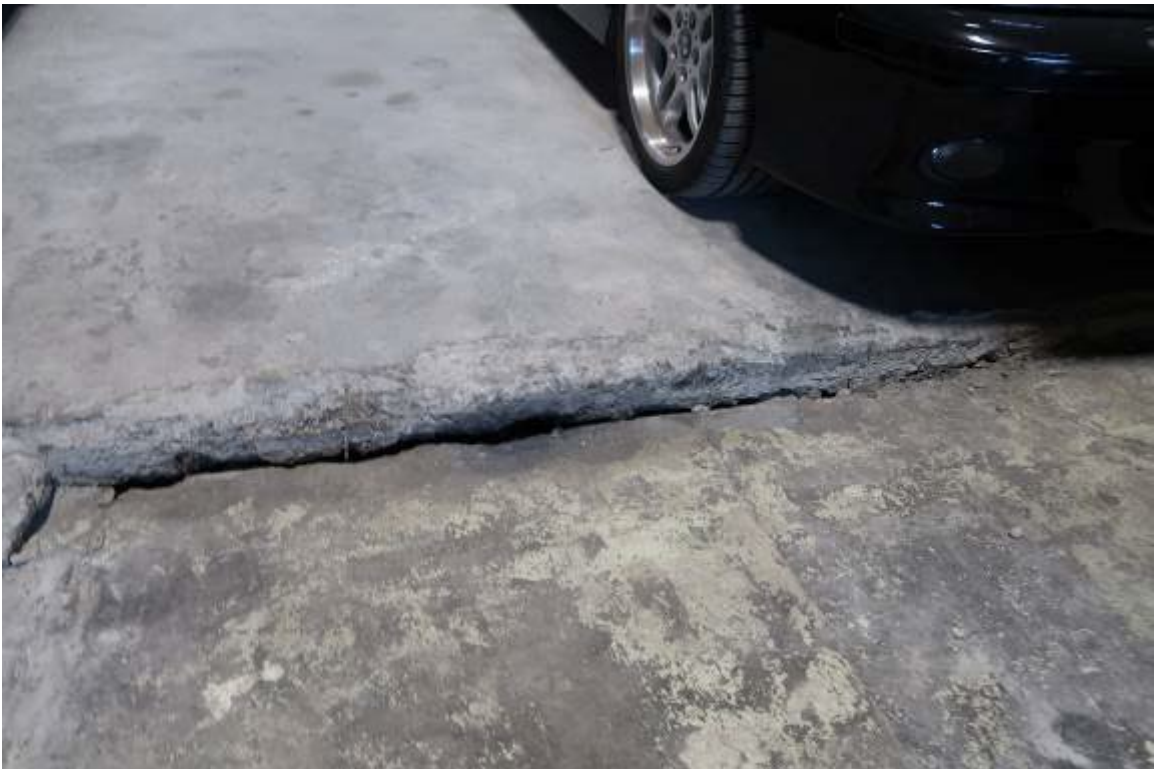
Varying Floor Levels

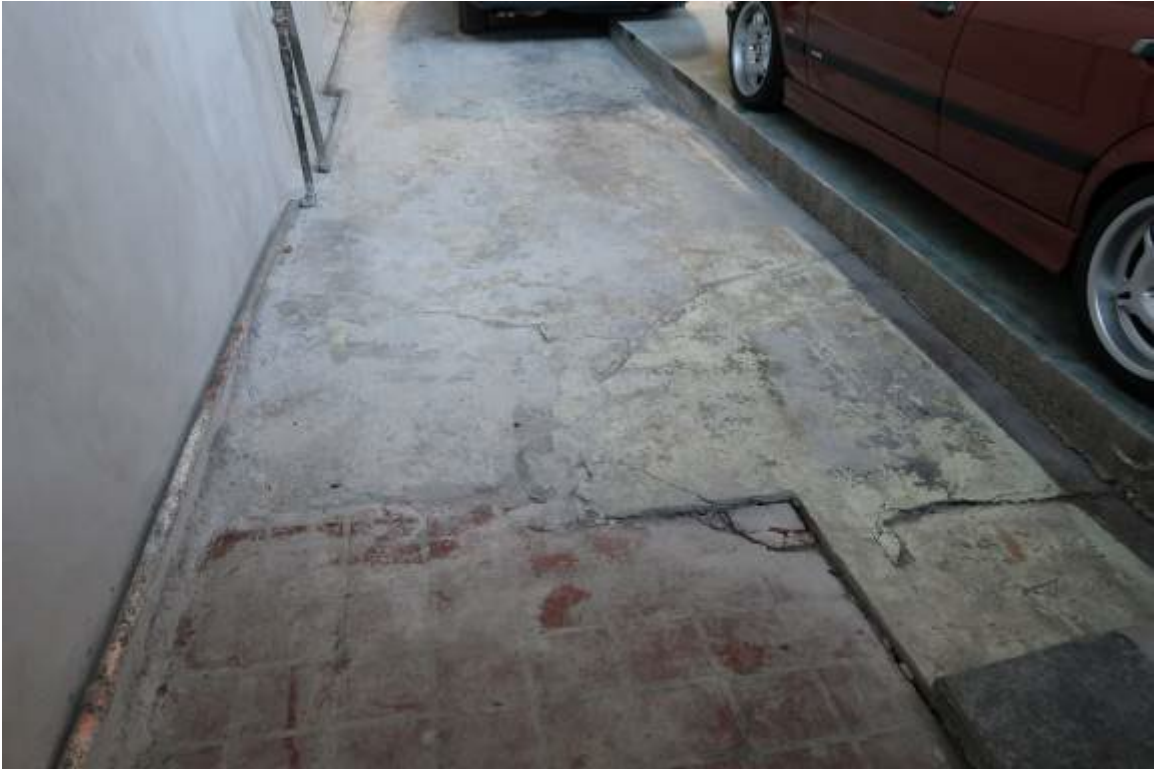
Varying Floor Levels & Damage

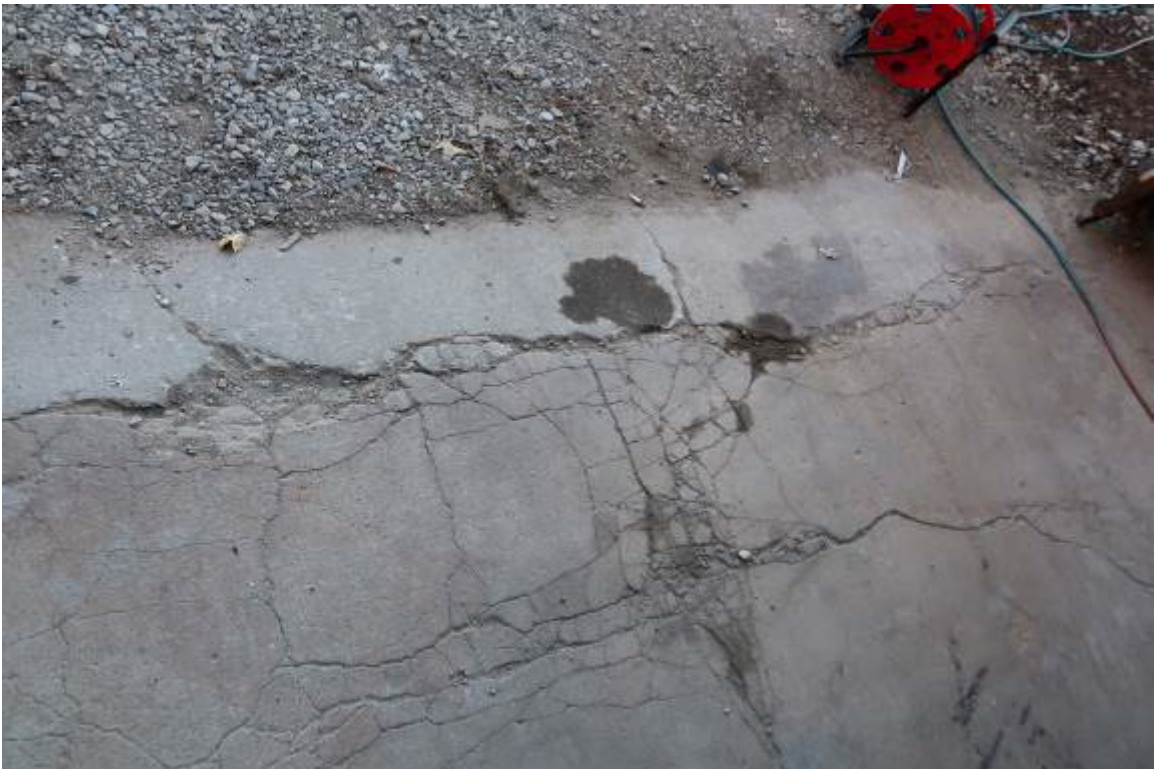
Floor Damage

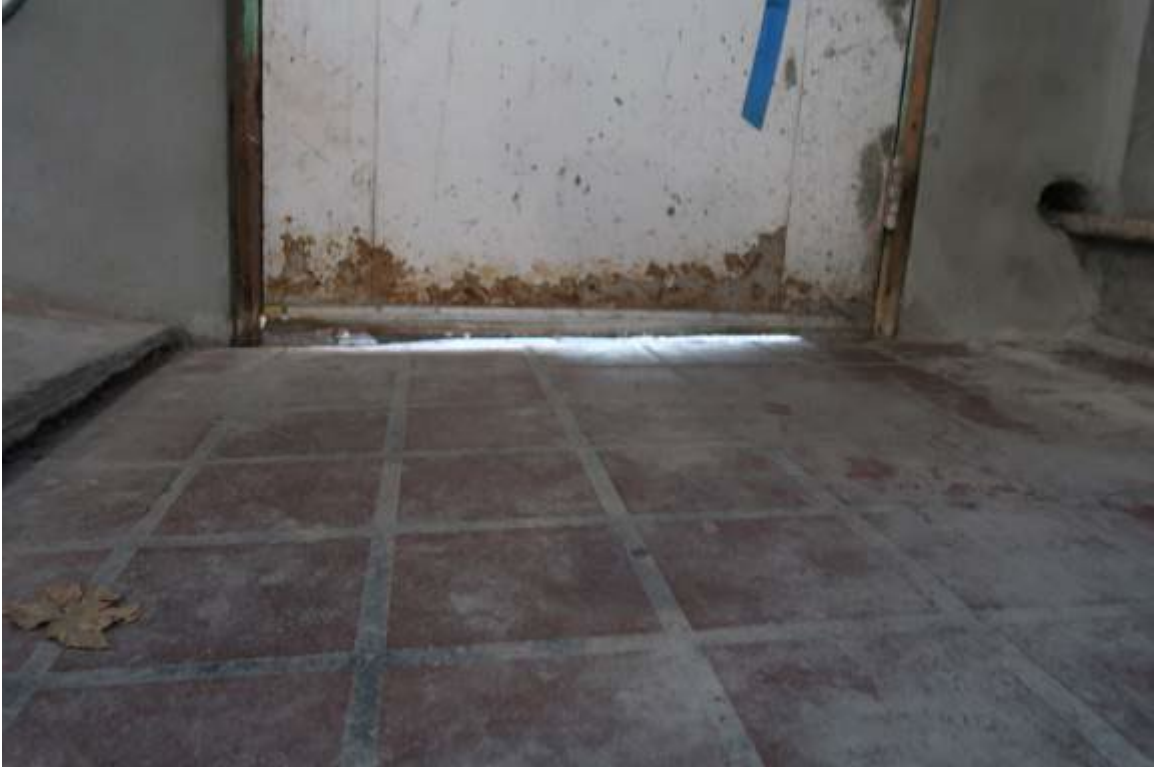
Settling & Rusted Entry Door

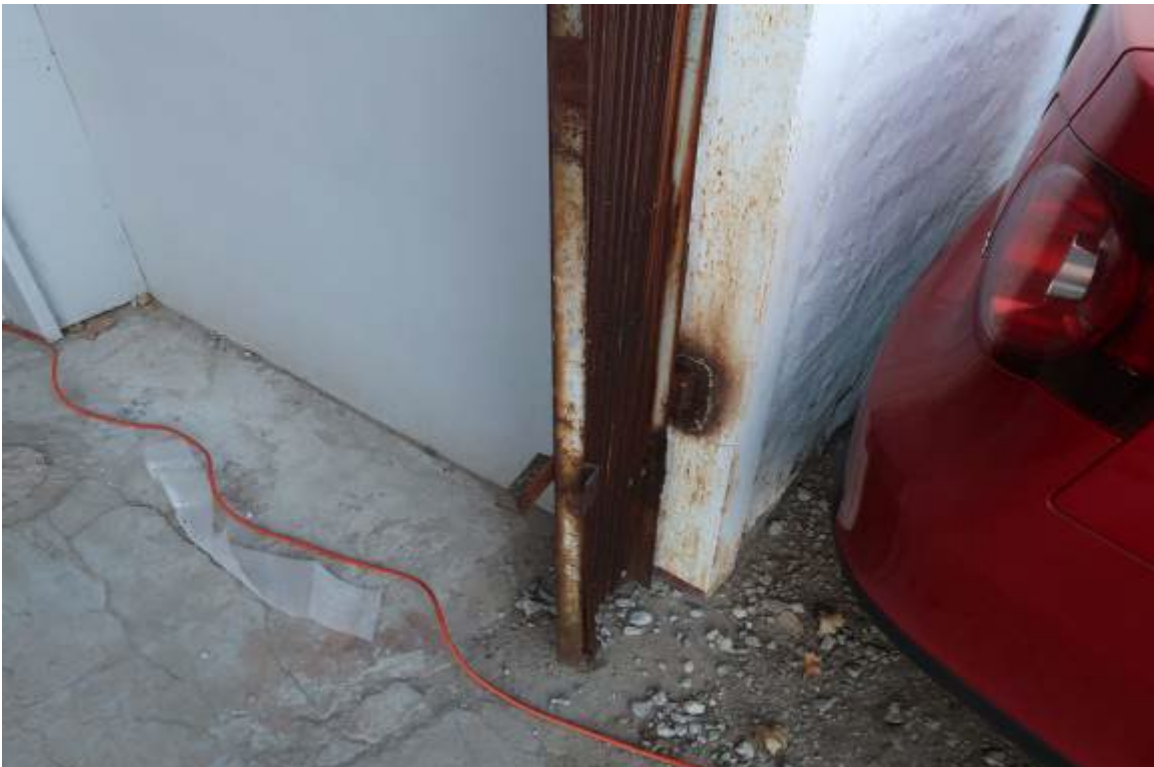
Garage Door Railing Damage

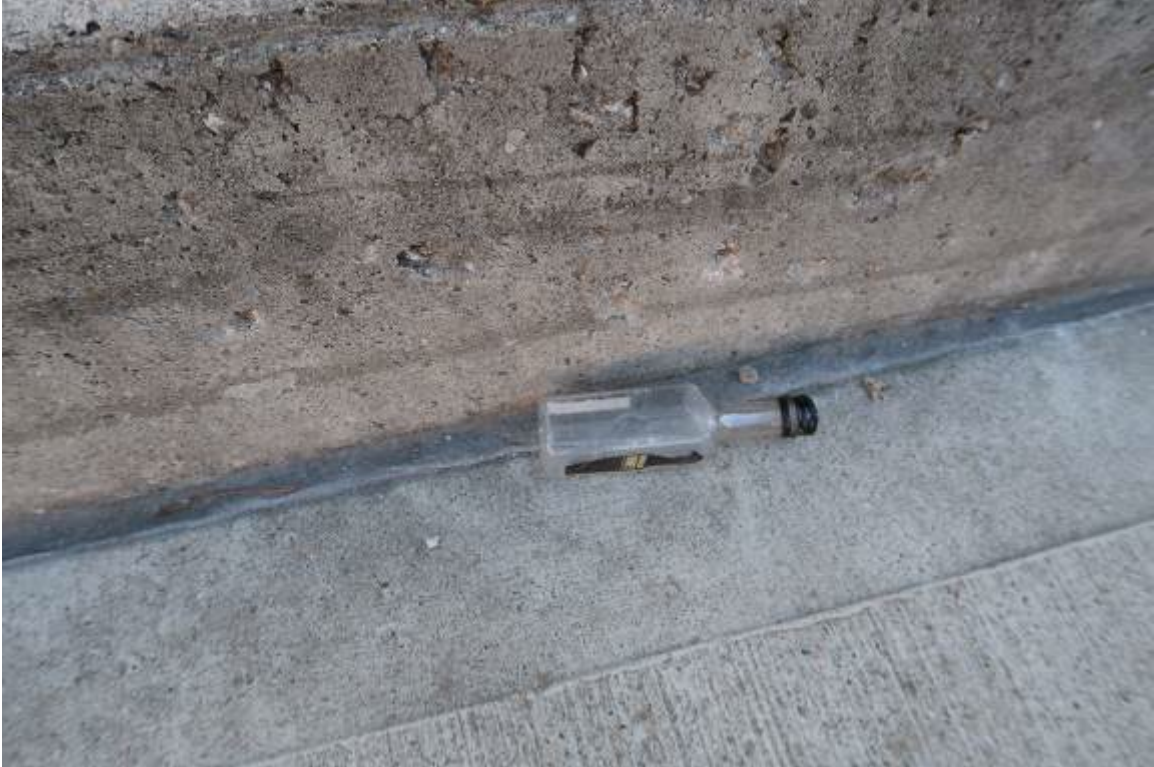
Crime – Loitering & Trash Along The North Elevation

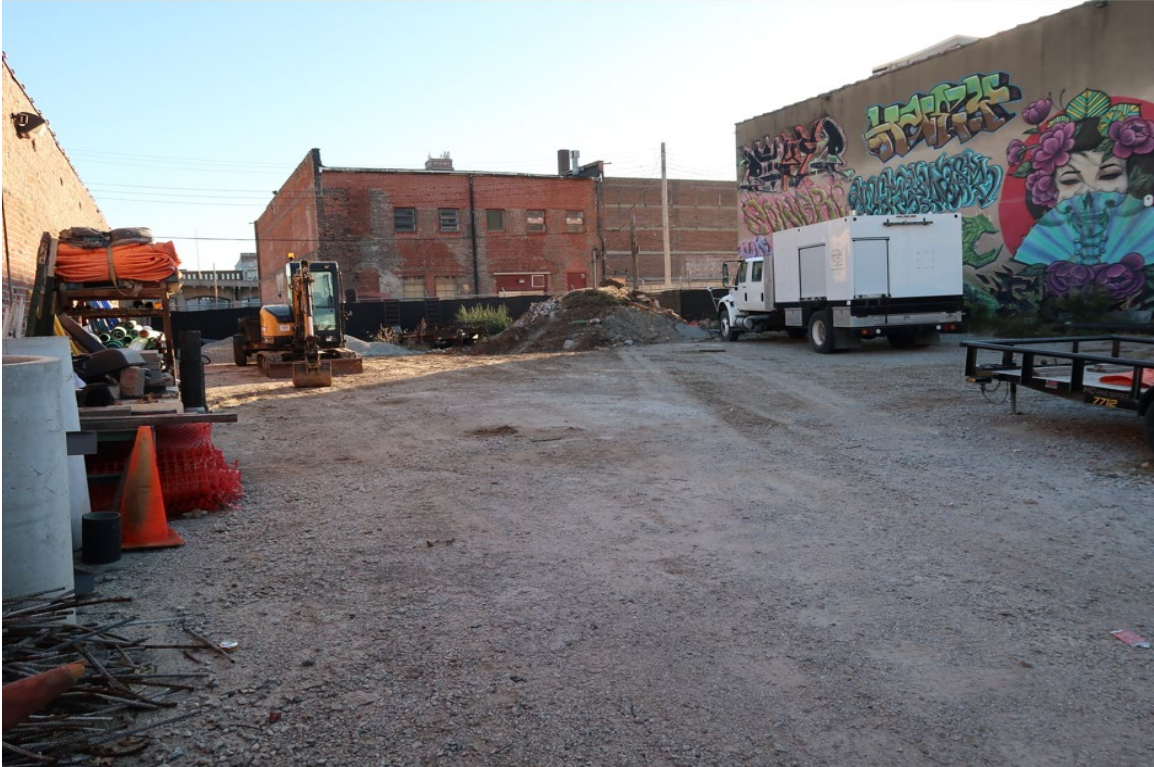
Deterioration Of Site Improvements includes potential violation of maintenance standards prescribed in Section 88-420-15. Another issue concerning storage yards and vehicular movements is the negative effect (deterioration) of adjoining public sidewalks and roadways.

Storage Yard – Improper Design & Maintenance

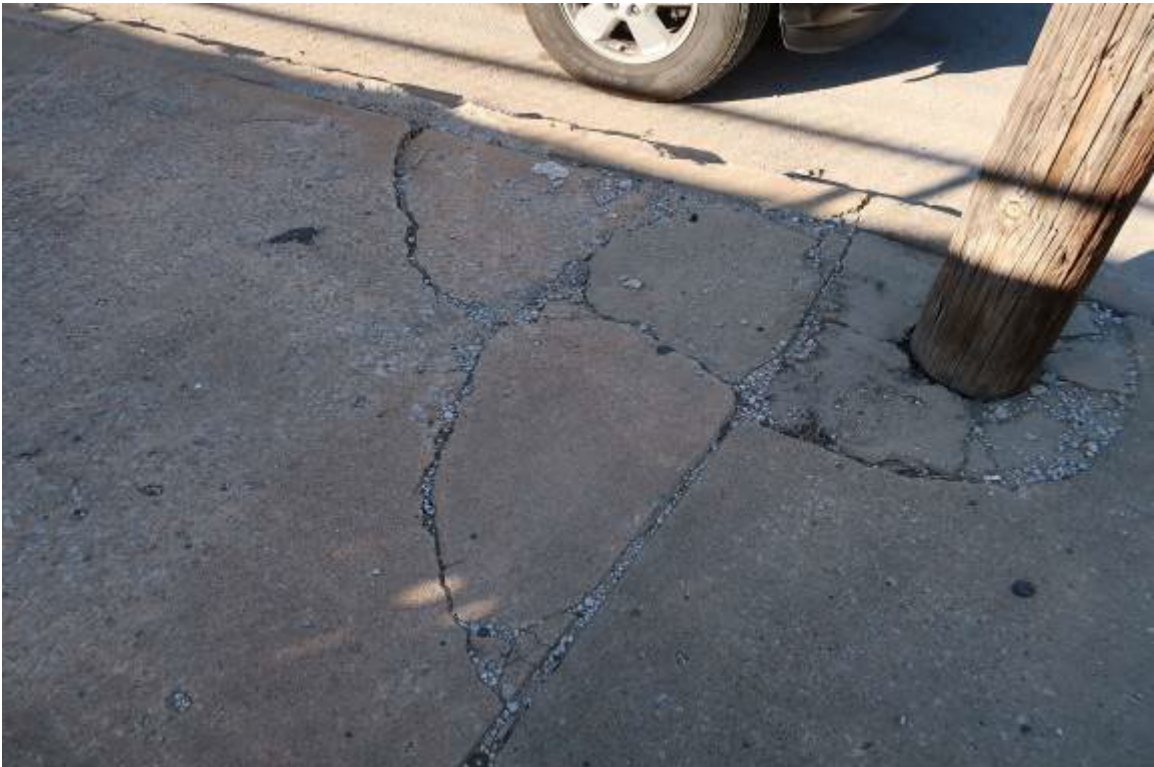
Adjoining Sidewalk Damage

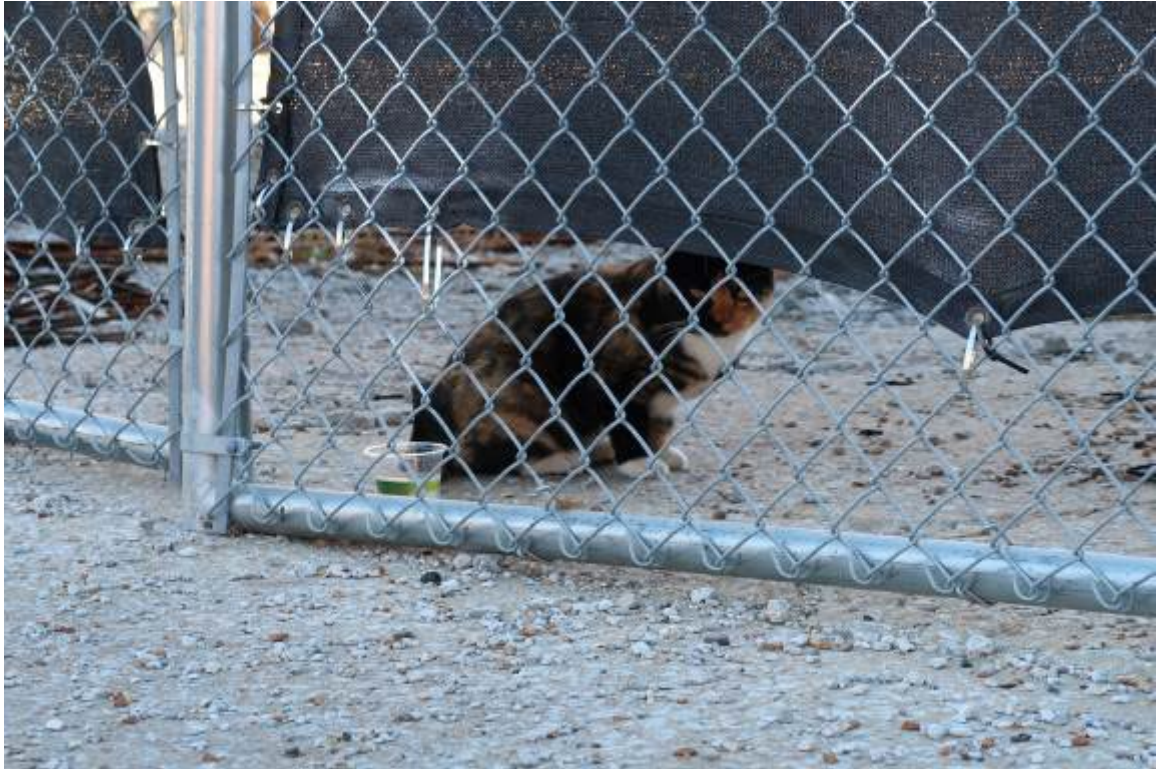
Gravel lots with access over adjoining public sidewalks creates safety concerns. Storage yards, even if fenced may create opportunity for loitering, vermin, and stray animals.

Storage Yard Safety Concern – Stray Animals
