AMENDED BLIGHT STUDY

WEST BOTTOMS STUDY AREA

FORESTER VIADUCT/BLUFF ROAD/W 12TH STREET/HICKORY STREET
KANSAS CITY, MISSOURI

NOVEMBER 17, 2023
RECORD No. 1800

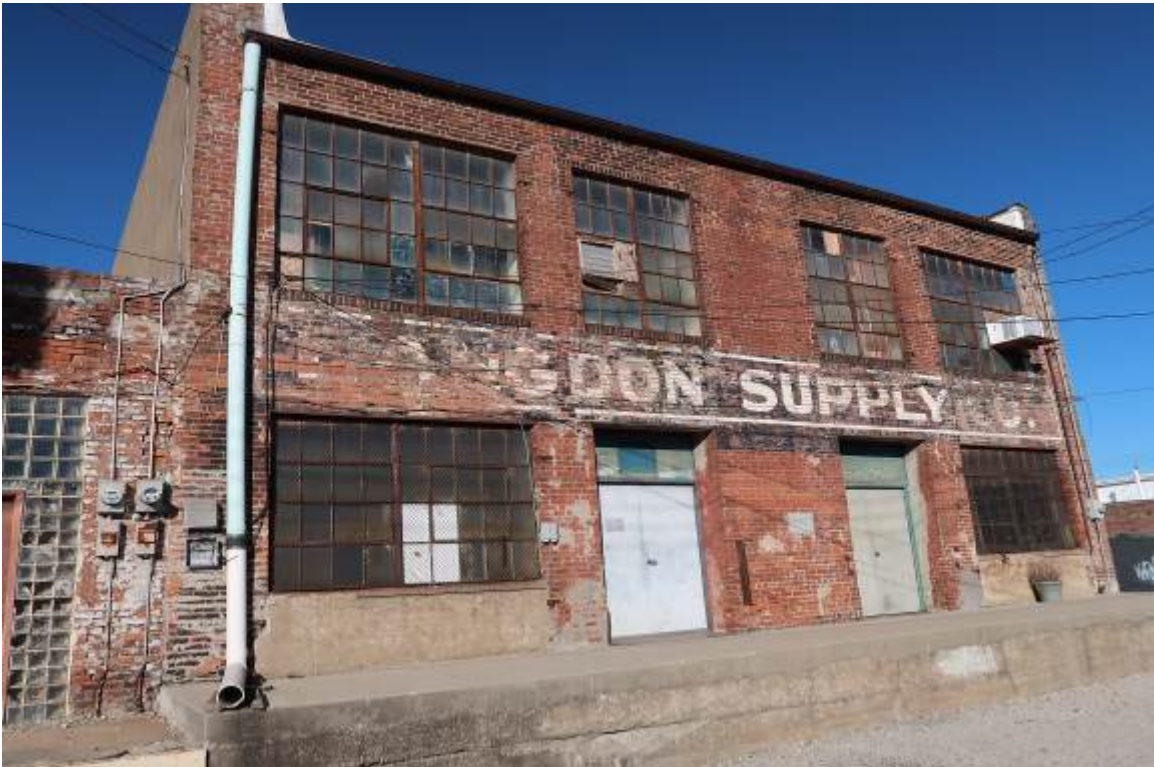
The Deteriorating Rear (South) Elevation Of 1317 Union Avenue

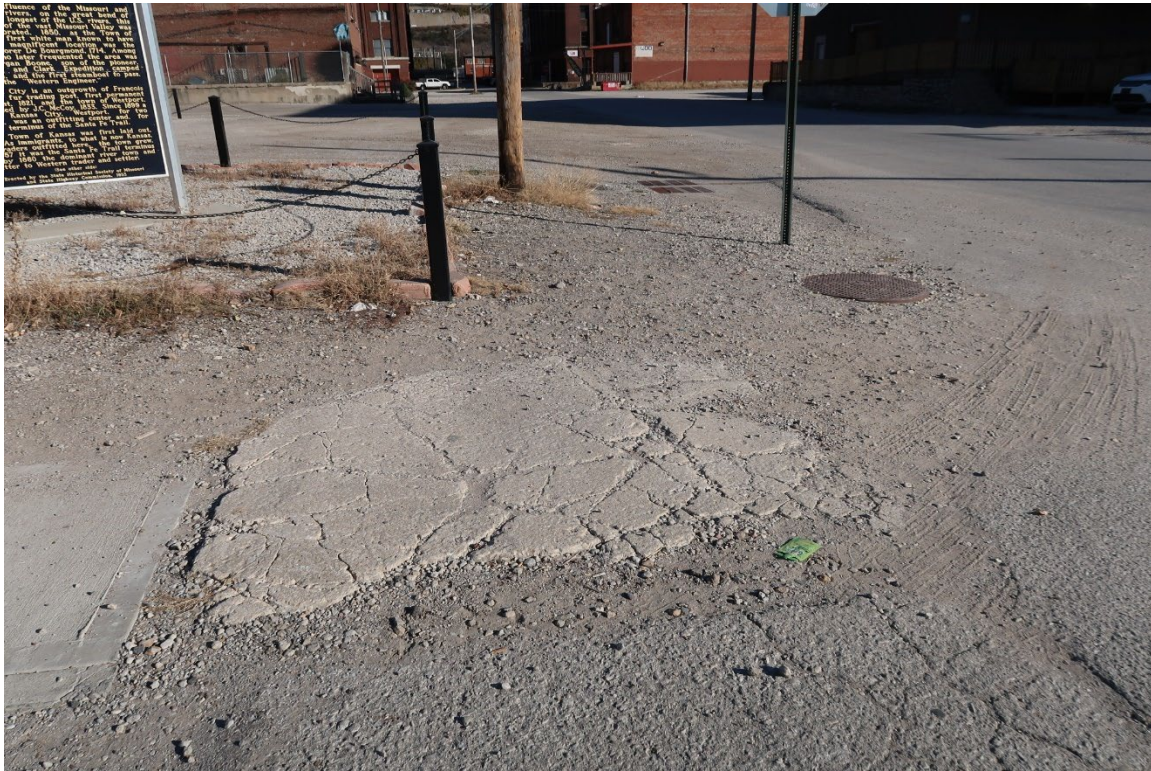
Damaged Pedestrian Sidewalk And Curbing Along Hickory Street

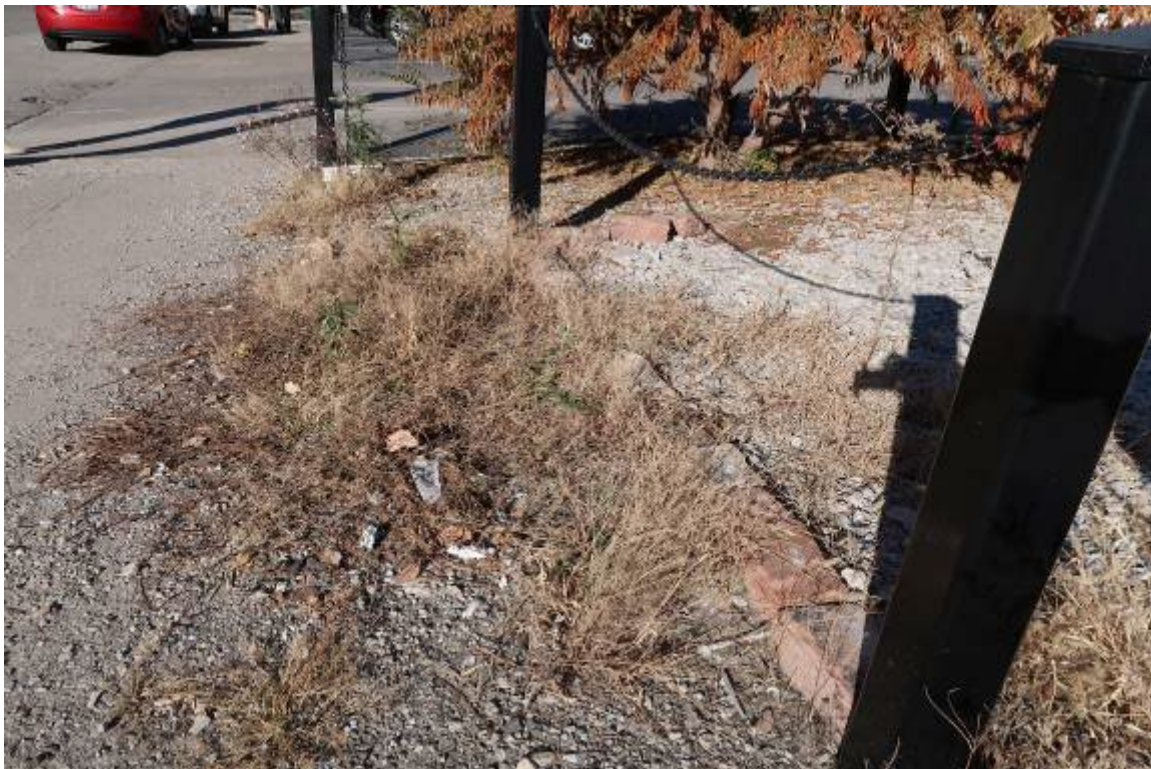
Unightly Landscaping & Trash Along Hickory Street

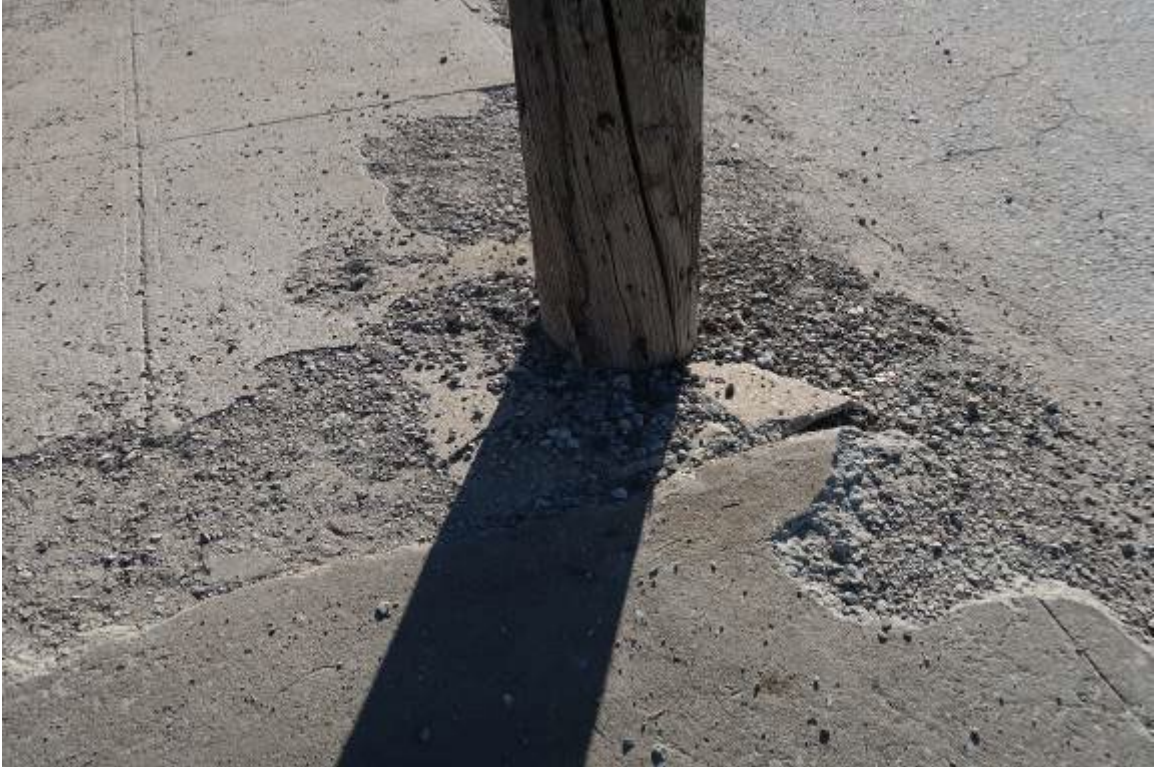
Damaged Pedestrian Sidewalk Along Hickory Street

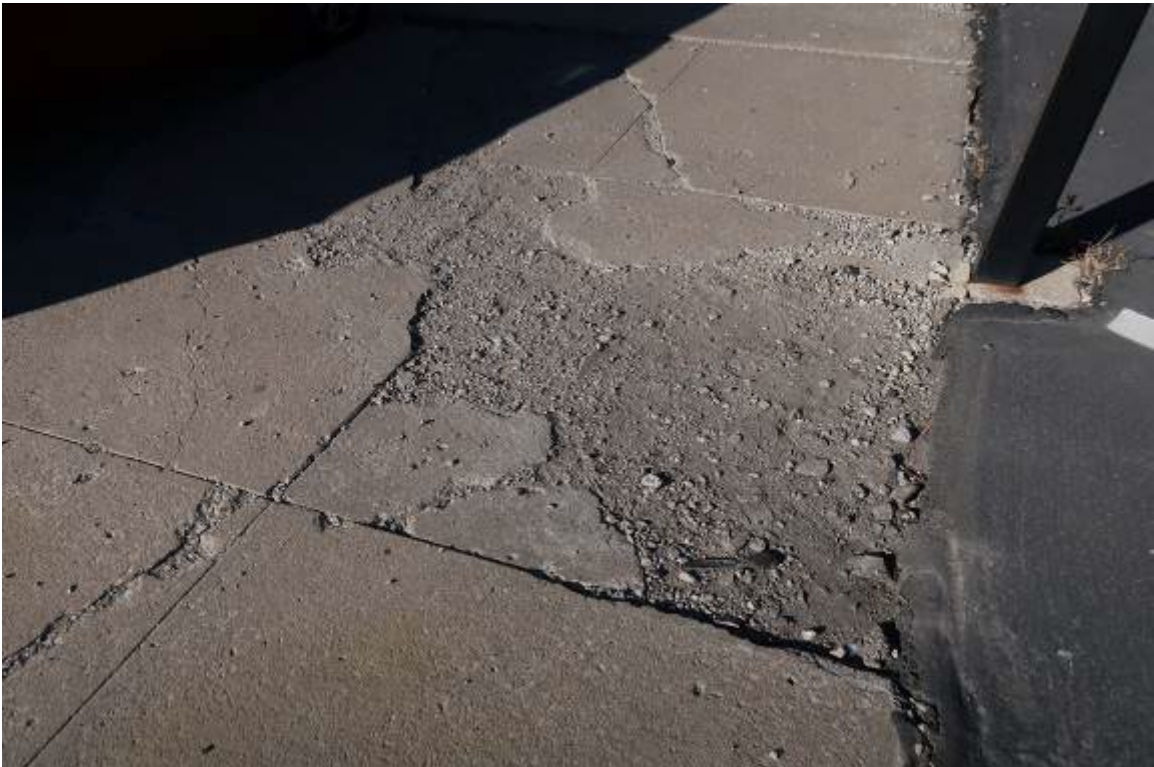
Damaged Pedestrian Sidewalk Along Hickory Street

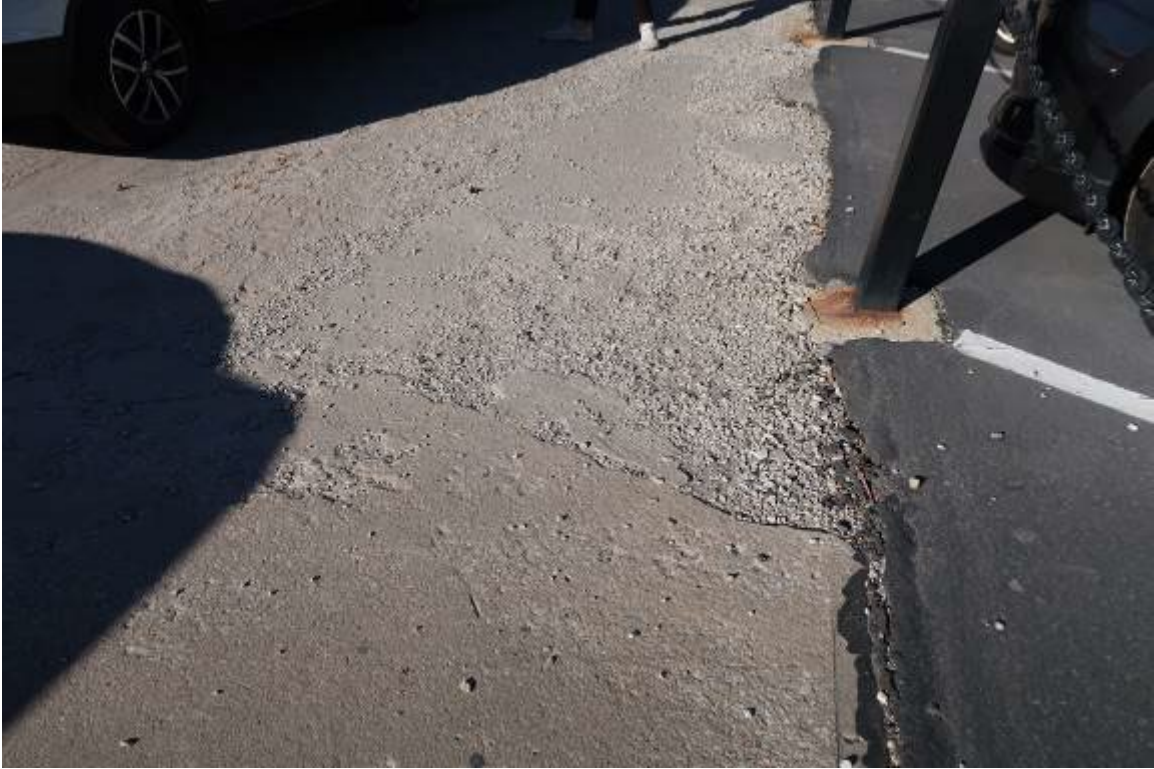
Damaged Pedestrian Sidewalk Along Hickory Street

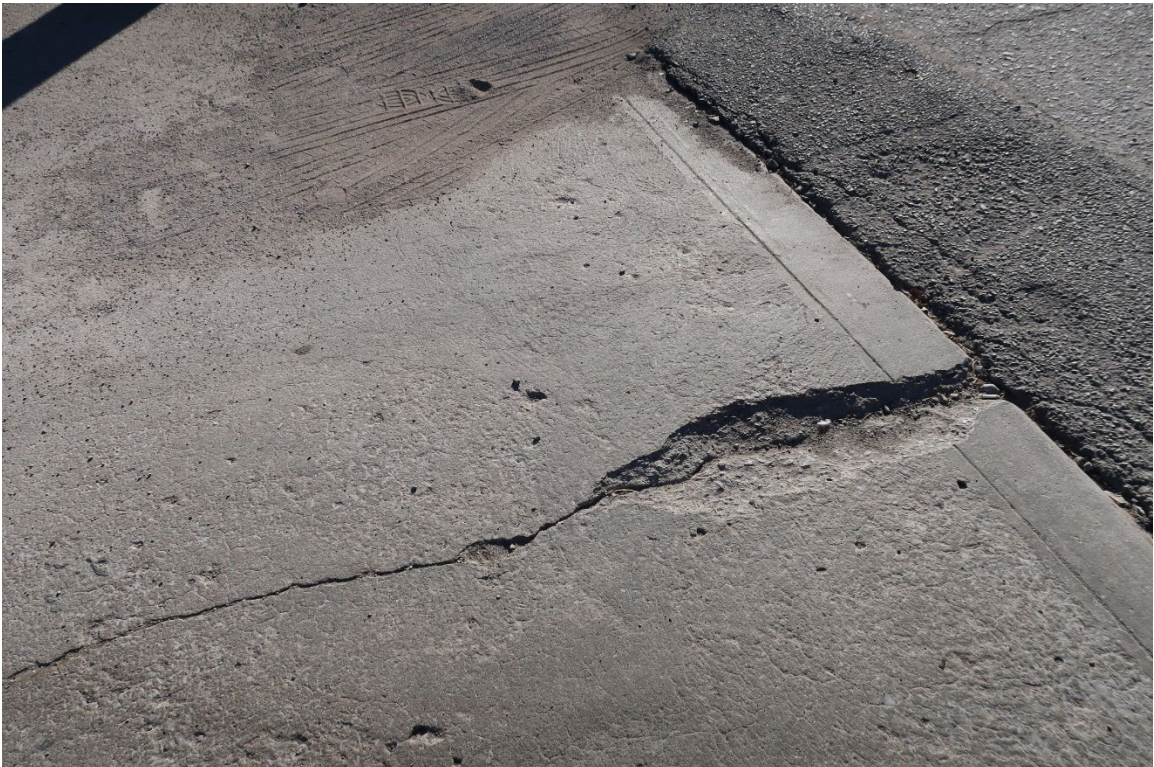
Damaged Driveway Along Hickory Street

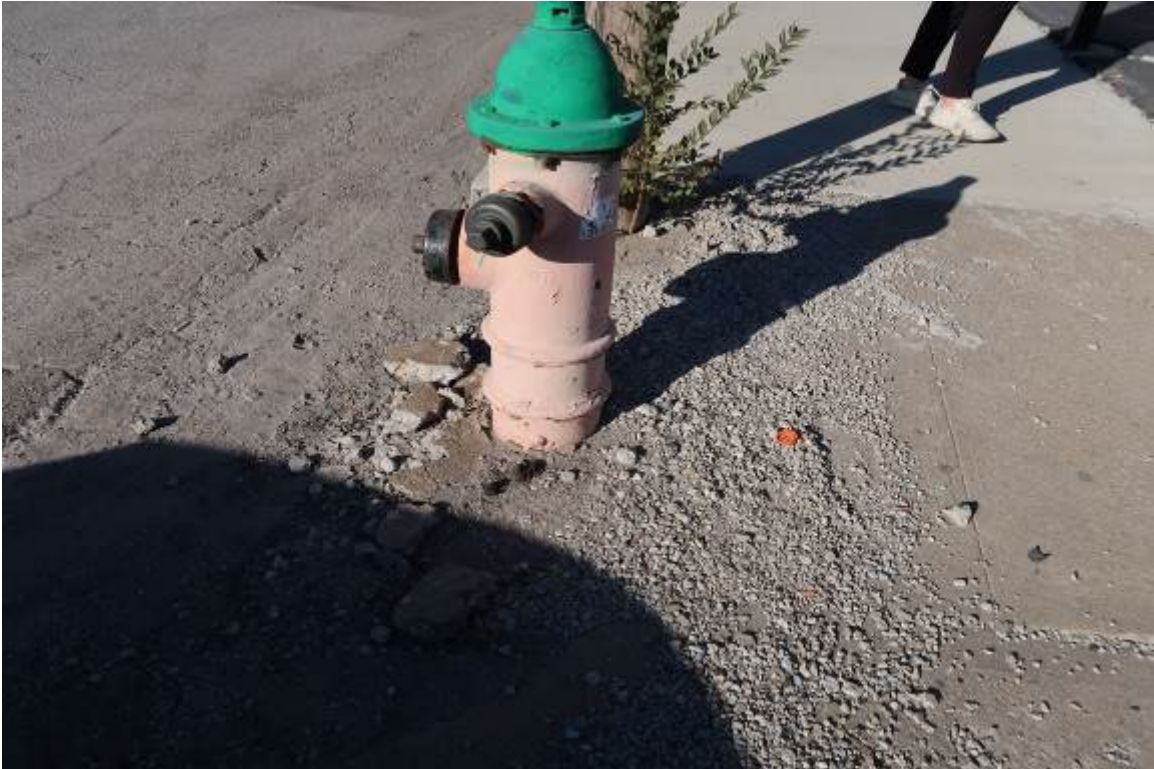
Damaged Pedestrian Sidewalk Along Hickory Street

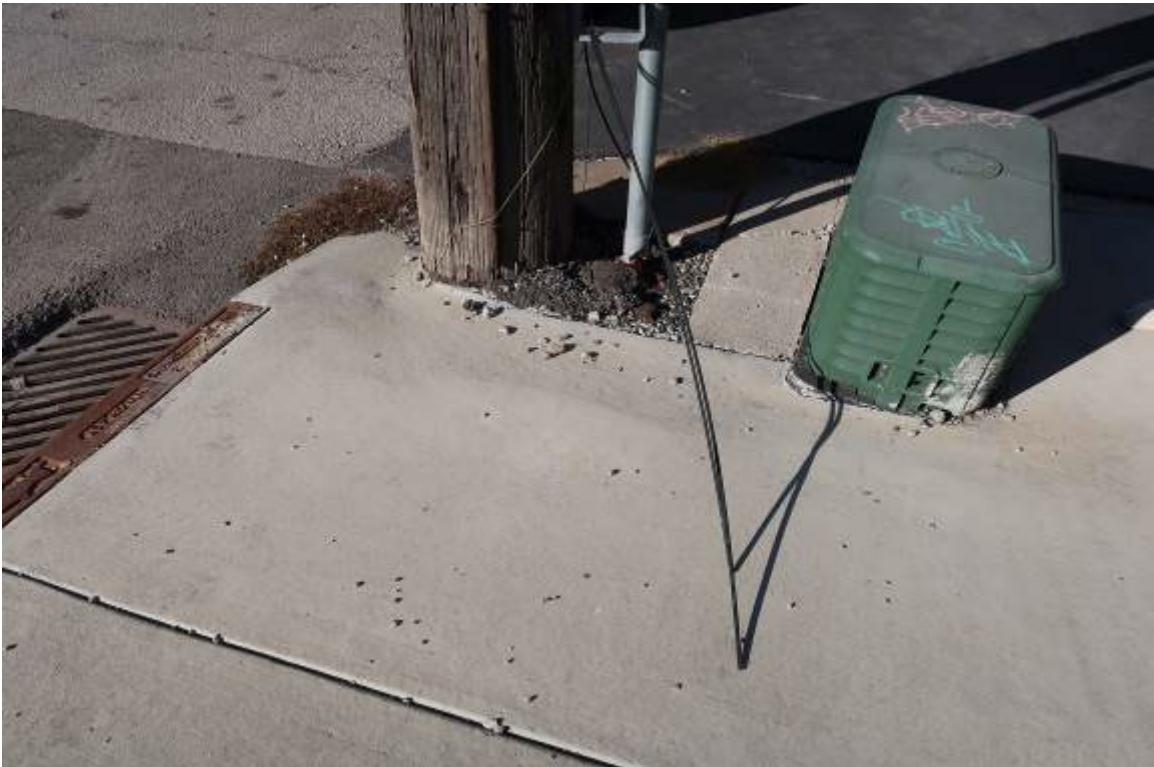
Wiring Hanging From Utility Pole Along Hickory Street Pedestrian Sidewalk
