Blight Study

**Hillcrest Community
Improvement District**

**Kansas City,
Missouri**

October 27, 2025

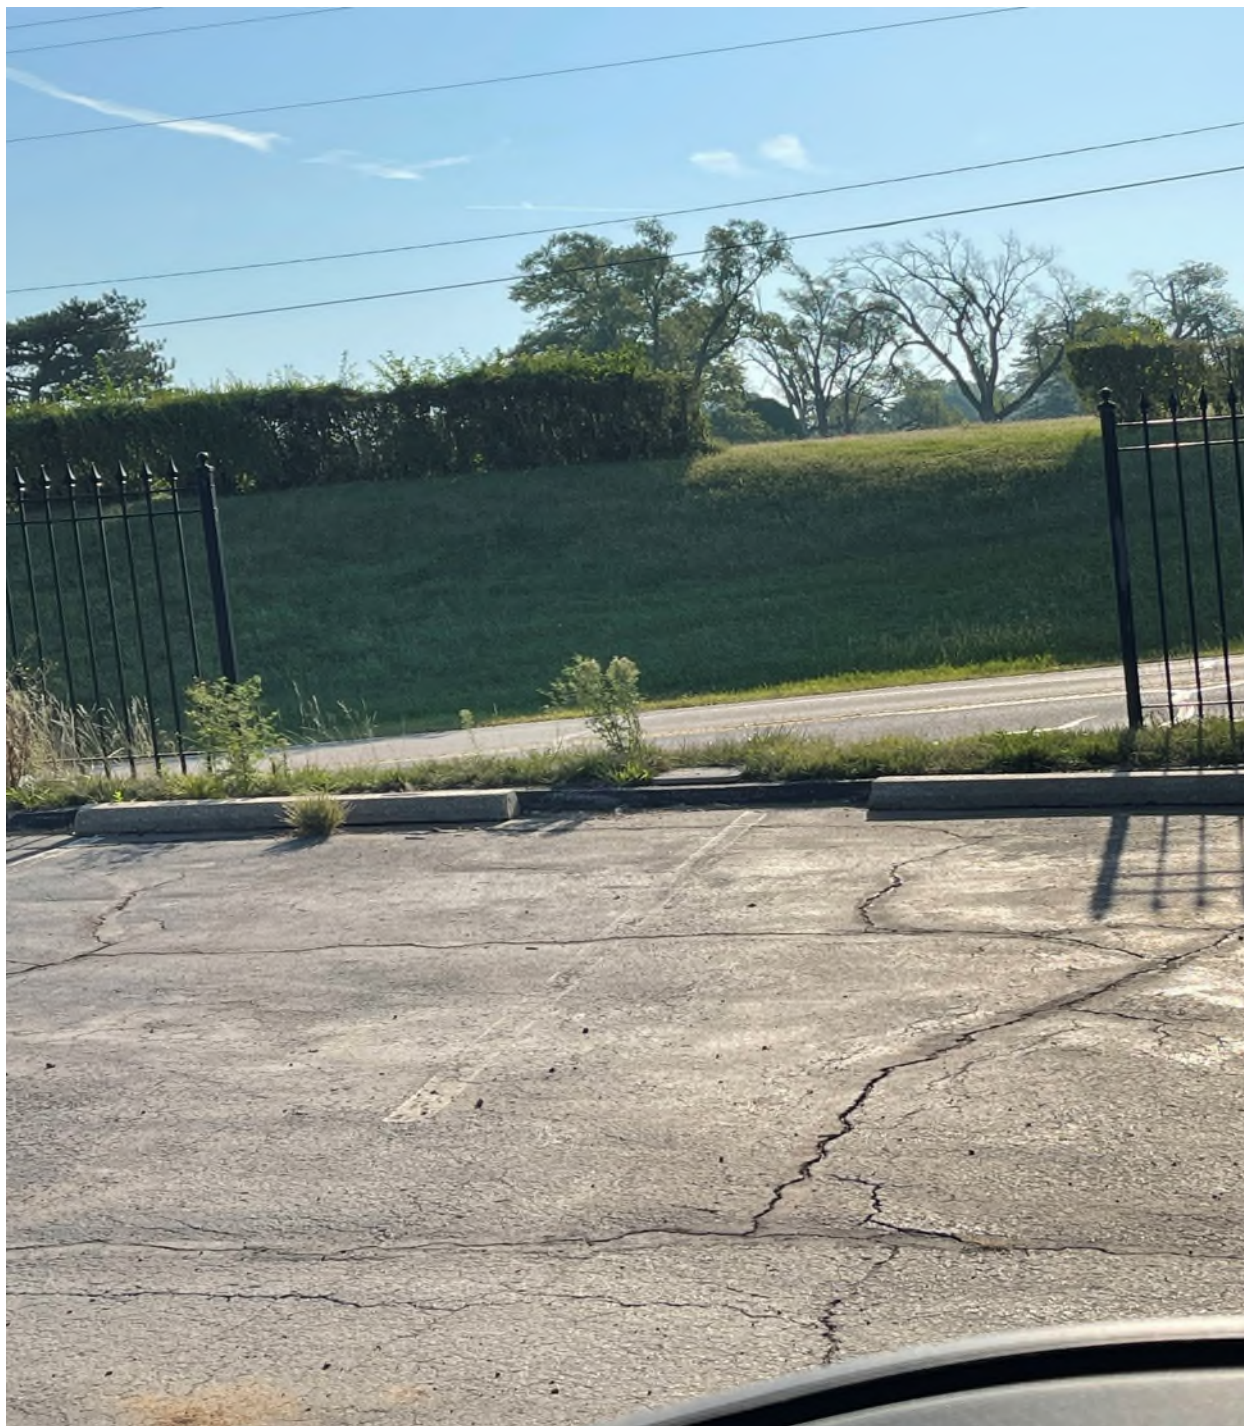
Figure 1: Destroyed Fencing

The fencing surround the Study Area is broken and clearly illegal trespassing has occurred, which has resulted in a multitude of problems throughout the Study Area. To begin, illegal trespassers have illegally dumped trash throughout the Study Area. Trespassers have stolen all electric components and copper throughout light poles and utility equipment within the Study Area, rendering these facilities useless. In the most extreme cases, trespassers have driven vehicles through fencing located along the eastern border of the Study Area along Hillcrest Road. Multiple police reports concerning these instances have been filed with the Kansas City, Missouri Police Department for reference.

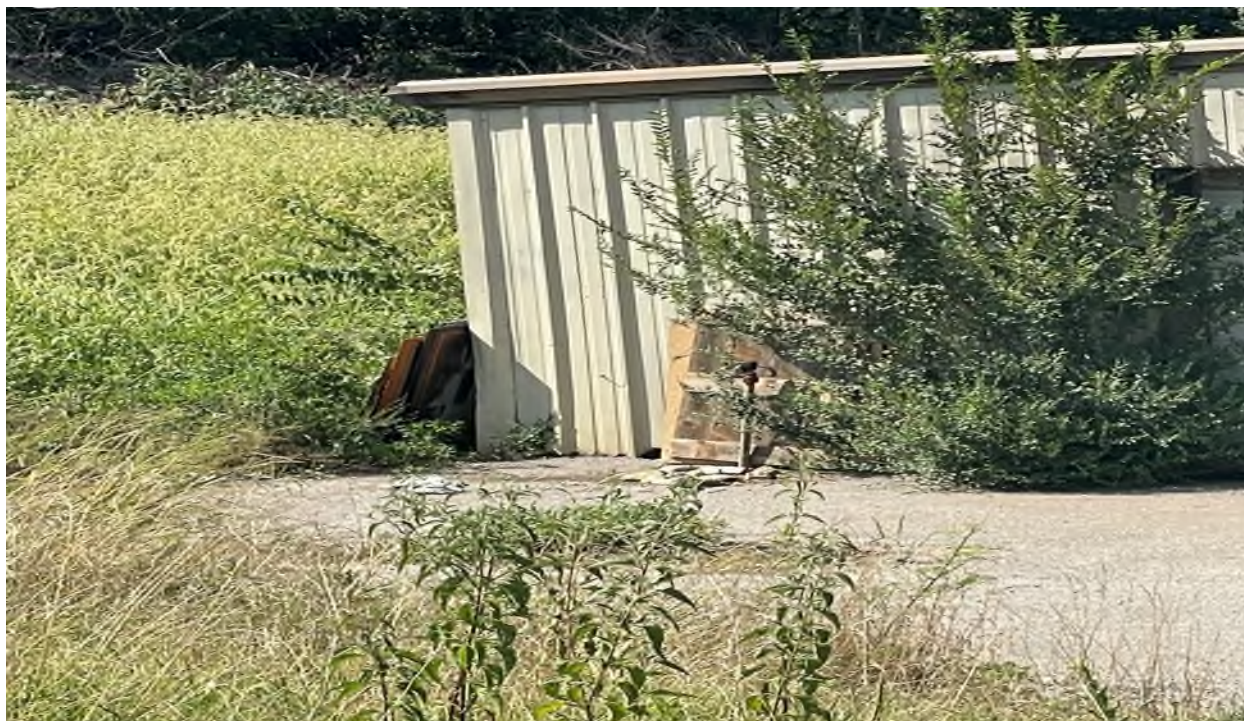
Figure 2: Deteriorated/Destroyed Structures

In addition, the Study Area contains dilapidated maintenance buildings, which cannot be utilized in their current condition. All maintenance buildings are plagued with deteriorating conditions and have been damaged by multiple instances of illegal trespassing. Aside from the criminal nature of the trespassing occurring, within these structures there is evidence of the structure being used to further other criminal activities, such as drug use, destruction of private property, and other similar conduct.

Deteriorating structure within Study Area.

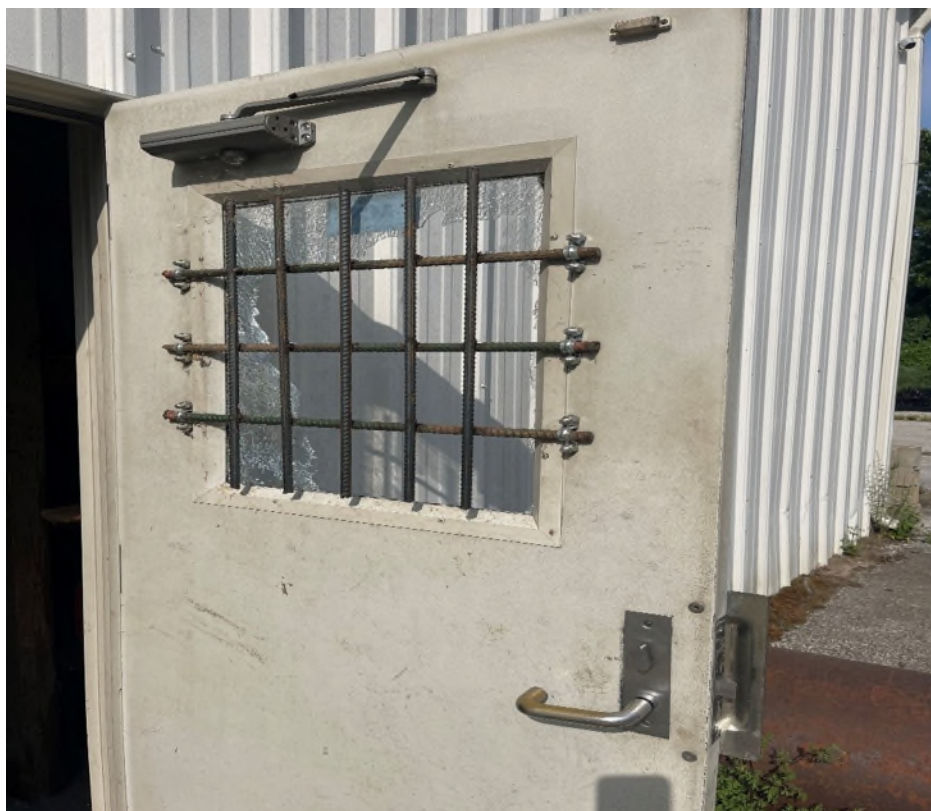
Evidence of destruction of maintenance building.

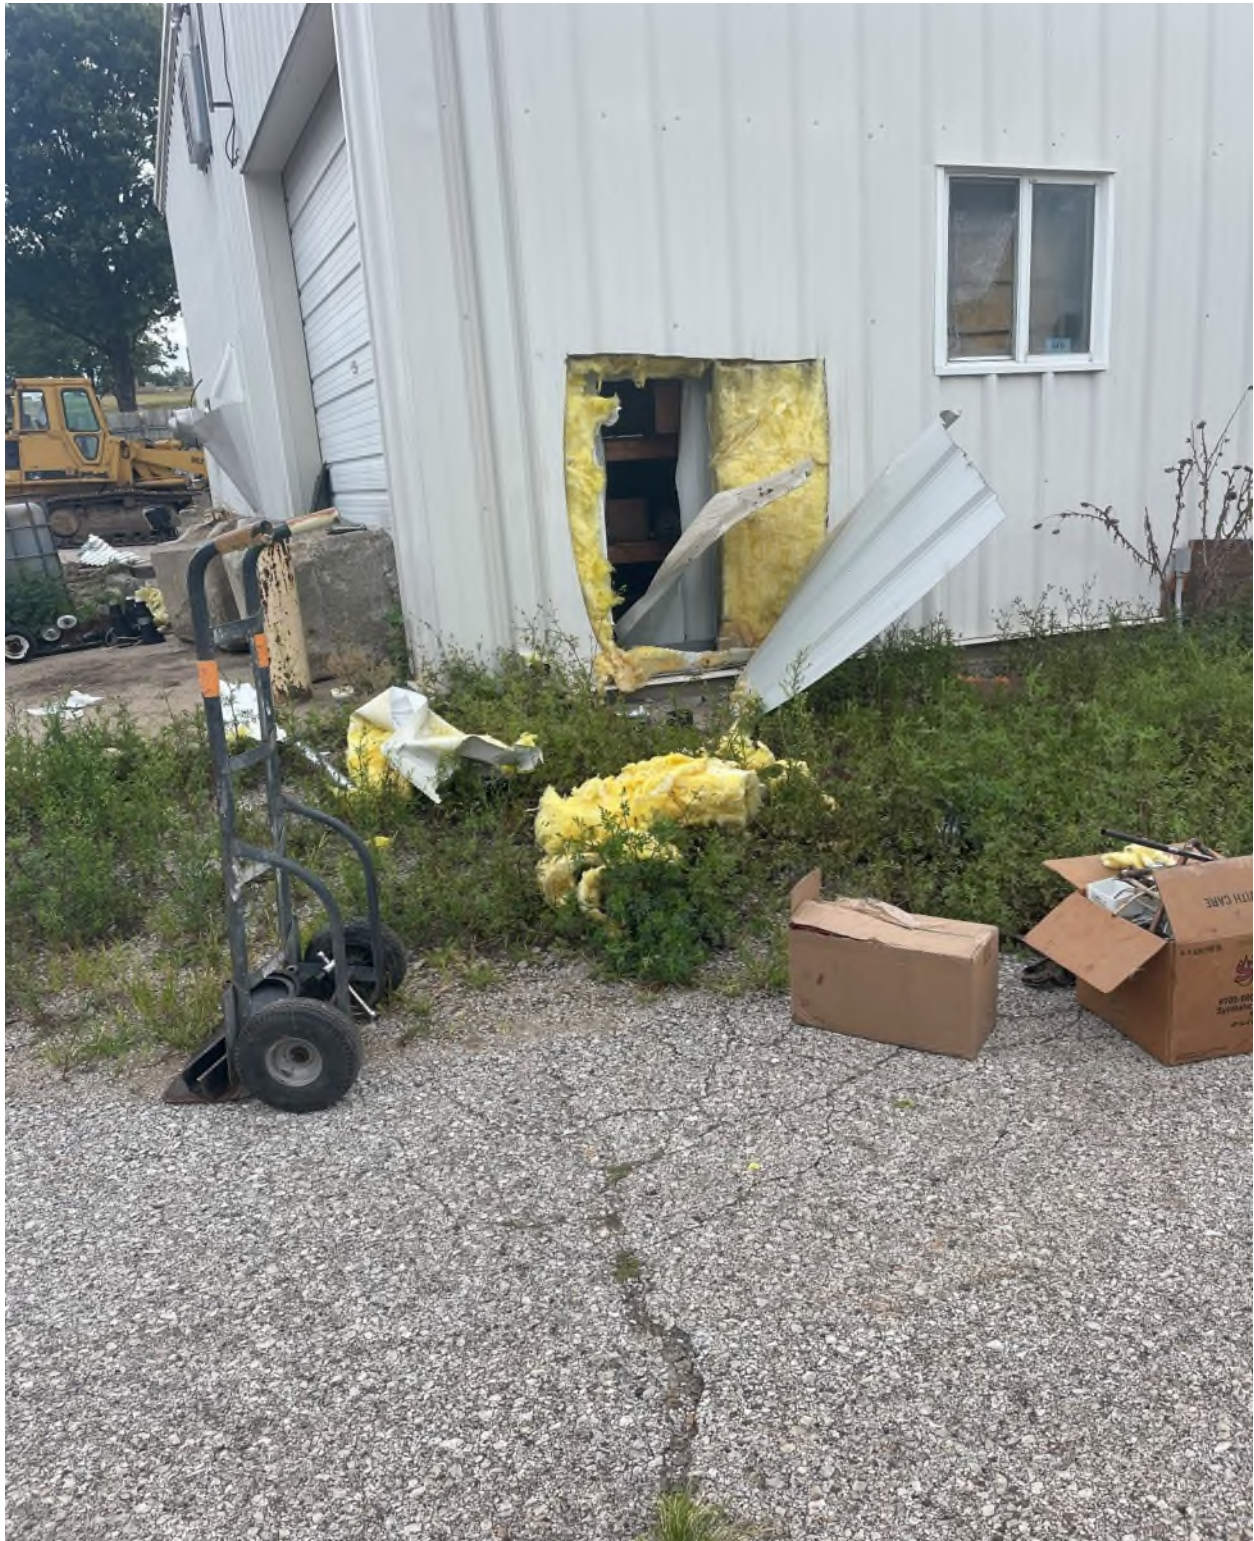
Evidence of illegal trespassing.

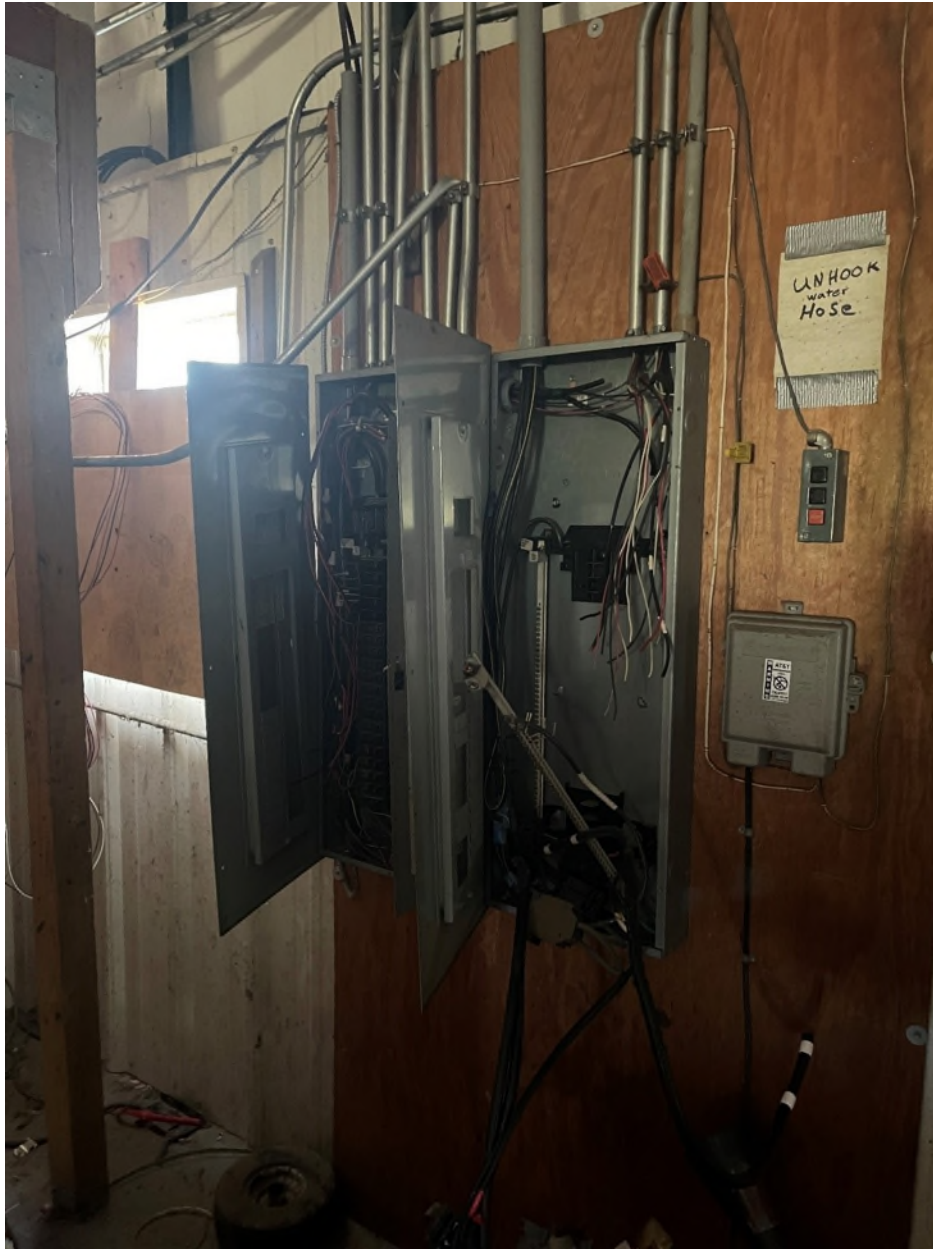
Destroyed electrical box from trespassers.

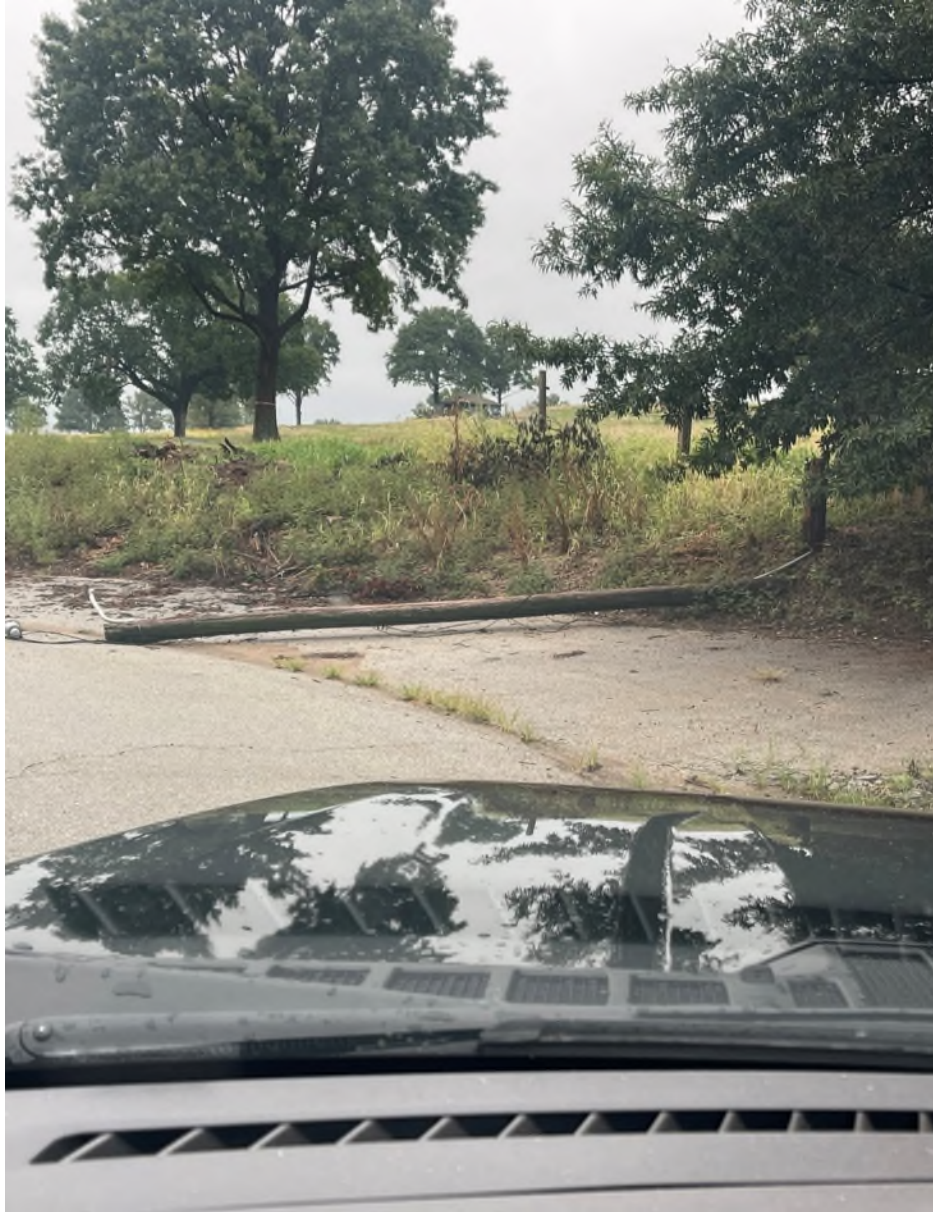
Destroyed public utility facilities from trespassers.

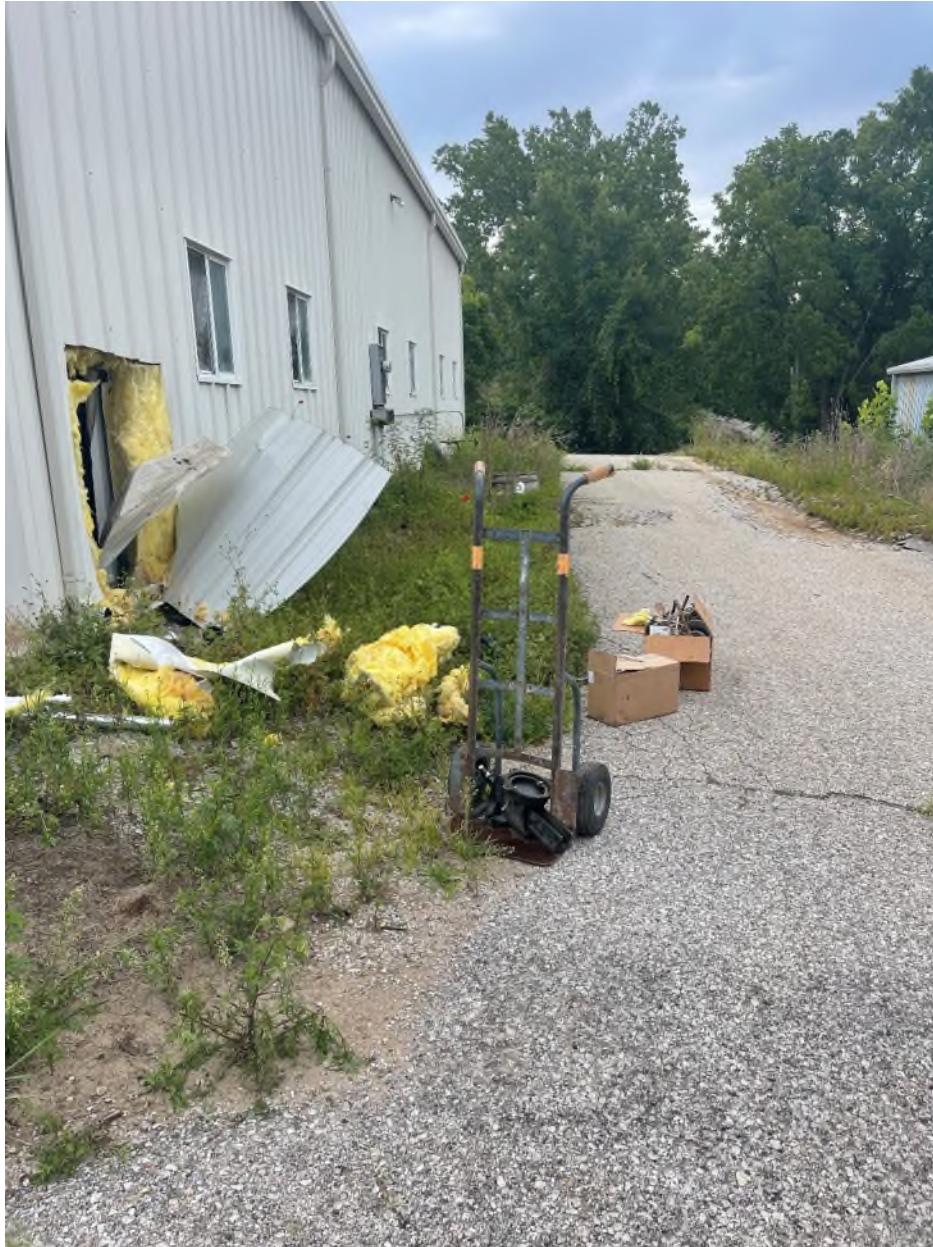
Figure 3: Dilapidated and Deteriorating Improvement

Deteriorating existent structure and asphalt.

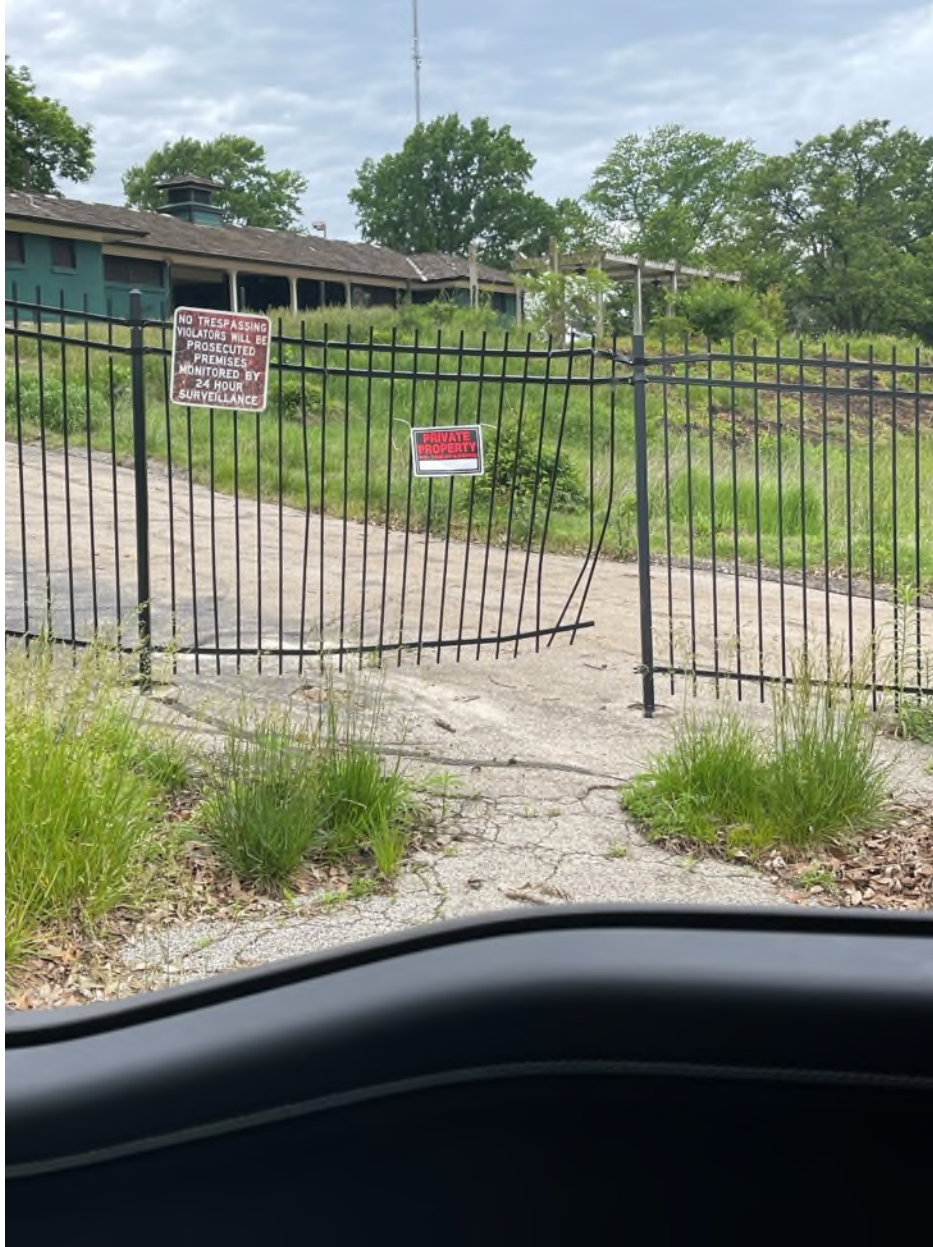
Evidence of trespassing (broken fencing) and deterioration of improvements within Study Area.

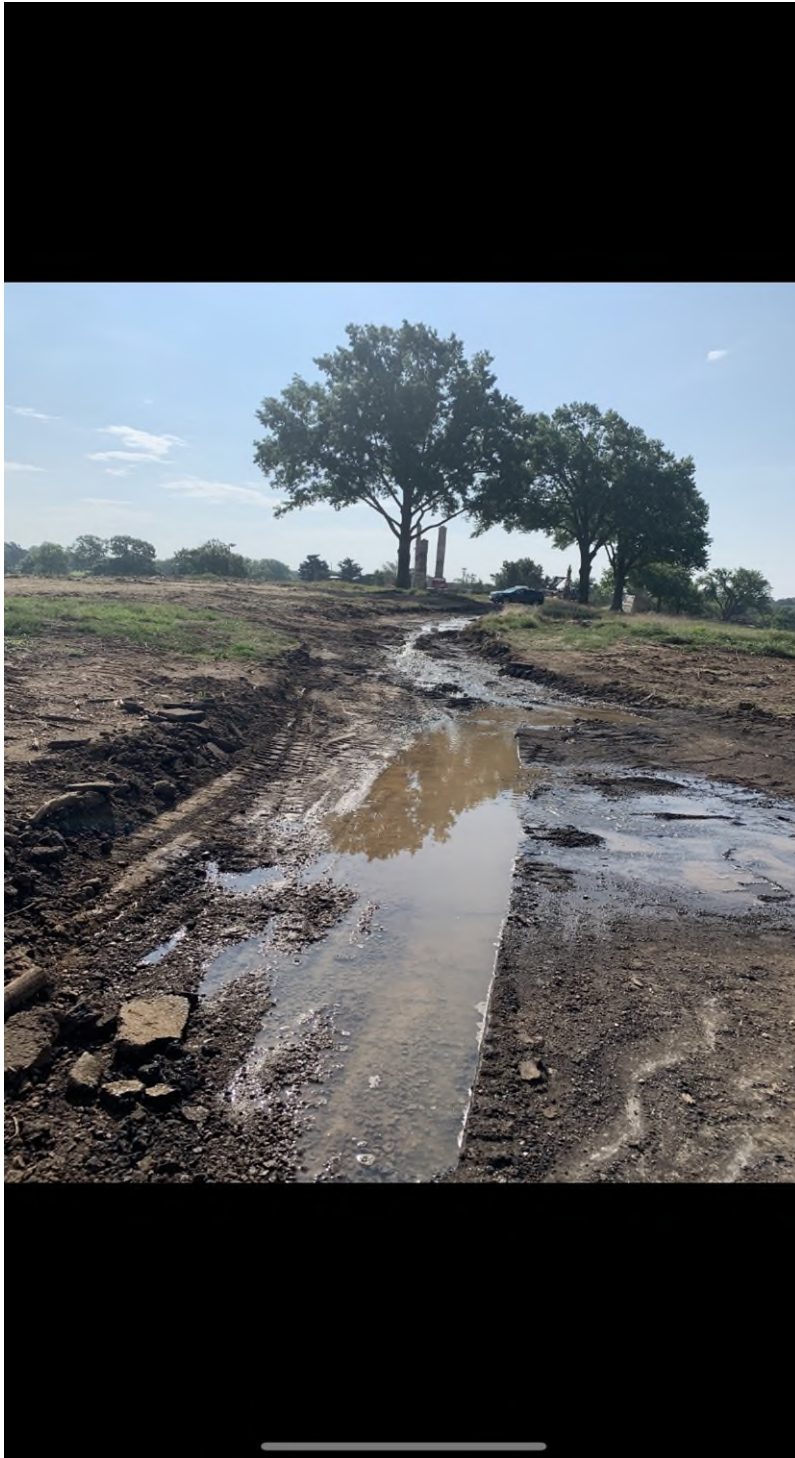
Figure 4: Inadequate Access

Lastly, the Study Area currently lacks maintained and usable internal access roads, which creates an unsafe condition for use of the existing internal roadways. This limits access to the Study Area and will not allow emergency vehicles proper access to the Study Area as a majority of the approximately 155.95-acre site has no roadways allowing movement within it aside from the dilapidated roadways depicted below.

Deteriorated access road within Study Area.

Any future development of the Study Area would require replacement of destroyed fencing, reconstruction of access, and repaving of all internal roads/parking facilities to facilitate proper access and traffic flow to and throughout the Study Area. It is anticipated that future access to the Study Area will require remediation of access points to reach the entirety of the Study Area and to facilitate full accessibility to all parts of the Study Area.

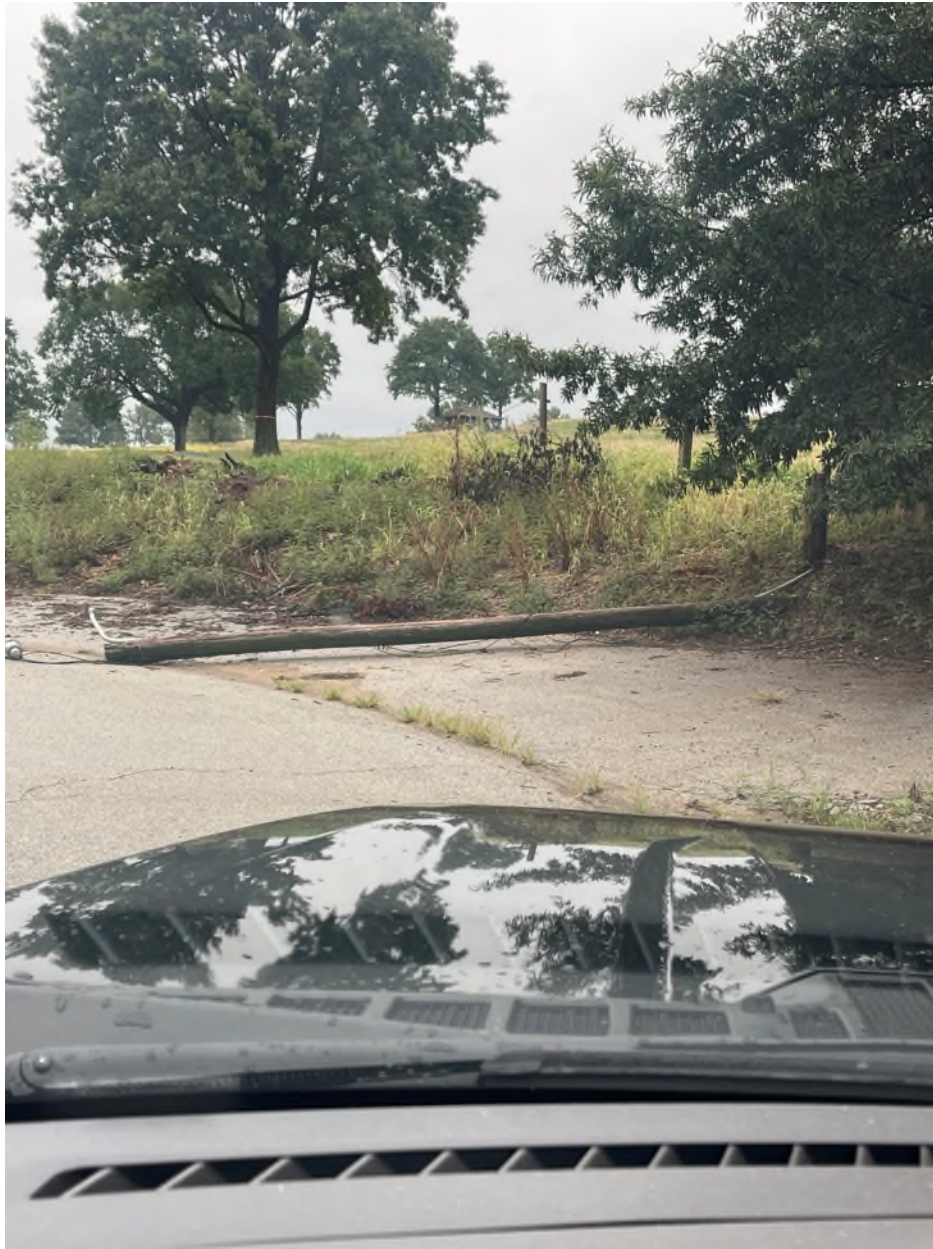
Figure 5: Inadequate Access

Deteriorated pavement for parking facilities.

Any future development of the Study Area will require significant renovations to the existing parking facilities, access points, and internal drives.

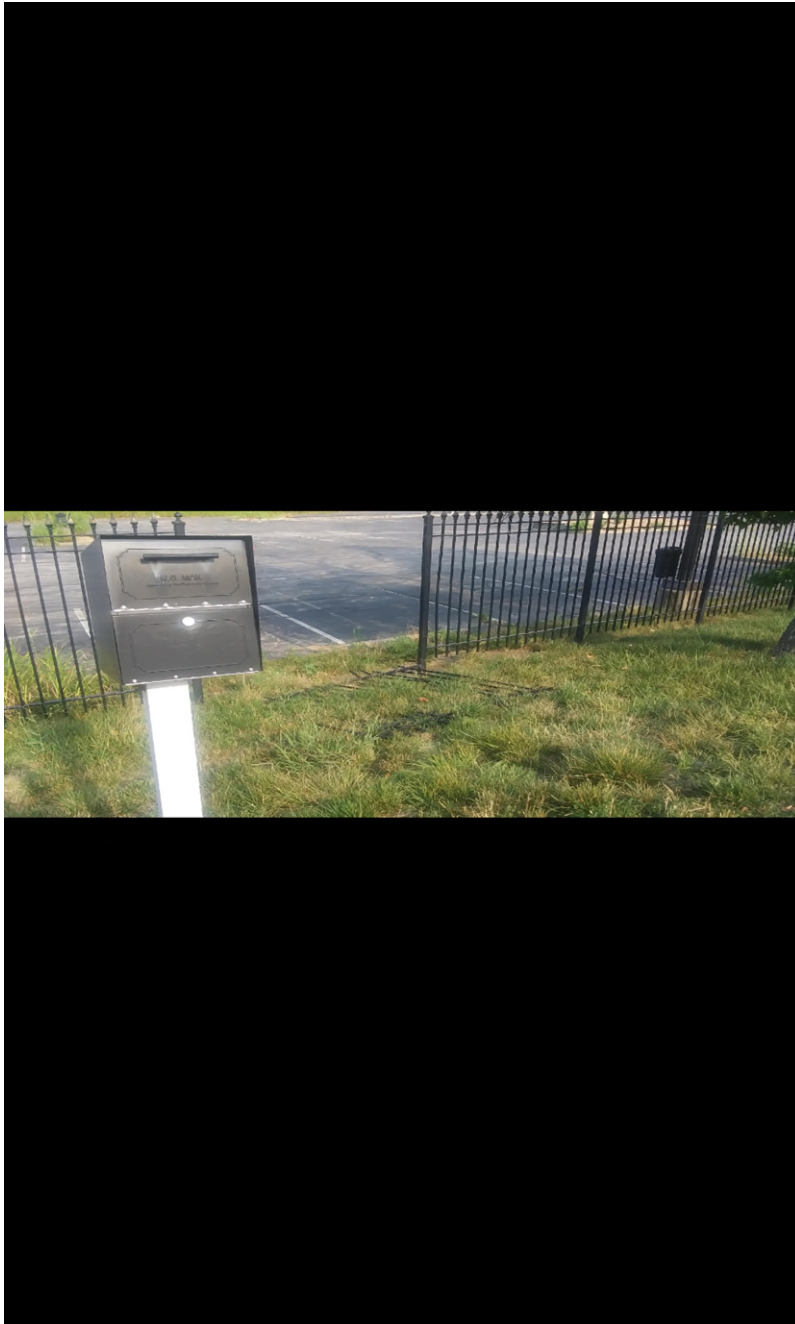
Figure 6: Deteriorating Site Improvements

In particular, the maintenance buildings and associated improvements (the “Golf Course”) have experienced consistent and pervasive deterioration. The Golf Course site area exhibits widespread asphalt cracking, crumbling, and uneven surfaces requiring repair. There is widespread dilapidation to the building, including cracks, siding disrepair, peeling exterior finishes, destroyed security fencing, and generalized degradation of building facades.

Destroyed security fencing.

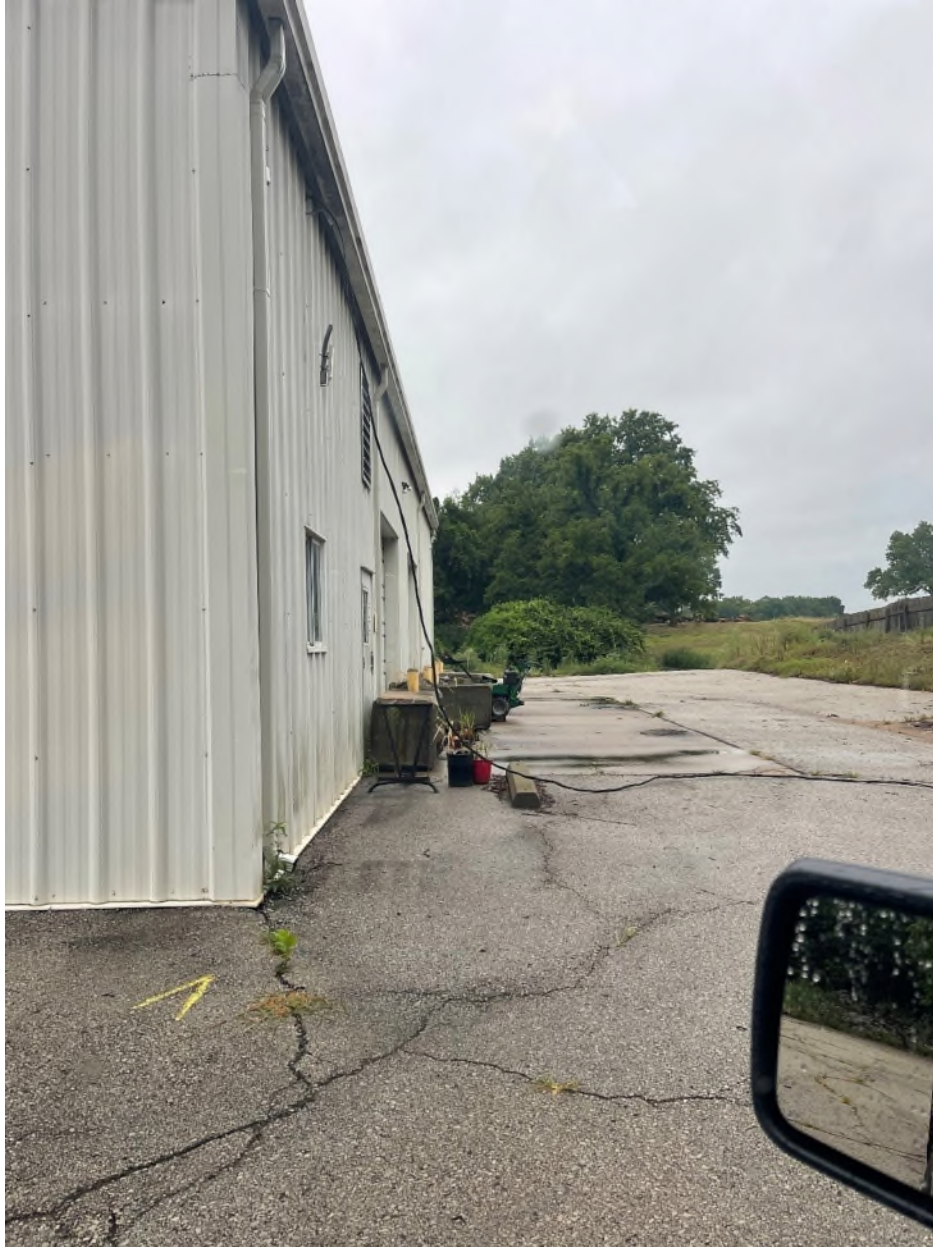
Deteriorating pavement and building façade.
