906 Grand Boulevard  
Community Improvement District

## **Blight Study**

906 Grand Building Hospitality, LLC  
Kansas City, Missouri  
December 2, 2021

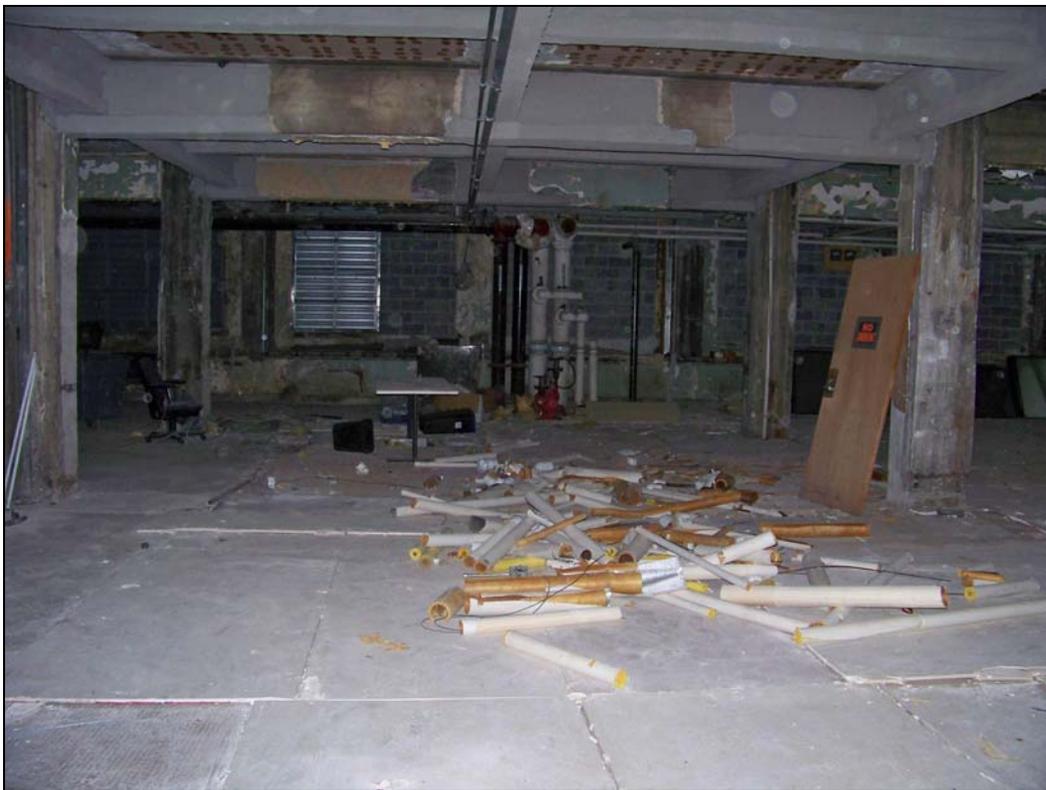
*Interior – deterioration of finishes; uneven floor; debris; lack of fire suppression*

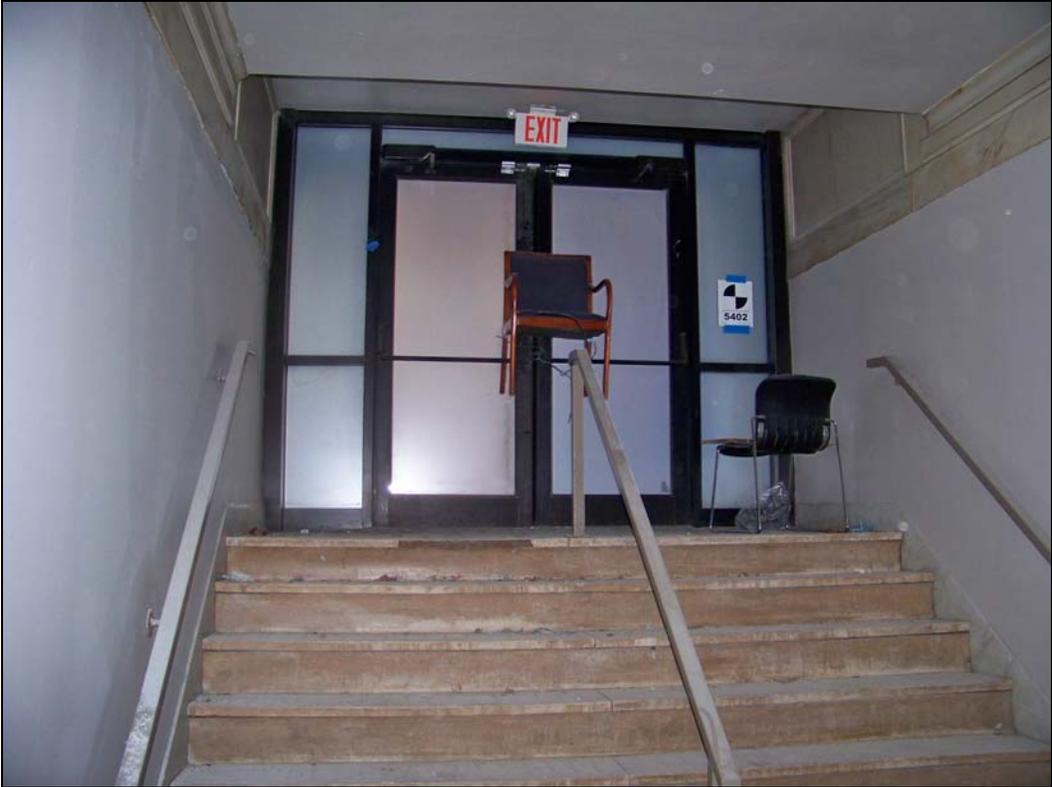
*Interior – west entrance door locks inoperable (doors secured with chair and cable lock)*

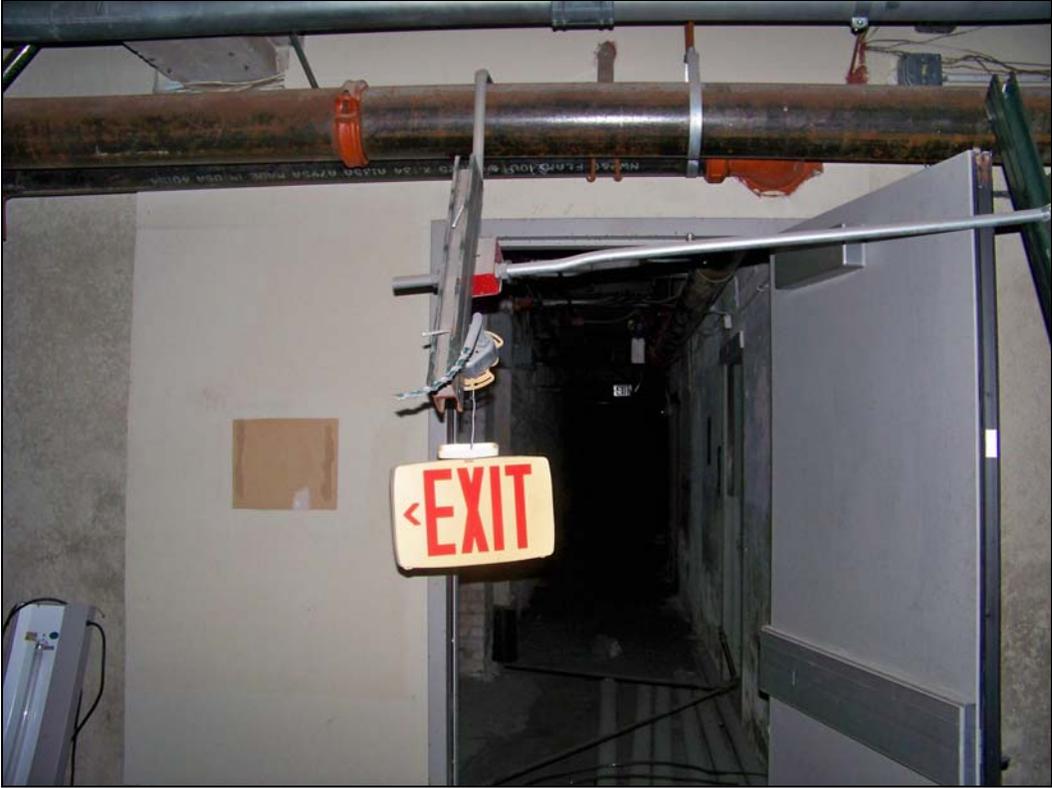
*Interior – nonfunctioning emergency lighting*

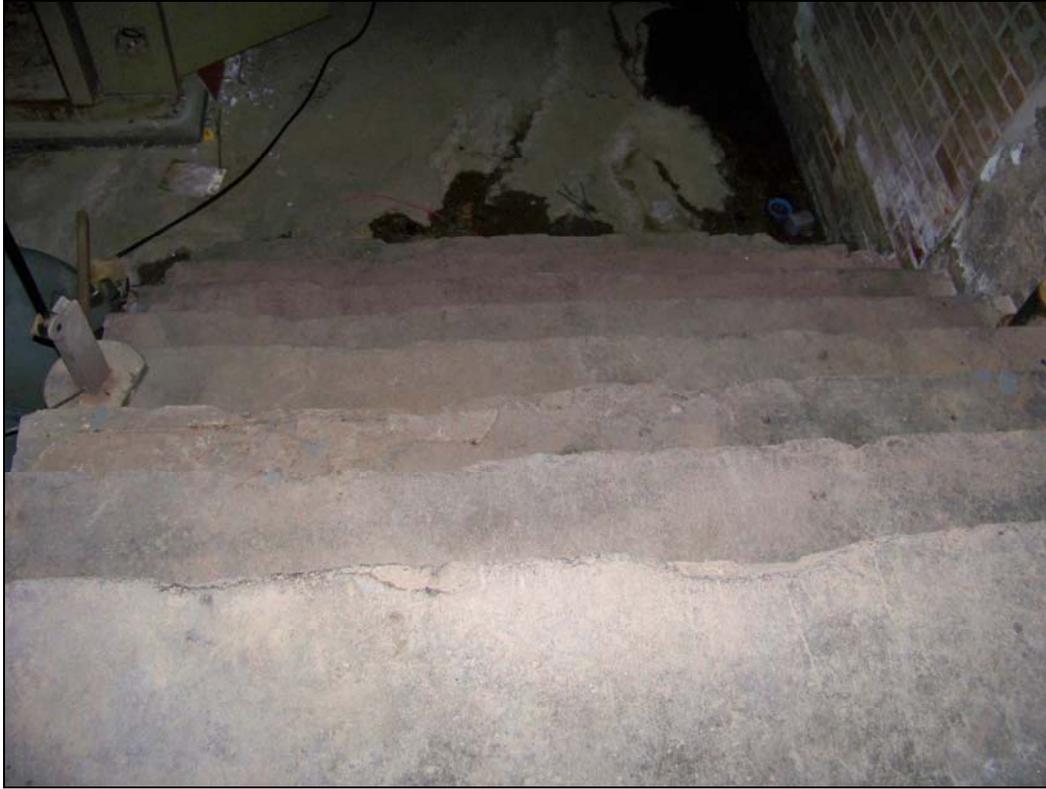
*Interior – deteriorated steps with no handrail in lower level; standing water*

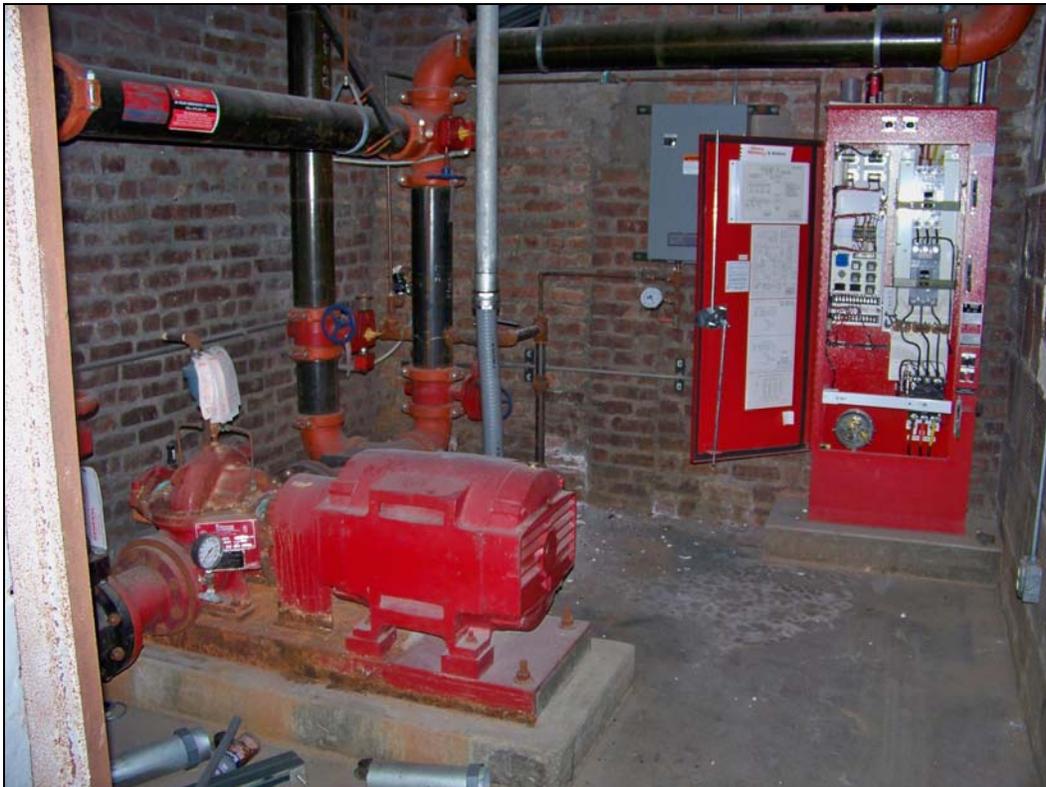
In addition to the lack of electricity, the flood also caused the shut-down of the fire pump in the lower level which critically impacts the ability of the fire suppression system (sprinklers) to operate. Sprinklers are not installed throughout the entirety of the building.

*Interior – nonfunctioning fire pump, corroded*

As noted previously a flood occurred within the Rialto Building due to a water main line break on 9<sup>th</sup> Street in Fall 2019 and since that time the building has been without power and without a functioning fire pump, which is an integral part of a fire sprinkler system. Without a fire pump the building and lives are at greater risk in the event of a building fire.

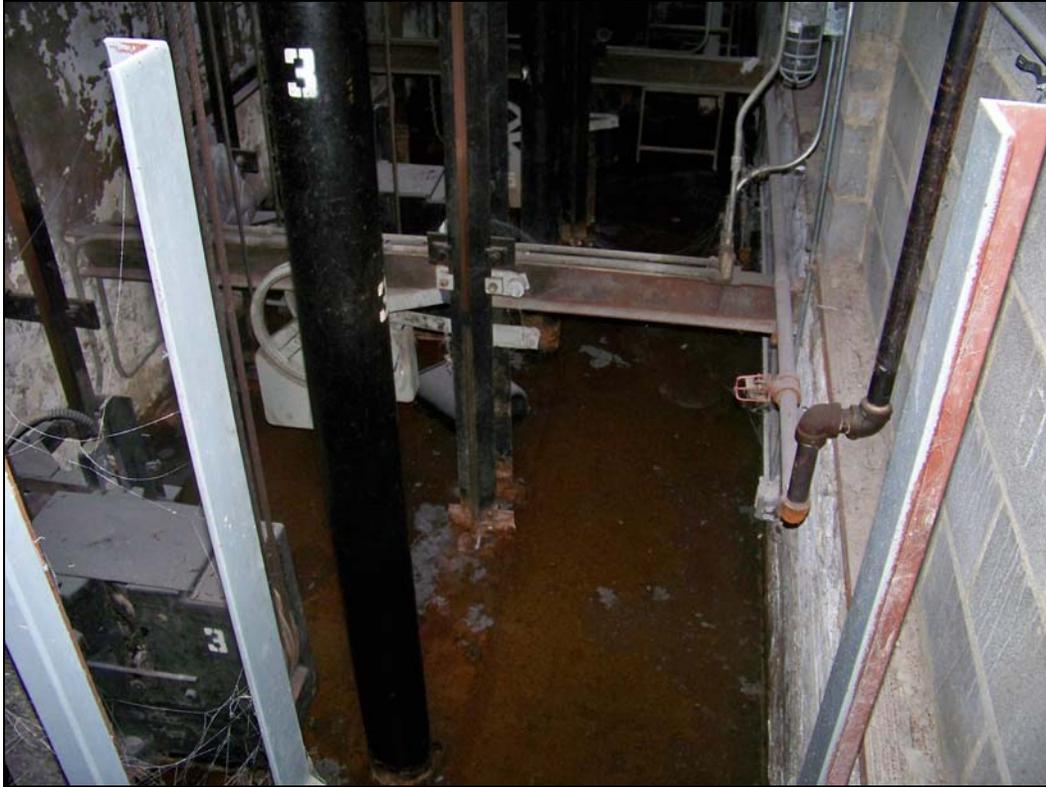
*Interior – standing water at bottom of elevator shaft*

- Approximately 6 inches of standing water is present at the bottom of the elevator shaft at Level B2. The source of this water was not visible. Structural steel members were submerged in the standing water and corrosion is present on these steel members.
- Approximately 24 inches of gypsum board is removed from all interior stud walls at Level B2.

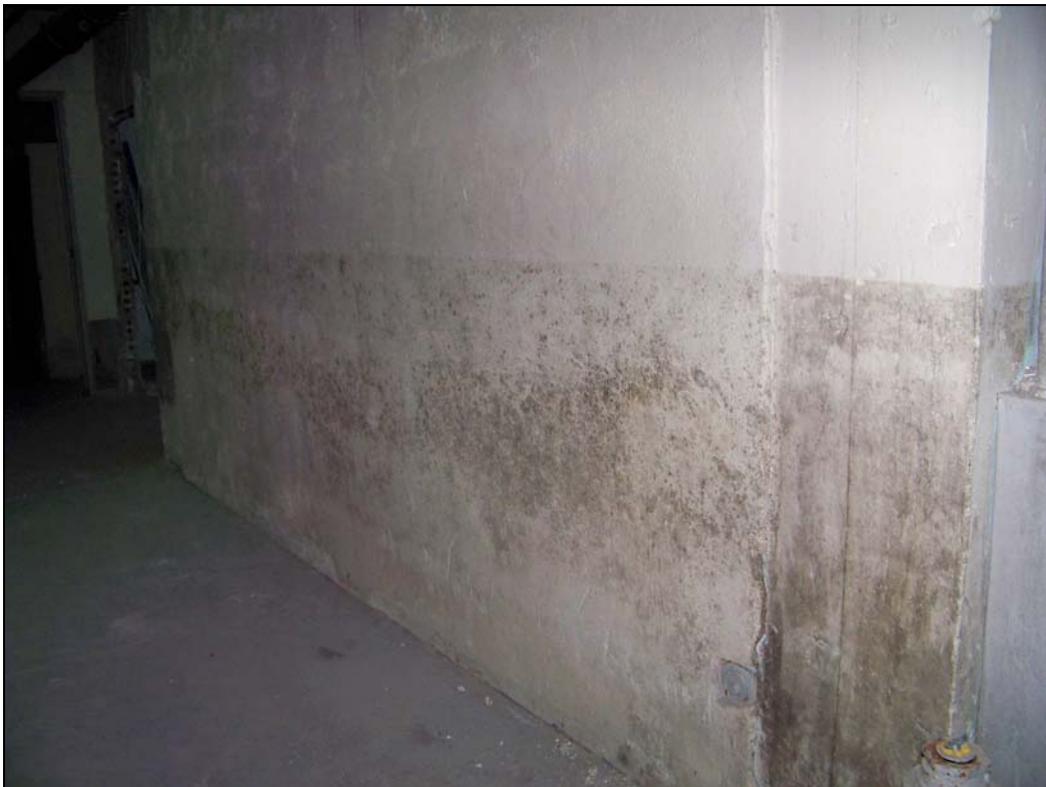
Electrical power has been unavailable since a flood in Fall 2019, caused by a water main line break on 9<sup>th</sup> Street that impacted the lower levels of the building which, among other things, impacts vertical transport (without power the elevators are nonfunctioning) in addition to all of the building systems. Some lighting is available through the use of generators and extensions from the neighboring building at 910 Grand Boulevard.

*Interior – water line of flooding in lower level; water and mold damage*

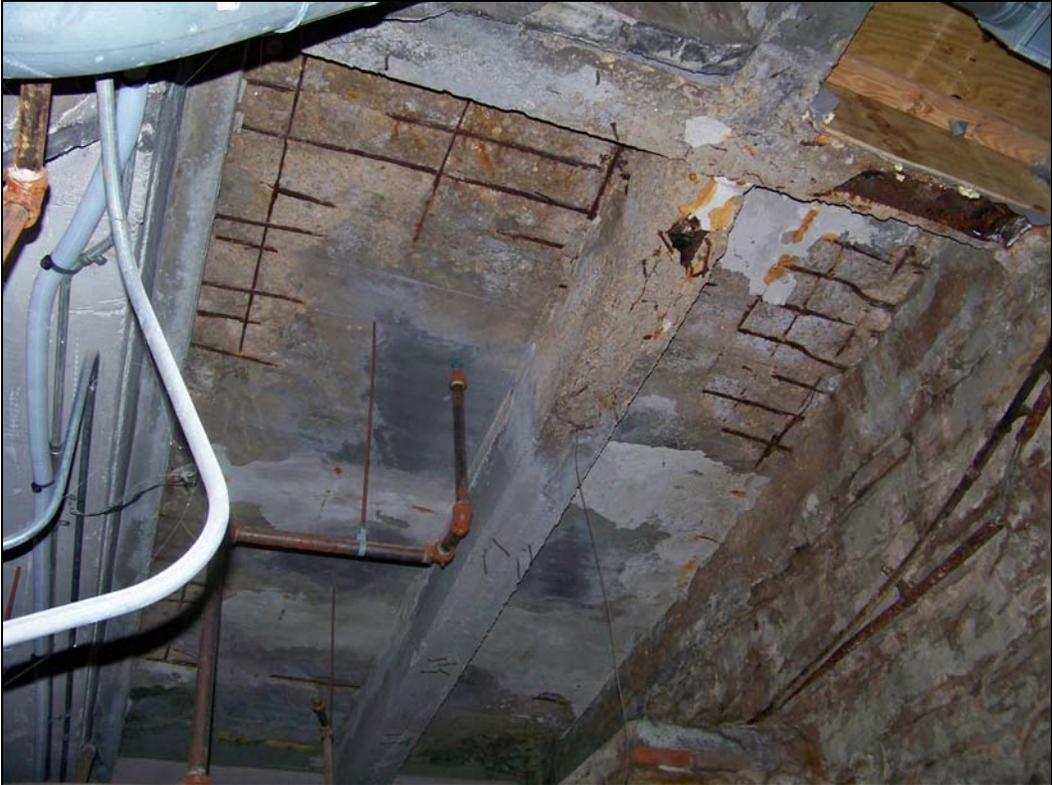
Vaults underneath the sidewalk along Grand Boulevard are accessible from the building's lower level where exposed, corroded reinforcing steel is evident on the bottom side of the sidewalk. As a result, the load capacity of the sidewalk has been diminished and must be replaced before further deterioration may cause injury to pedestrians using the sidewalk.

*Interior – spalled concrete, exposed steel reinforcement on bottom side of elevated sidewalk over vault*

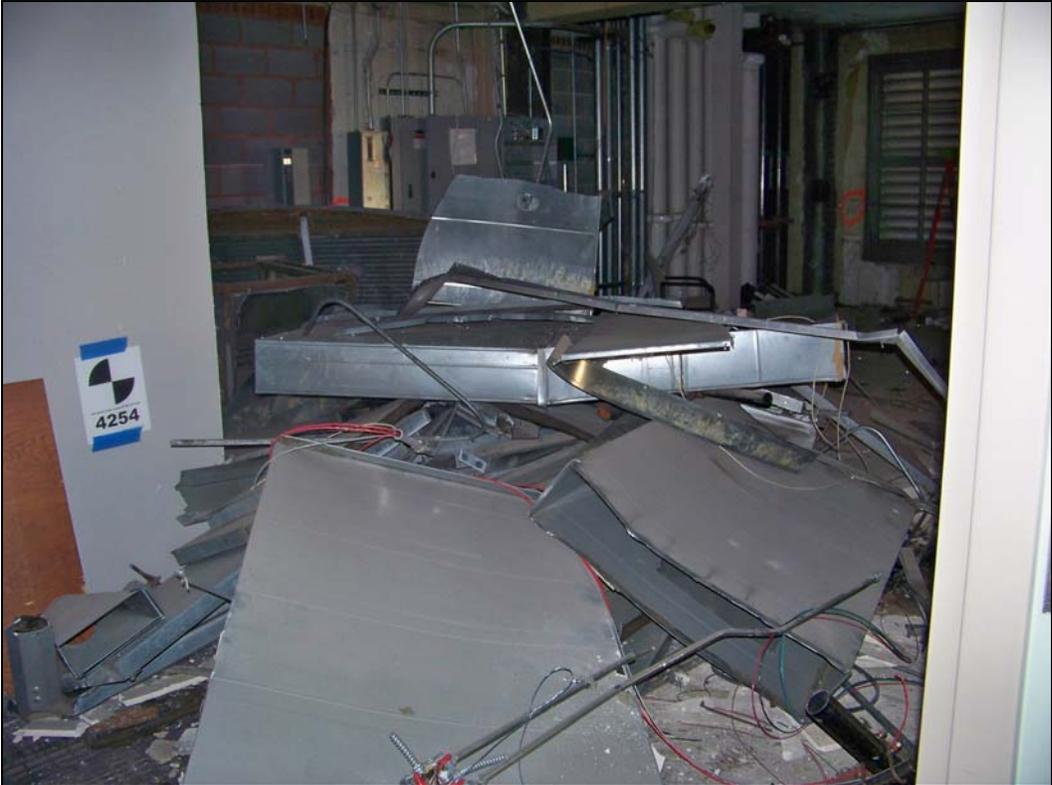
*Interior – debris*

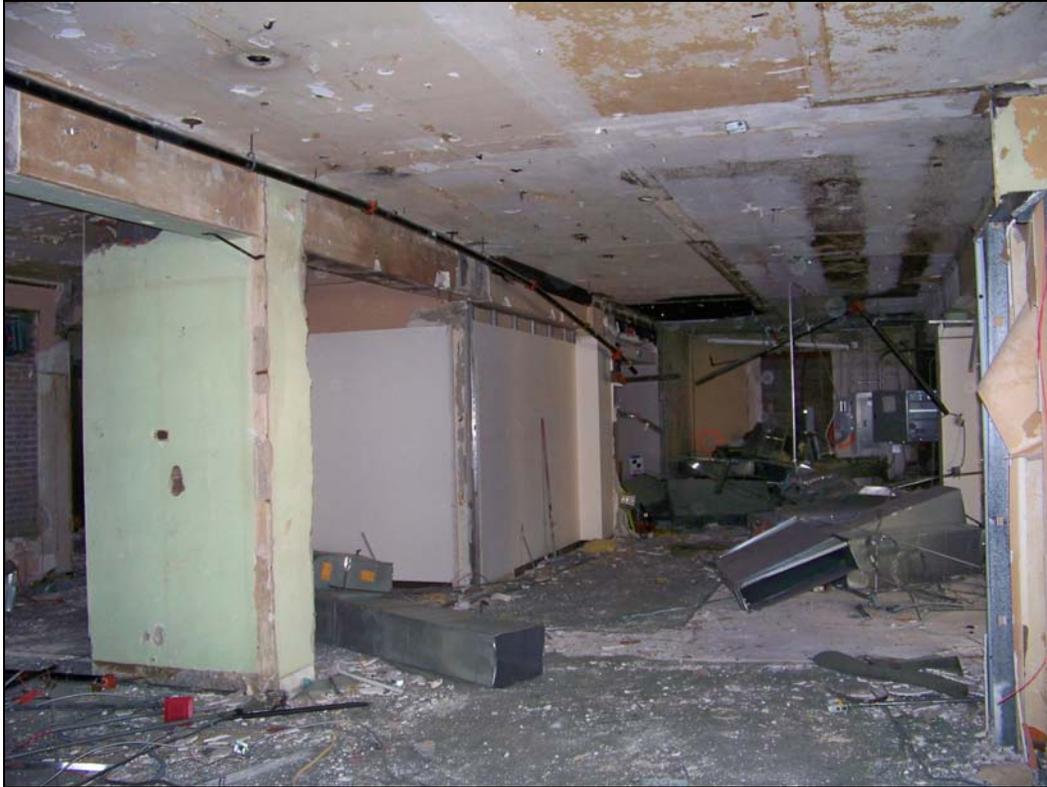
*Interior – debris; disconnected HVAC, plumbing systems; lack of operable life safety systems*

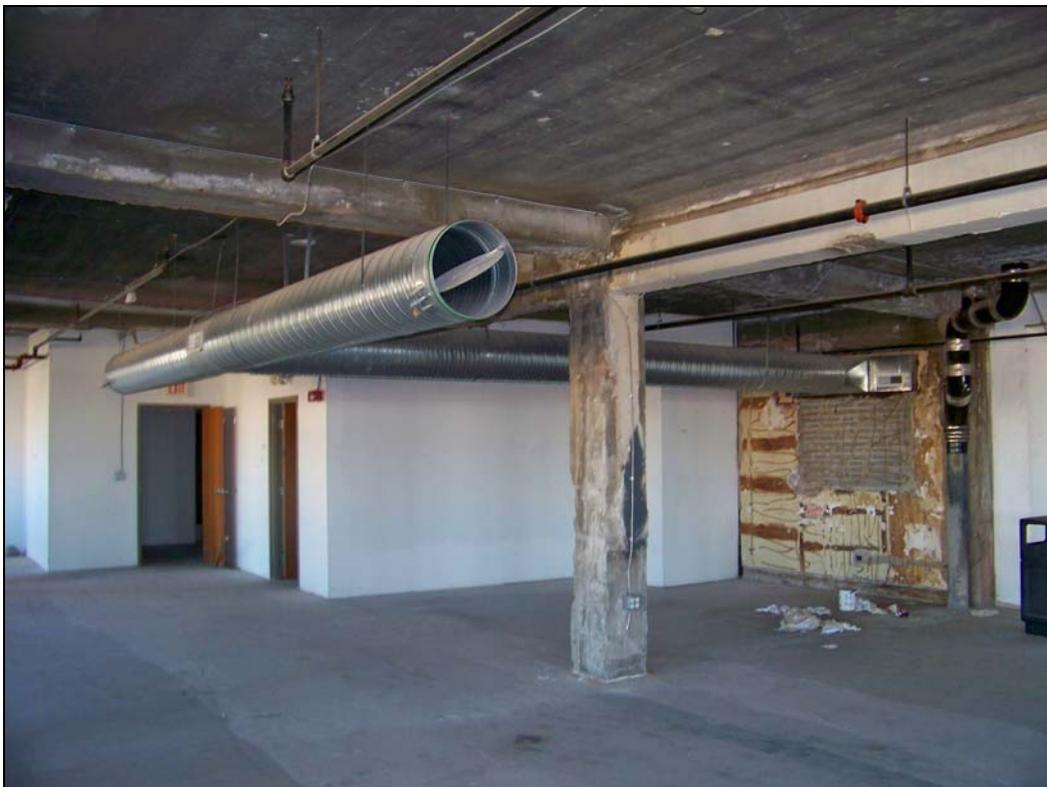
*Interior – inoperable fire sprinkler system, HVAC*

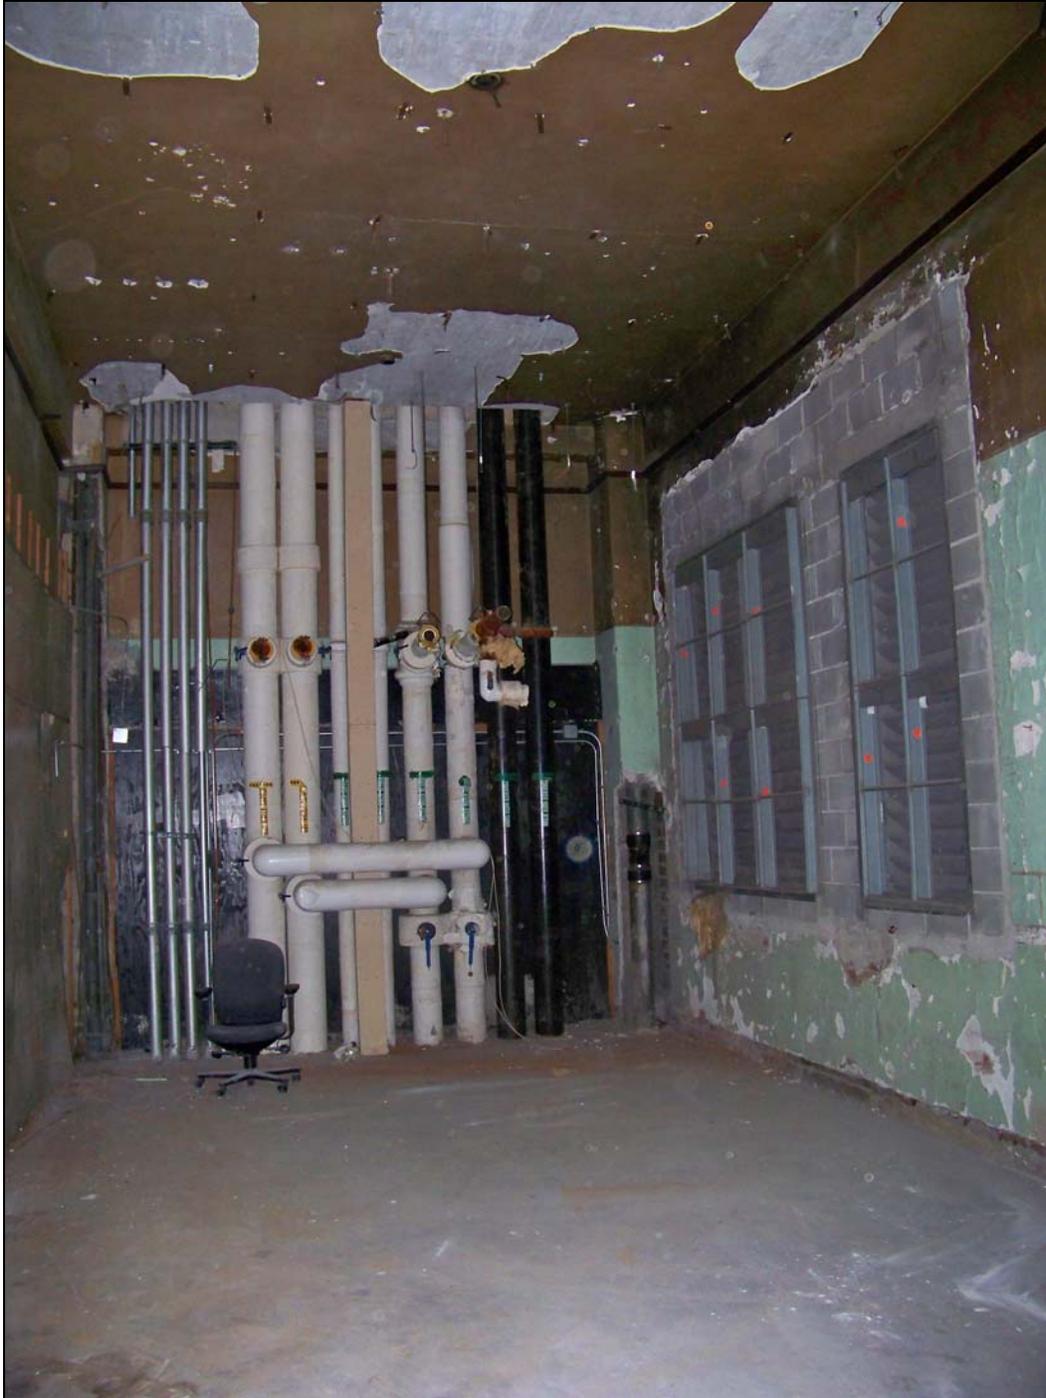
*Interior – disconnected, inoperable plumbing*

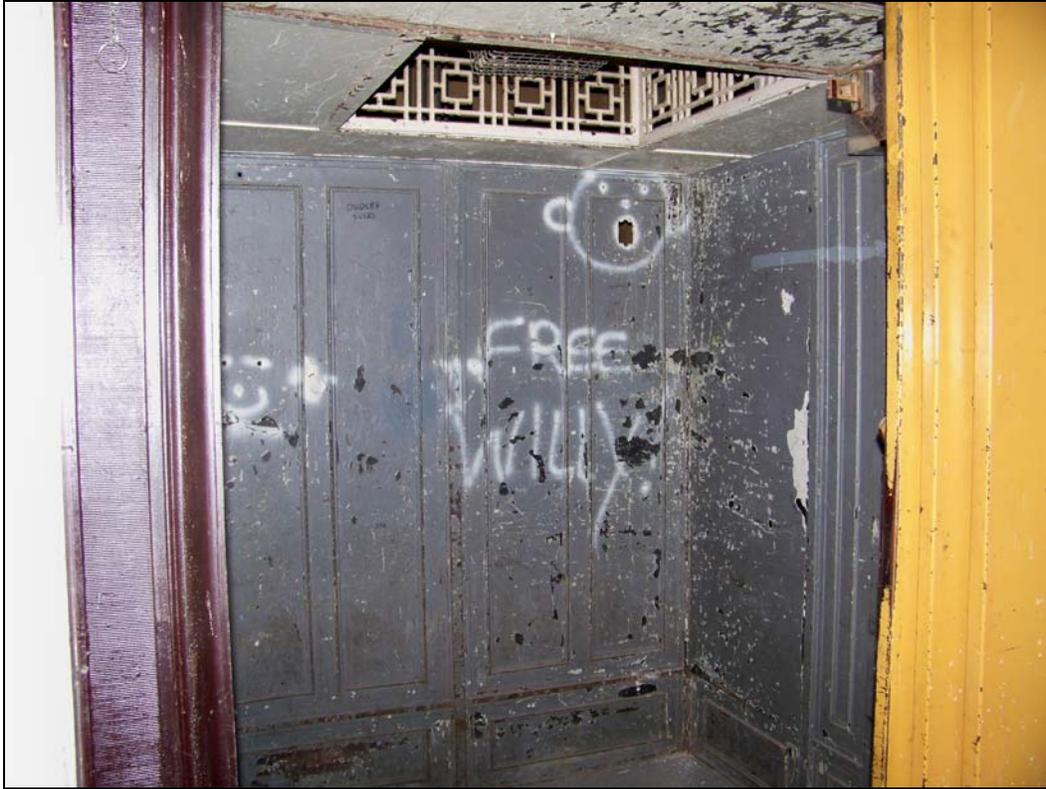
*Interior – open inoperable elevator; graffiti, trespass*

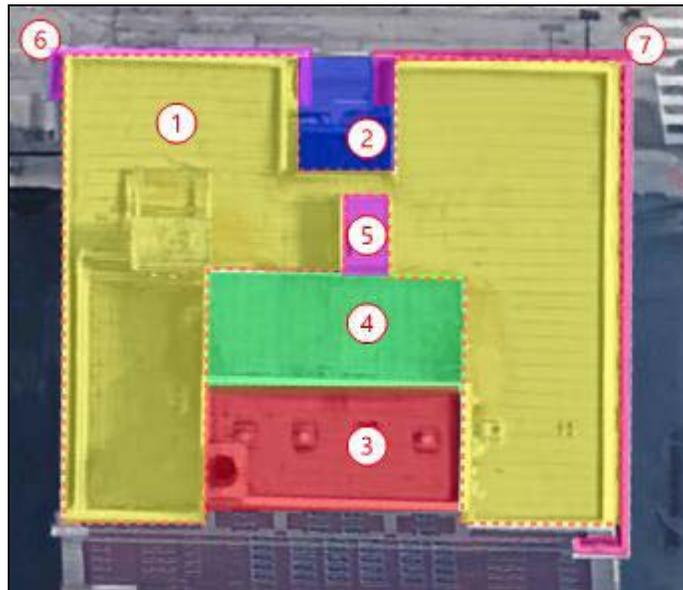
The combined area of these seven roof area totals approximately 11,500 square feet. Roof areas 1, 2 and 5 cover finished interior space. Roof areas 3 and 4 cover the elevator and mechanical penthouses respectively. Roof areas 6 and 7 cover the top side of the cornices on the east and north facade of the building. The visible portions of the roof on areas 1 through 5 consist of a low-slope, modified bitumen with granulated cap sheets. The visible portions of the roof on areas 6 and 7 consist of low-slope EPDM roof membrane. Parapets surrounding the roof areas are typically capped with sheet metal copings.

Roof Areas 1 through 5 are nearing the end of their service life require significant repair, if not replacement. Roof Areas 6 and 7 are generally in good condition. Significant conditions noted within the Envelope Assessment include the following (pp. 3-7):

- Water infiltration noted on roof areas 1, 2 and 3.
- Multiple roof cap sheets have fish-mouths near the base of the parapet on Roof Areas 1 and 2.
- Penetrations through the roof membrane on Roof Area 1 are sealed with thick layers of bituminous material. Bitumen at these ‘pitch pockets’ is hard and brittle and typically contains voids. Corrosion staining is present at many of these ‘pitch pockets’ from the embedded steel elements.

The roofs are in need of substantial repair immediately or complete replacement within the next two to five years.

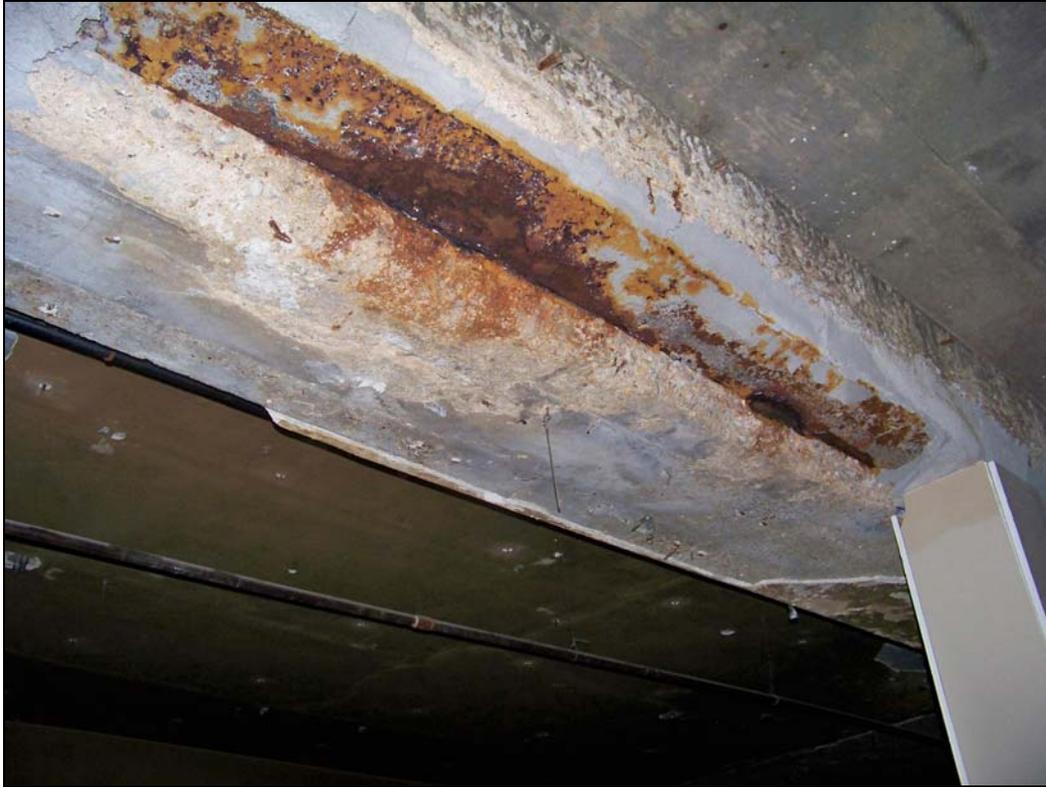
*Interior – delamination of structural beam, corrosion of structural steel*

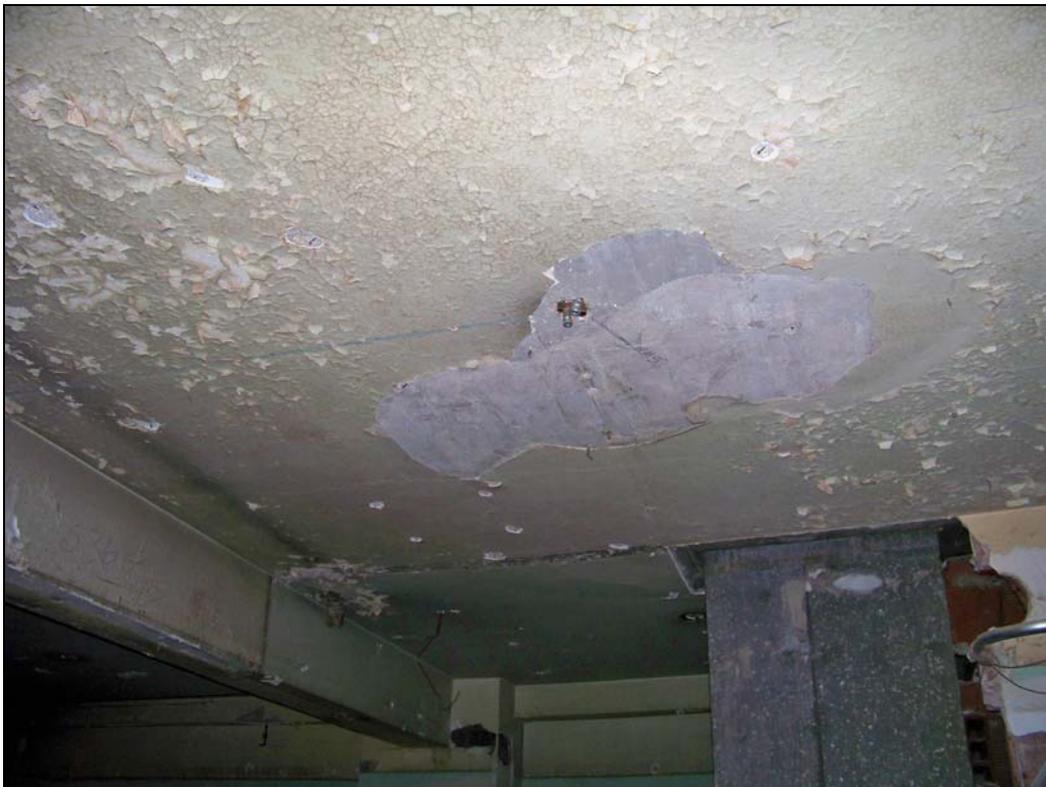
*Interior – failure of finishes*

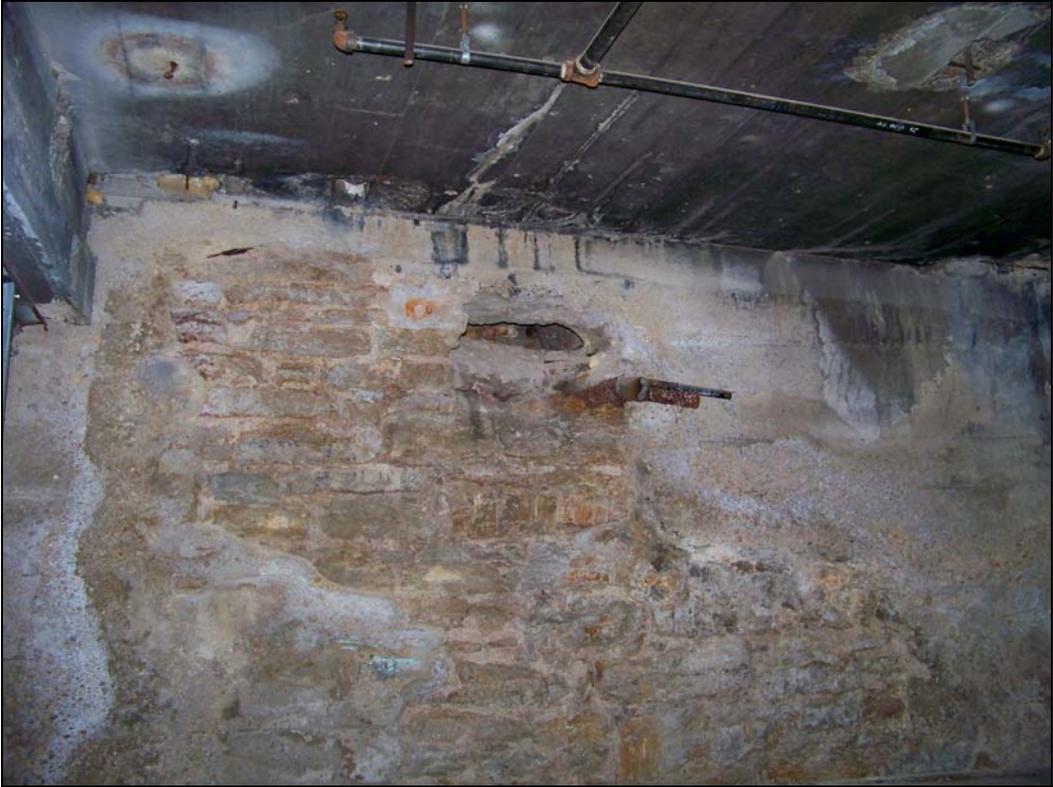
- Mineral and moisture staining is evident at the top of the north and east foundation walls below elevated sidewalks. Concrete framing of the elevated sidewalks is spalled in many locations and steel reinforcement is exposed.
- Water is present at the base of many exterior foundation walls throughout Levels B1 and B2. Water is present in quantities enough to dampen wall surfaces and the surface of the floor slab up to approximately 12 inches inboard of the foundation wall.
- One mechanical system on each level B2 and B1 are surrounded by water. Water was identified dripping from the mechanical system itself on level B1.
- The floor level of Level B2 varies by approximately 3 feet. The lowest area is near the center of the building and at the elevator shaft. Standing water is present at multiple locations near the center of the building.

*Interior – water staining, spalling of foundation wall*

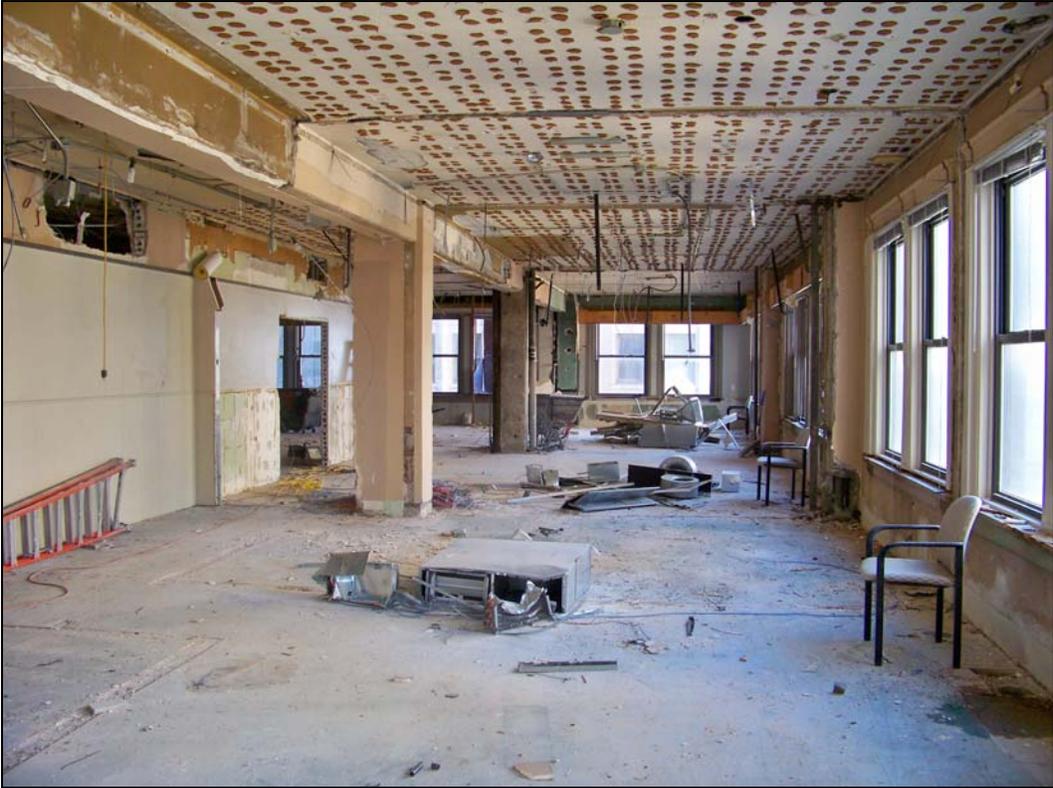
*Interior – damage to walls; removal of building systems*

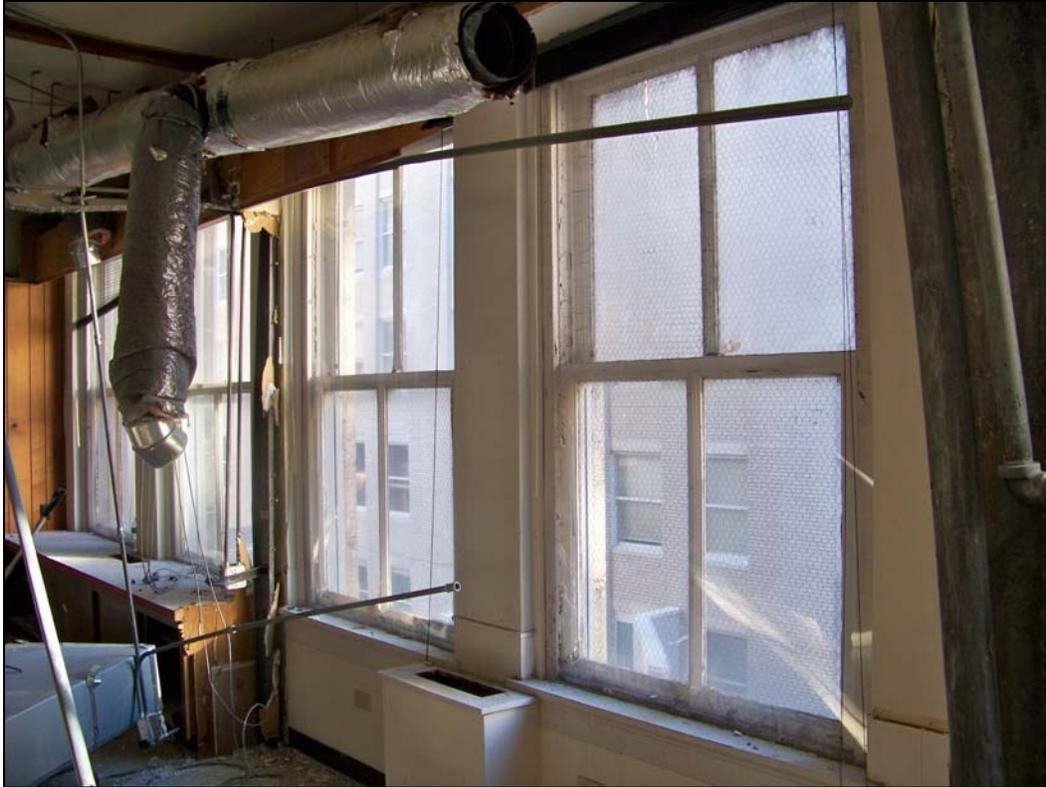
- Original steel framed/wired glass windows remain on the west facade and at the elevator shafts on the south facade. Several cracked glass panes were identified throughout these facades. Multiple broken glass panes typically observed on the second, fourth, fifth, eighth, and ninth floors.

*Interior – deteriorated glazing of original steel framed windows; broken glass panes*

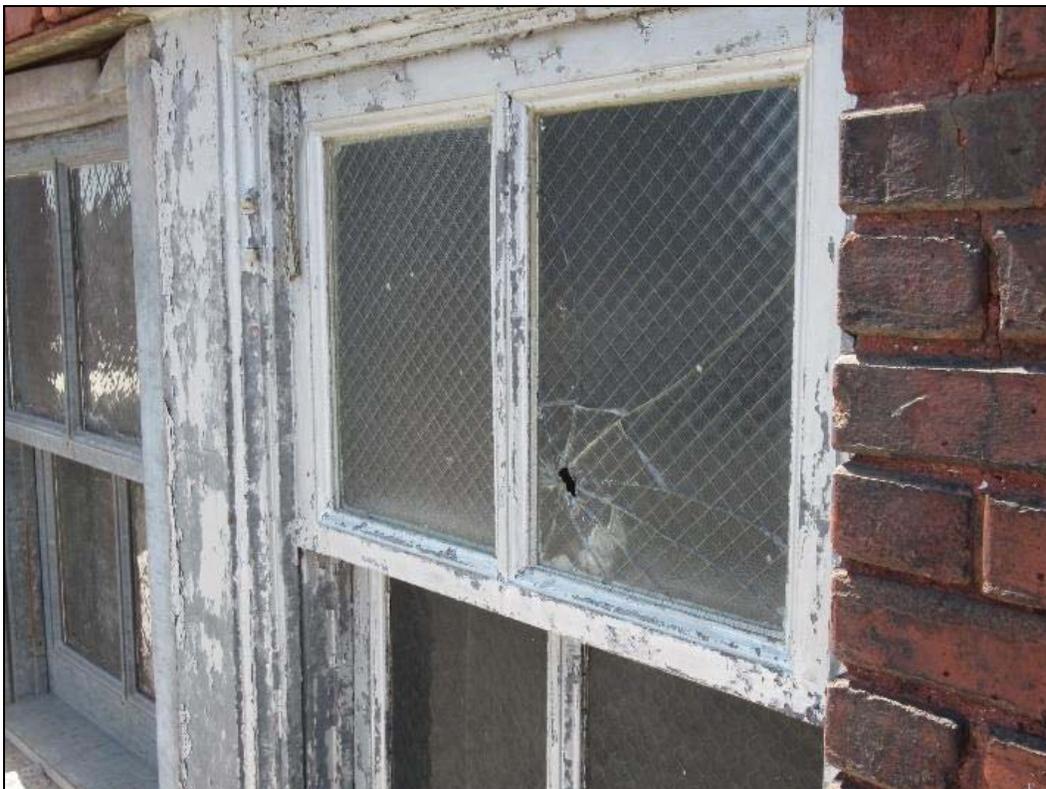
*West façade – broken window panes; failure of finishes*

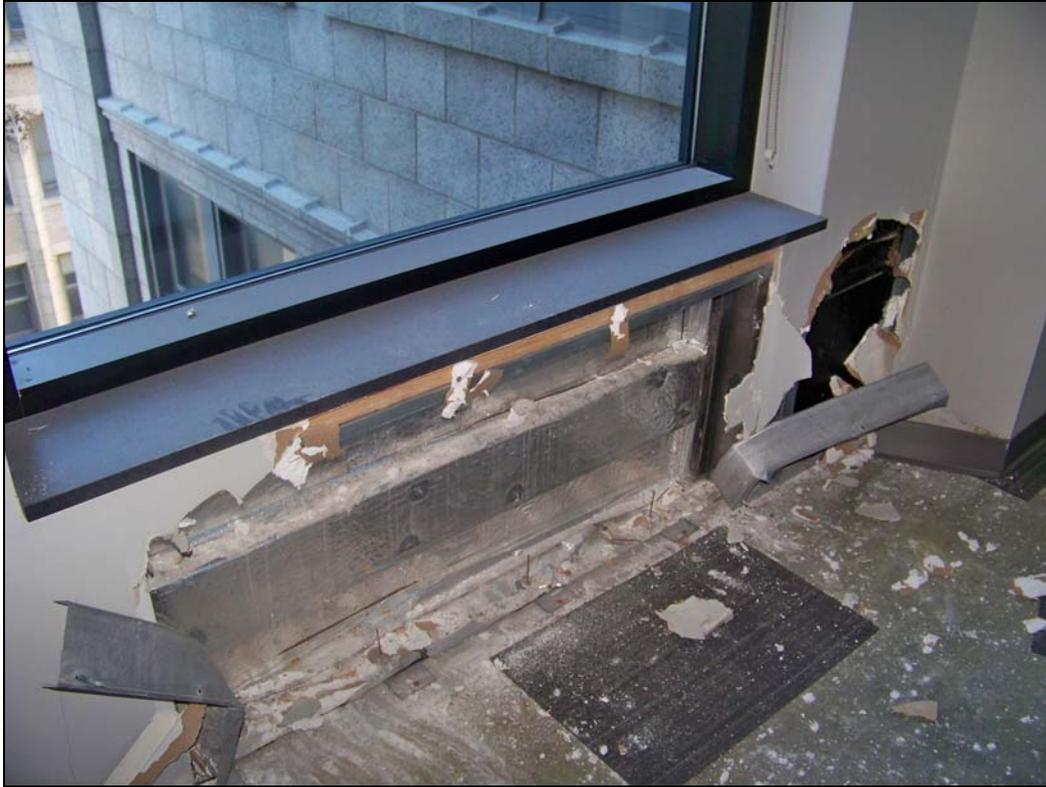
*Interior – damaged wall, metal sill plate*

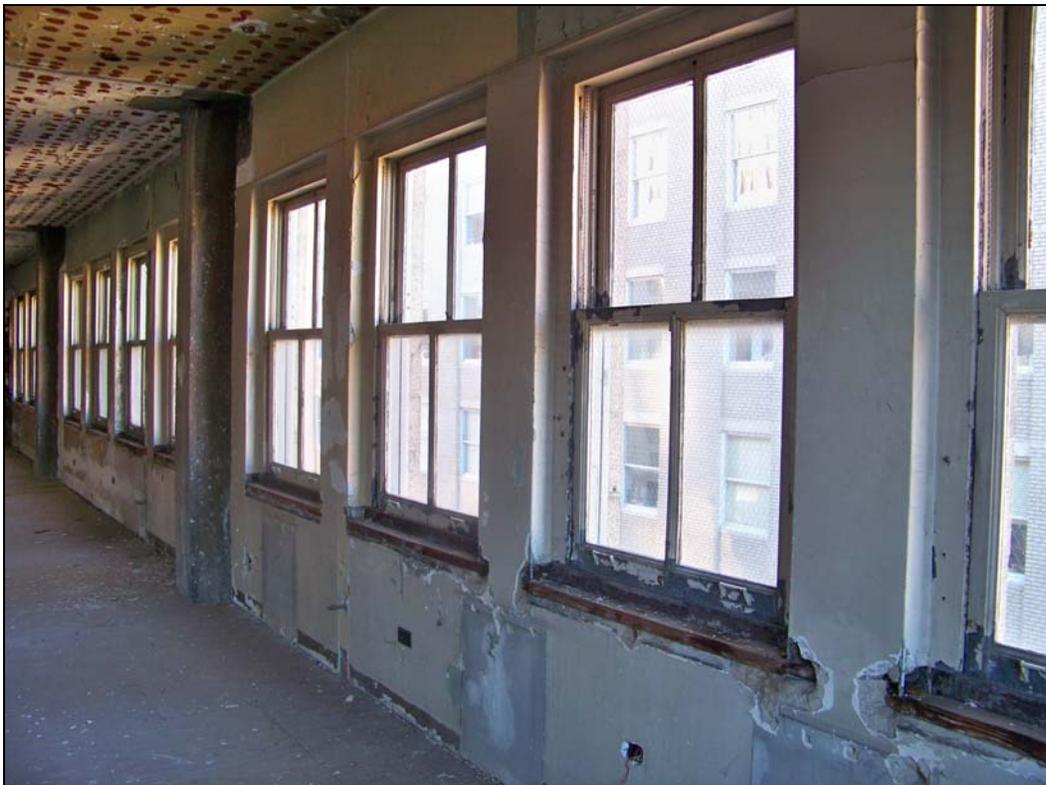
*Interior – failure of finishes; damaged materials*

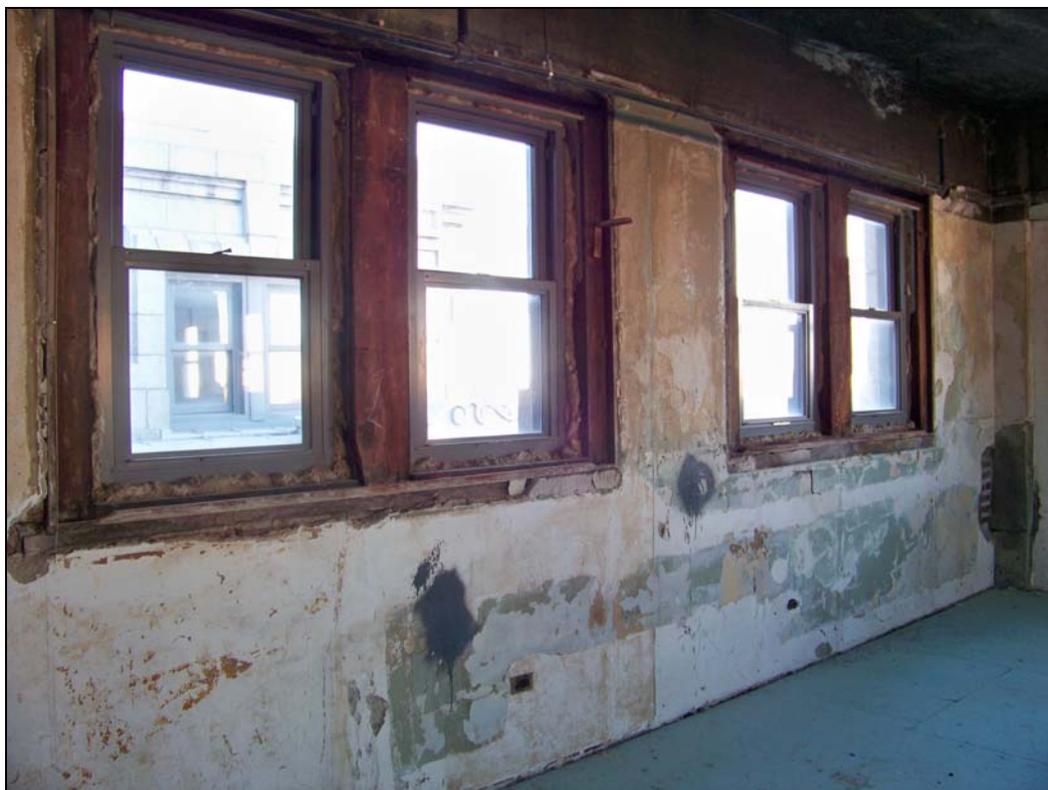
*Interior – improper sealing of windows; lack/failure of finishes*

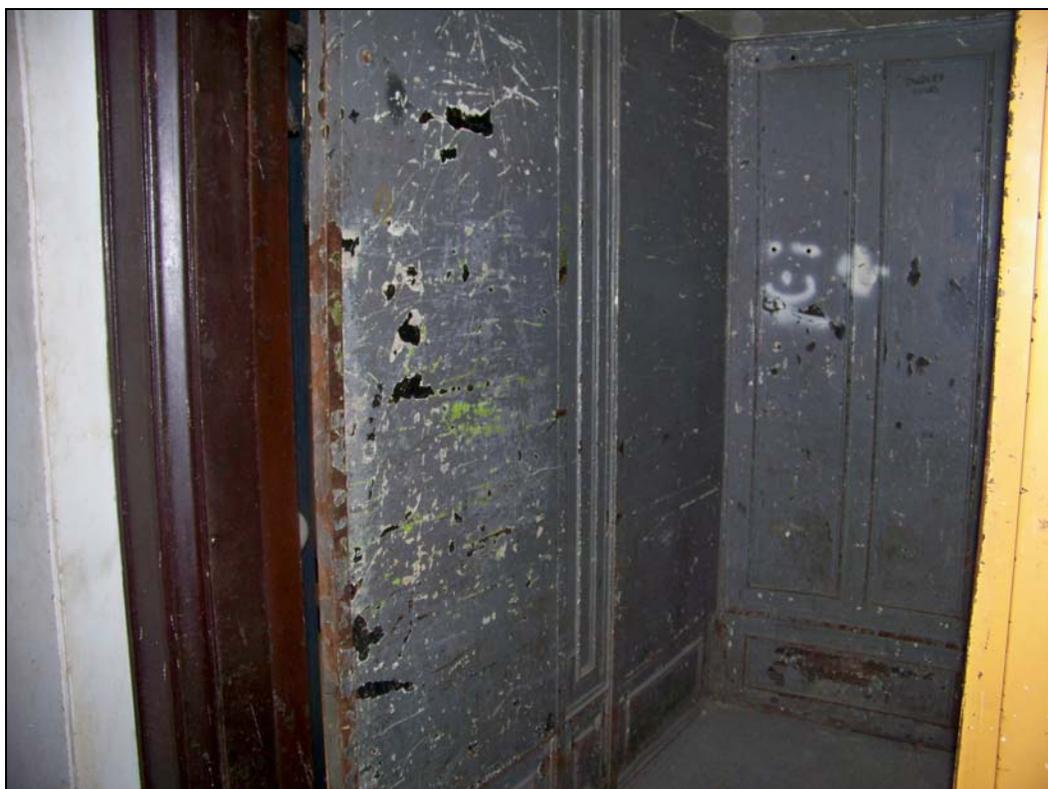
*Interior – deterioration of elevator cab*

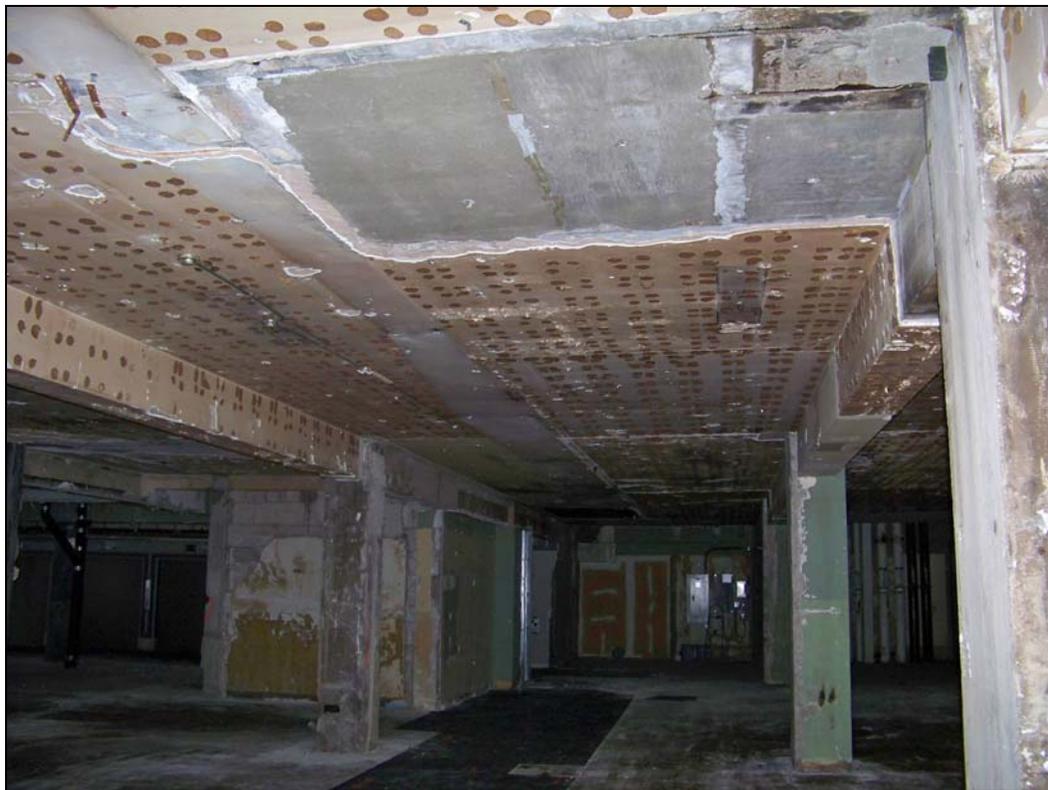
*Interior – deterioration/damage of interior finishes, flooring, columns; building systems nonexistent*
