906 Grand Boulevard  
Community Improvement District

## **Blight Study**

906 Grand Building Hospitality, LLC  
Kansas City, Missouri  
December 2, 2021

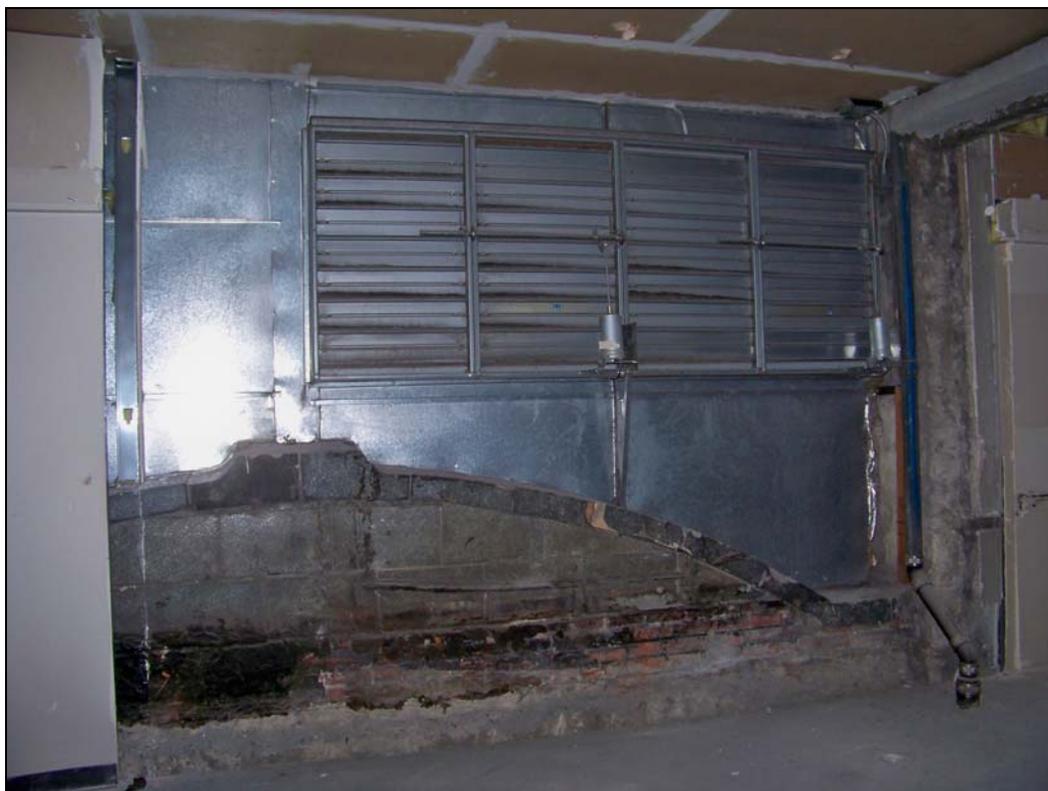
*Interior – covering of gap in exterior masonry wall with sheet metal*

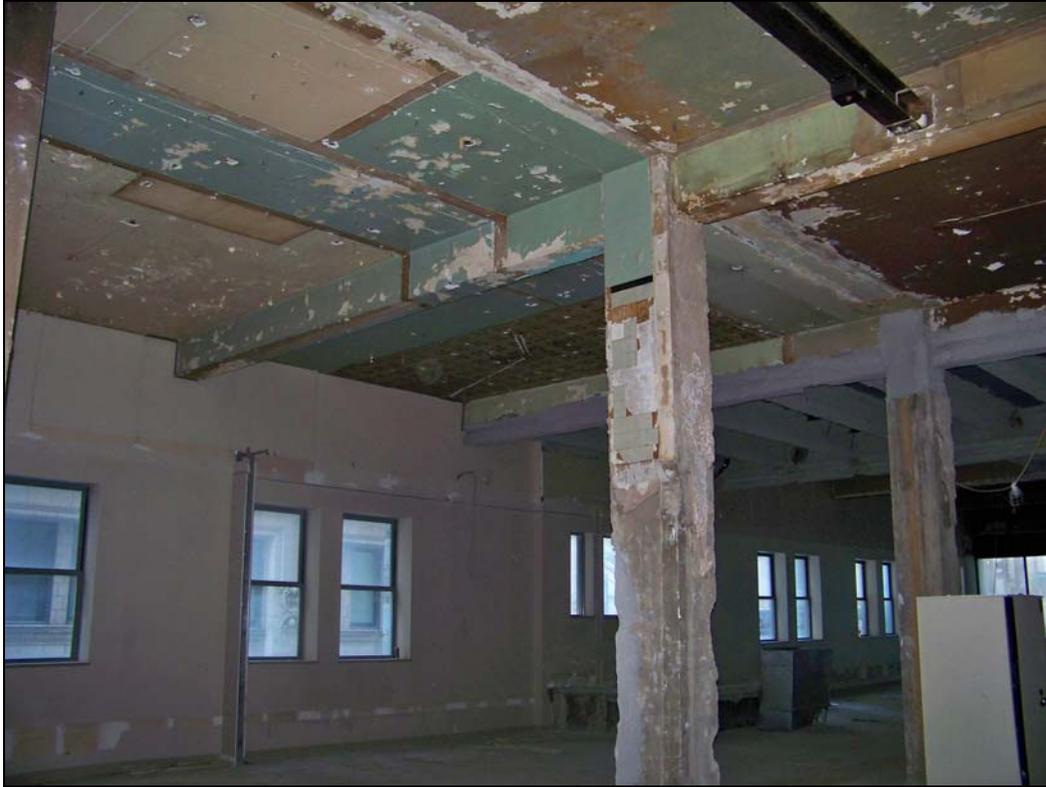
*Interior – deterioration of structural beams, columns; deterioration/damage of interior finishes*

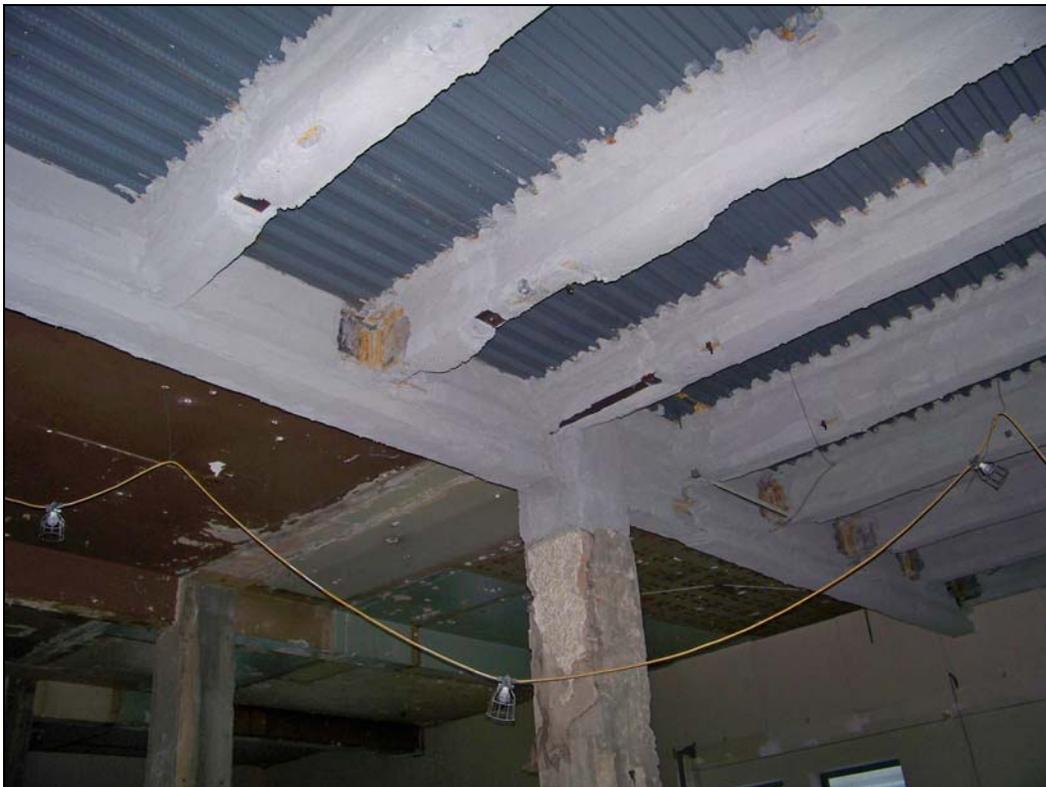
*Interior – deterioration of structural beams, columns; deterioration/damage of interior finishes*

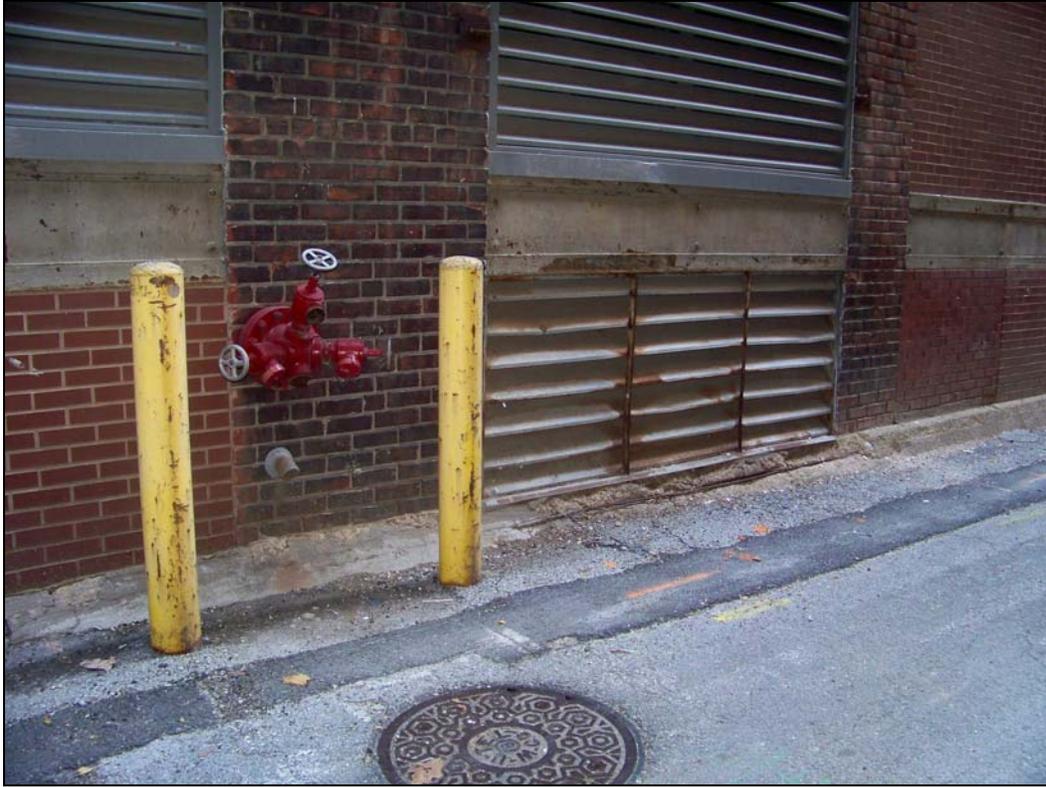
*Interior – spalled concrete at west alley curb*
