**Blight Analysis:**

2700-06 Troost Avenue  
Kansas City, Missouri

May 11, 2015

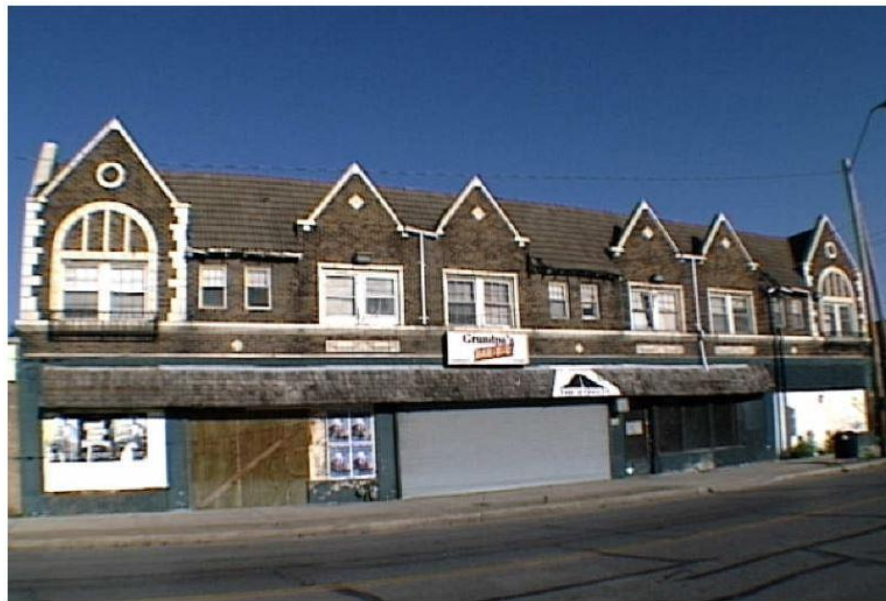
29-810-01-25-00-0-00-000 05/19/2005

Figure 3 – Source Jackson County Assessor's Office. 2005 property assessment photo.

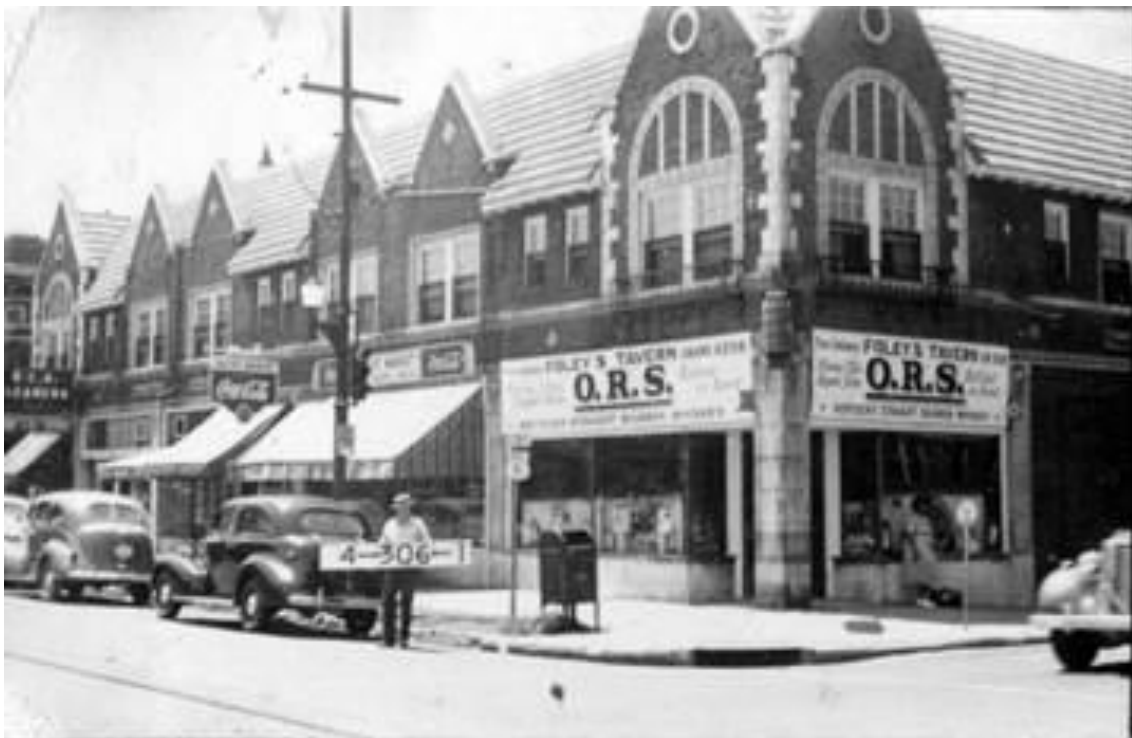
As previously mentioned, the Redevelopment Area is comprised of one property parcel, and that parcel contains one improvement, the Alana Apartment Hotel. The Alana Apartment Hotel was constructed in 1928, which makes the original improvements approximately 87 years of age. The facility was placed on the National Register of Historic Places in 2006. Constructed by local businessman Jacob Steinzeig, the Alana Apartment Hotel is an excellent example of a mixed-use corner neighborhood store. This type of property was constructed in Kansas City's growing neighborhoods during the early 20th century to provide residential opportunities and commercial services to local residents. Designed in the Tudor Revival style by architect Charles M. Williams, the Alana Apartment Hotel illustrates the adaptation of popular residential designs to commercial structures in an effort to blend with surrounding neighborhood development.<sup>2</sup> In March 1927, Steinzeig received a building permit for the construction of a 100-foot by 141 foot two-story brick building with a tile roof. By 1928, construction of the building was complete and a variety of businesses occupied the Troost Avenue storefronts of the Alana Apartment Hotel. Beginning at the corner of 27<sup>th</sup> & Troost and moving south, patrons could visit the Silverforb Pharmacy, the Piggly Wiggly grocery store, a dry cleaners, a bakery, a beauty shop and a restaurant.<sup>3</sup>

Historical 1940 Tax Assessor Photograph looking southwest.

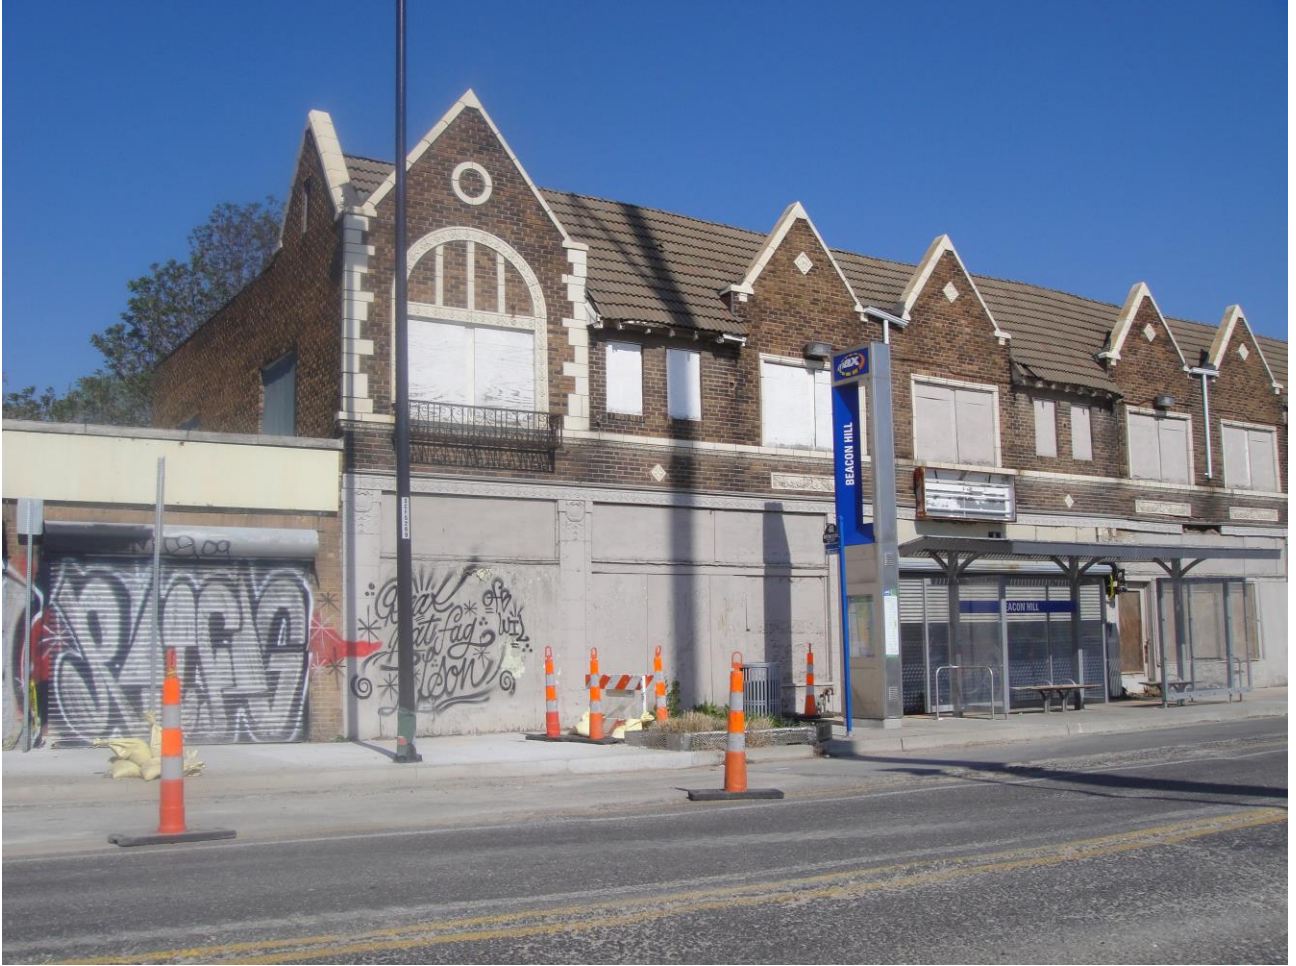
Presently, the physical condition of the facility is estimated to be poor to very poor. This is largely based on site inspection activities and the previously mentioned lack of maintenance/repair and replacement programs. Due to the inaccessibility of the site, no interior investigations were completed as part of this analysis.

Photo 1 – Current image of the Alana Hotel Facility within the Redevelopment Area. The facility is essentially unchanged since the 2005 Jackson County Assessment photo.

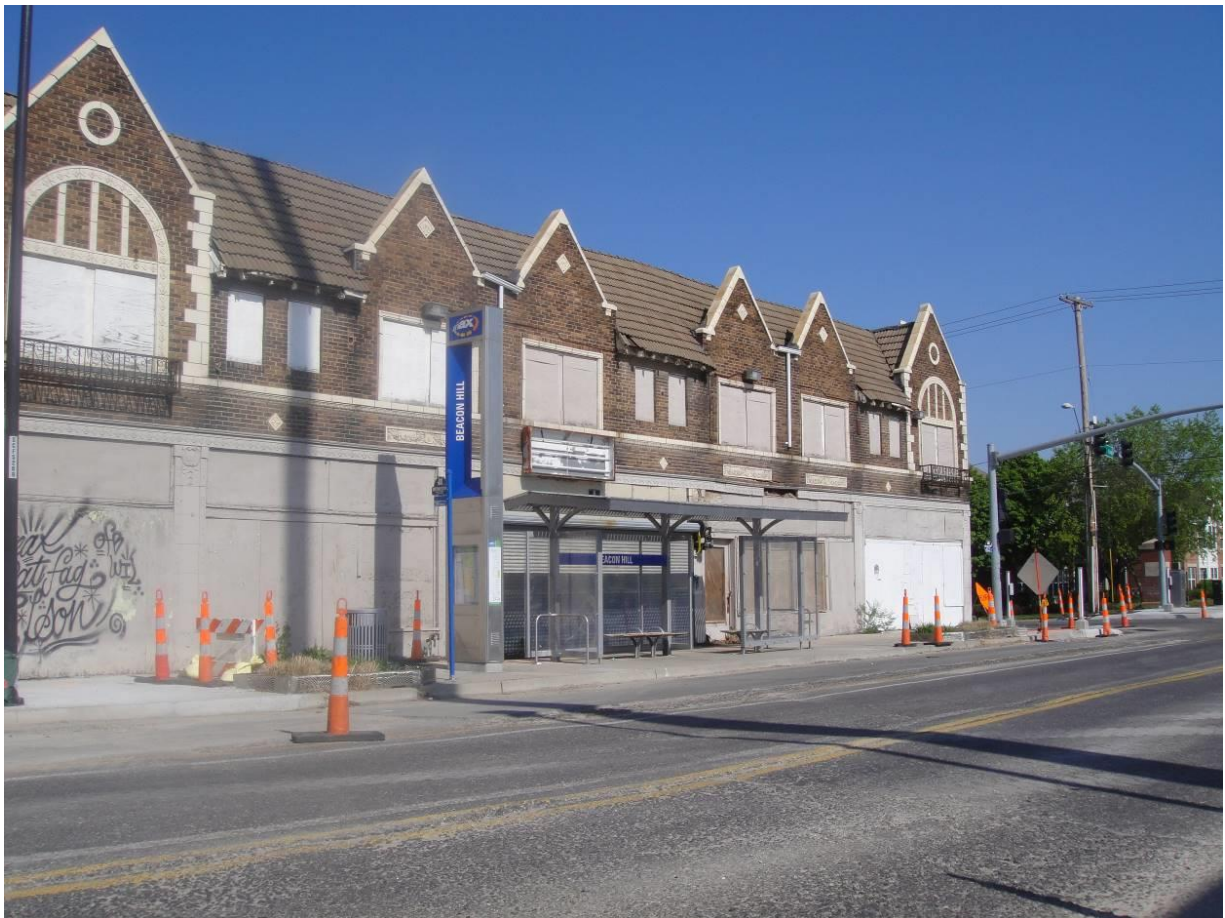
disrepair. Within the subject facility, vacancies for many years have left residential and tenant spaces unusable, contributing to the perception of the deterioration of the structure. The vacancy rate of the Development Area appears to be 100%.

Photo 2 - Photo indicates facility entirely vacant.

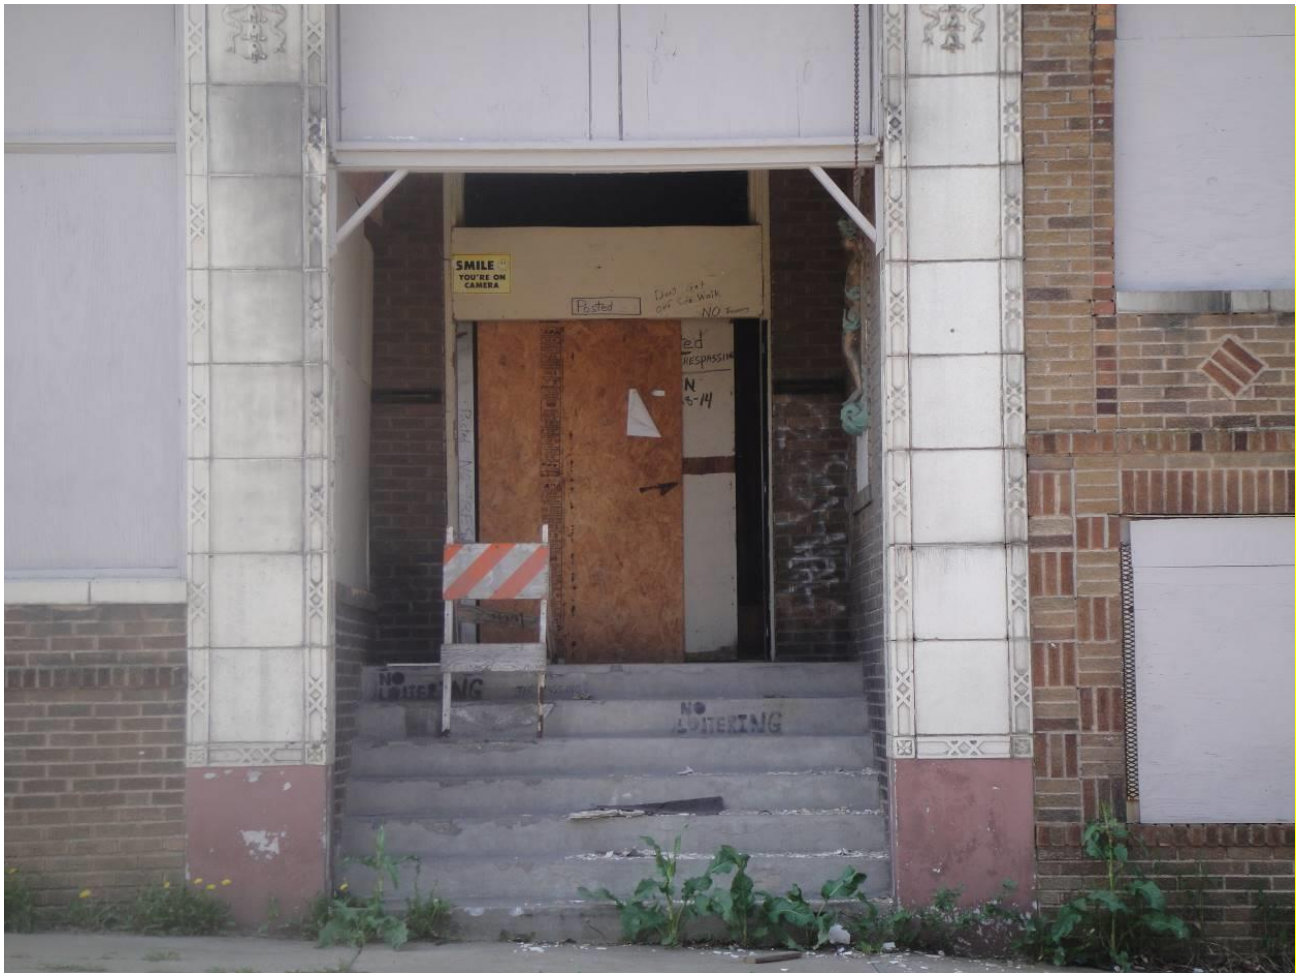
One of the most critical deficiencies in the inadequacy of a structures design is accessibility. Significant modifications would be required to each and every dwelling unit, as well as the shared public spaces and commercial tenant spaces to make them accessible for individuals who are physically disabled. While we were not able to access the interior of the subject property, it could be assumed that due to the age of the facility, many existing building improvements suffer from this outmoded design and fall short of current Americans with Disabilities Act (ADA) standards. These improvements might include, but not be limited to; a lack of ADA compliant ingress/egress to buildings, and adequate ADA accessible restrooms. The cost of making ADA compliant improvements within the area are often times cost prohibitive.

Photo 3 – View of the northern entrance to the subject building. Note the general lack of maintenance, as well as the lack of adequate ADA access. Lack of ADA access is a contributing factor to the overall inadequacy and outmoded design of the facility.

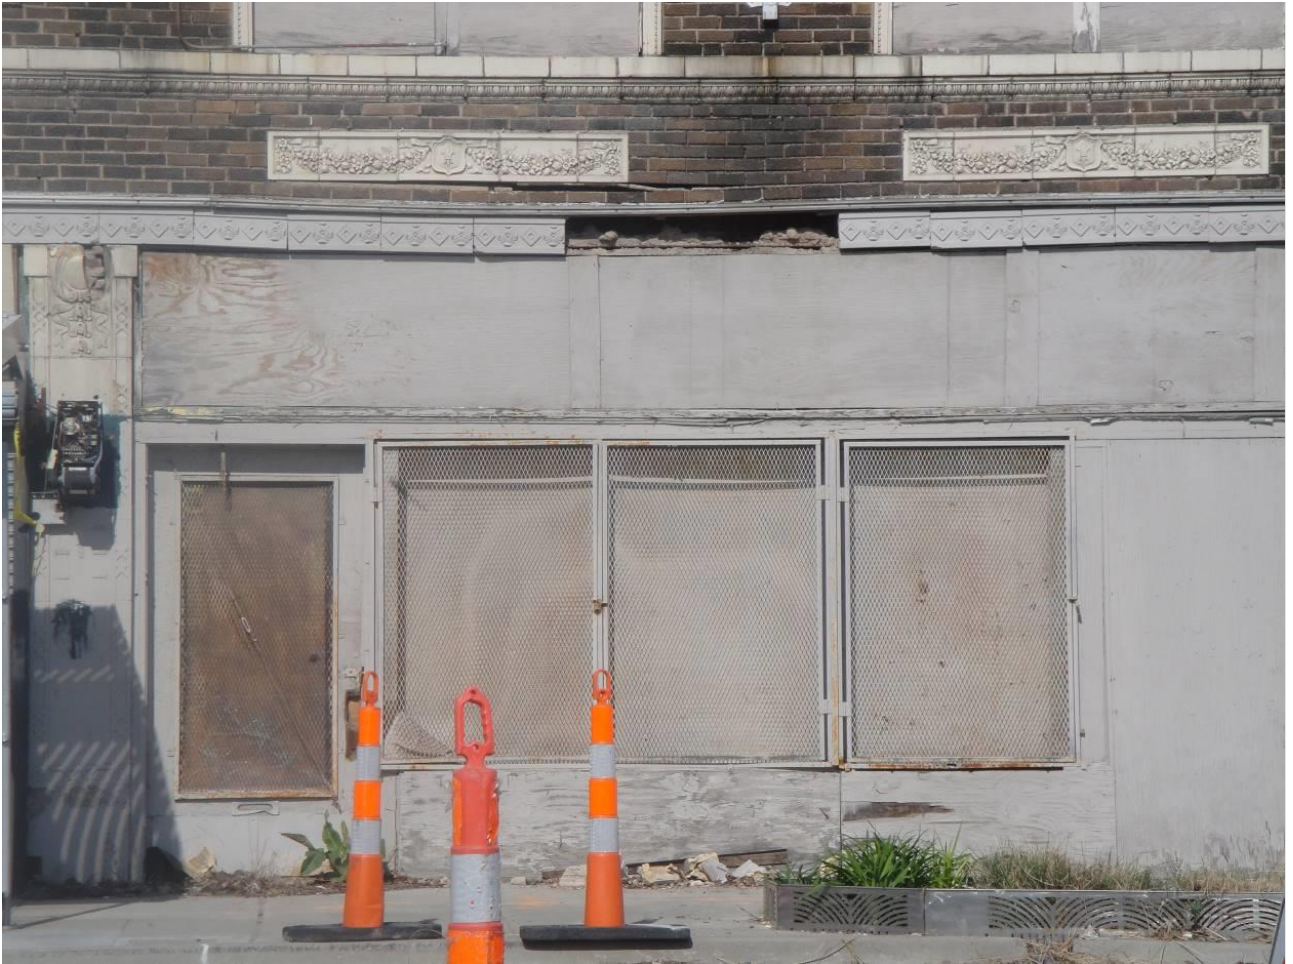
Photo 4 – Detail of the eastern façade of 2700 Troost. Note façade deterioration due to the lack of downspout.

This condition can cause further exterior and potentially interior damage and deterioration due to water infiltration. This can also add to the perception of an underutilized, vacant facility along the Troost Avenue Corridor.

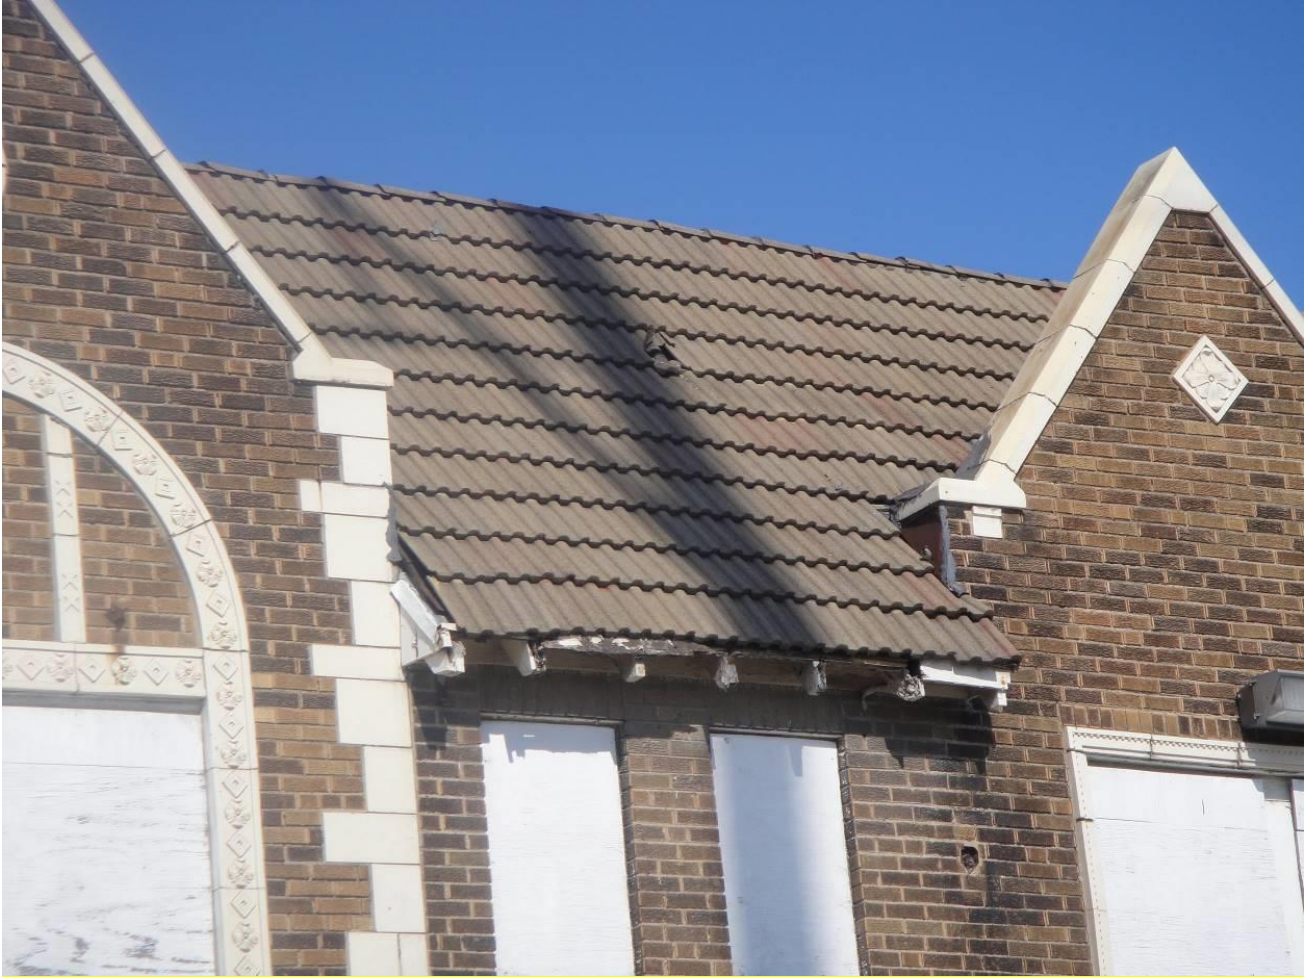
Photo 5 – View of the parapet detail along the eastern façade of the subject building.

**Note scattered, damaged roof materials.** Roofing material appears to be original to facility. **Also note lack of gutter and downspout systems to facilitate the discharge of excess rain-water away from the building structure.** If deteriorated conditions persist, they could lead to water infiltration which would decrease value of property and deter potential tenants and shoppers, constituting an economic liability and contributing in the inability to pay reasonable taxes.

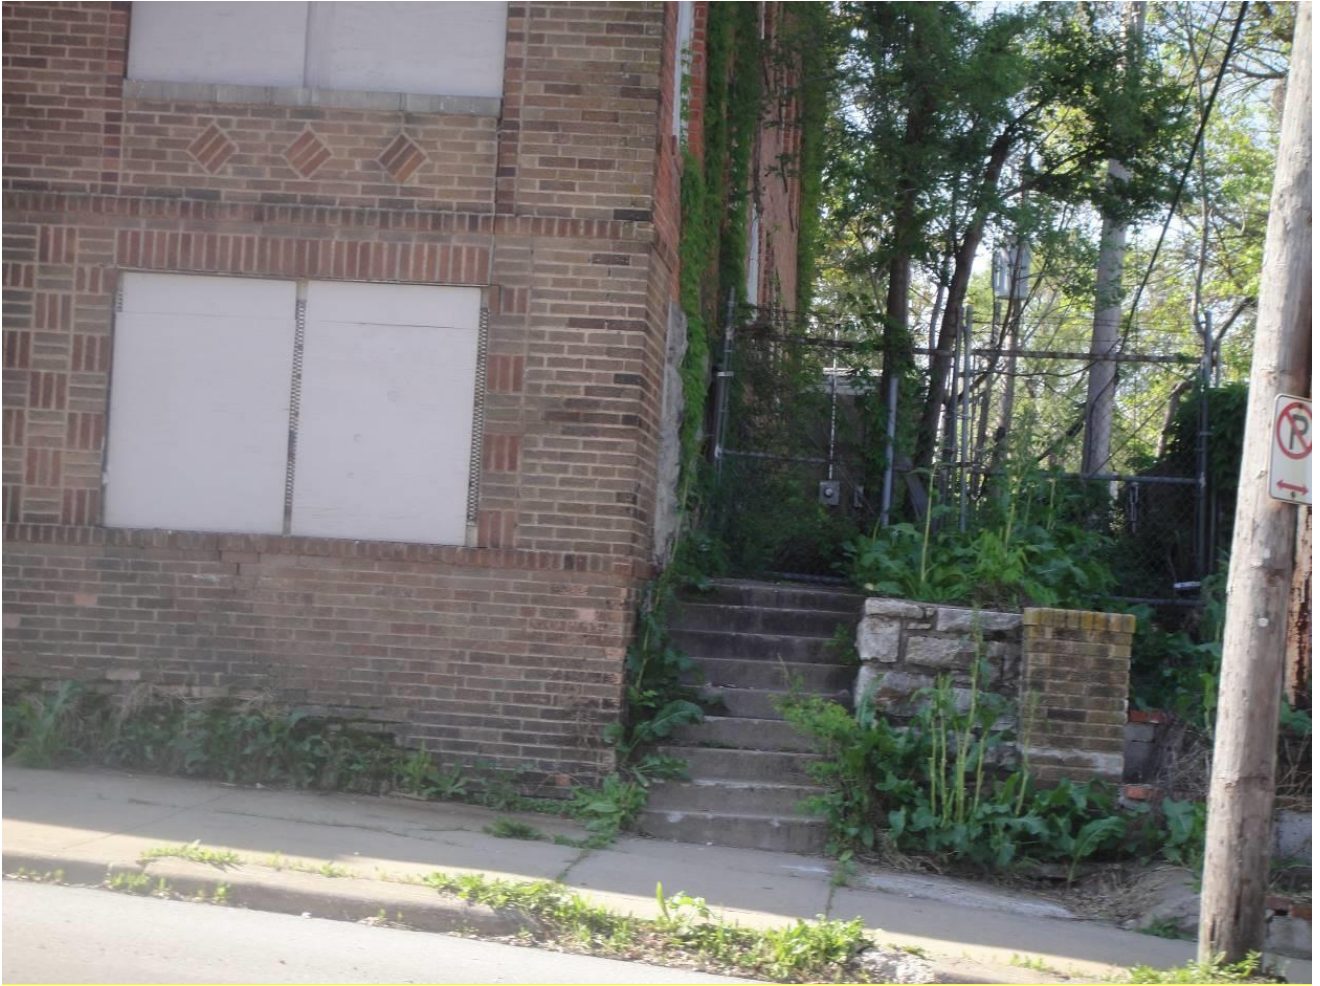
Photo 5 – Western access to the subject property and facility. This area is poorly lit and conducive to illegal dumping and vagrancy.

Illegal dumping and vagrancy are crimes and may cause an economic liability by making the area less desirable to prospective tenants and area residents, potentially decreasing property values. In addition, this condition can also deter shoppers from frequenting this local retail establishment resulting in a loss of possible sales tax.

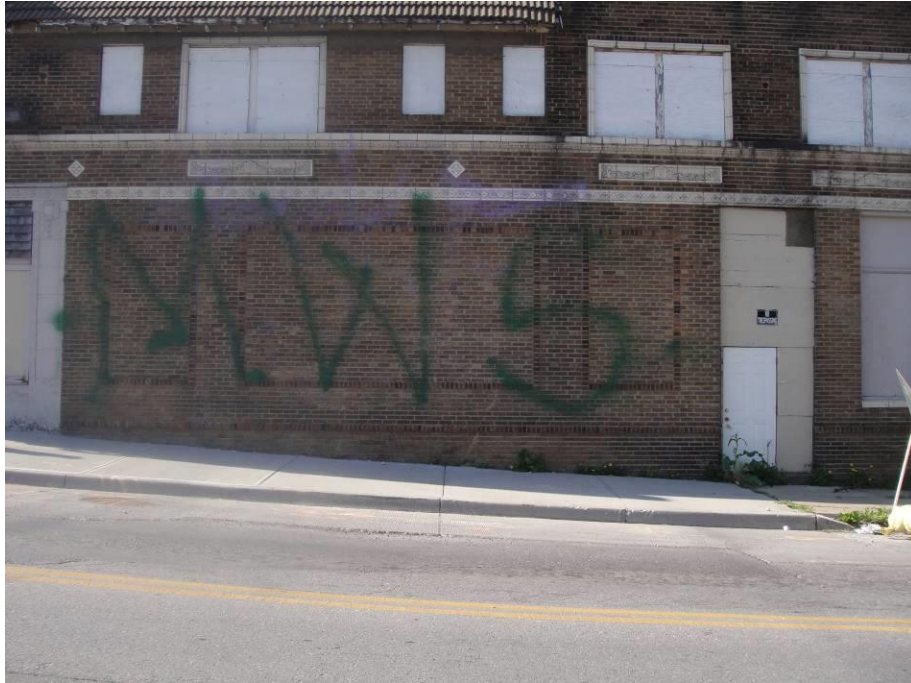
Photo 6 – Graffiti along the northern façade of the subject building. The presence of graffiti continues the perception of a underutilized and vacant facility and can cause a economic and social liability to the surrounding neighborhood.

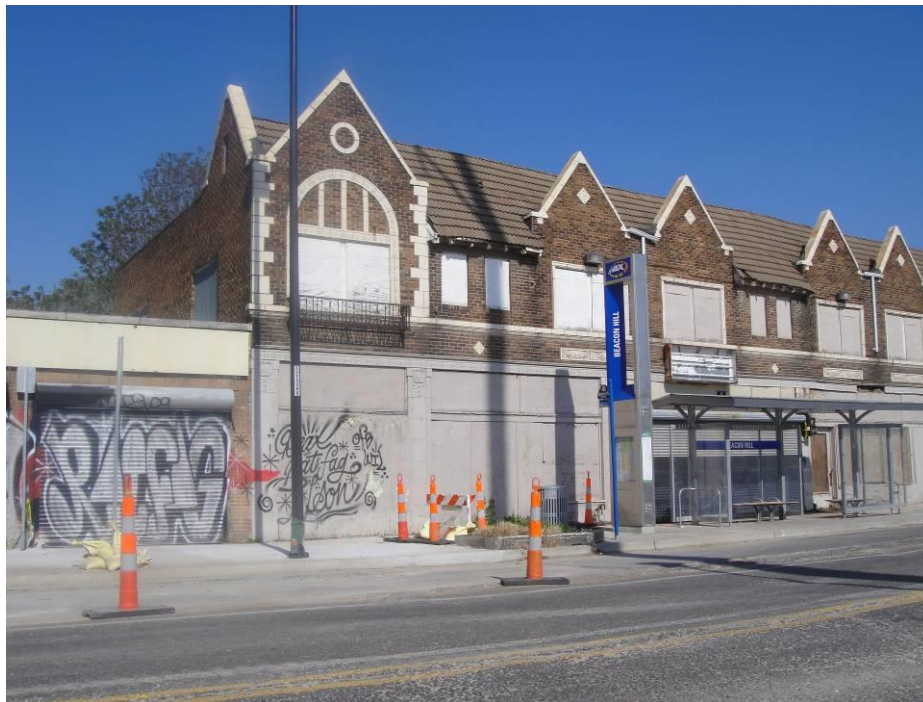
Photo 7 – View of the eastern façade of the subject building. Note graffiti present. The presence of graffiti continues the perception of a underutilized and vacant facility and can cause a economic and social liability to the surrounding neighborhood.

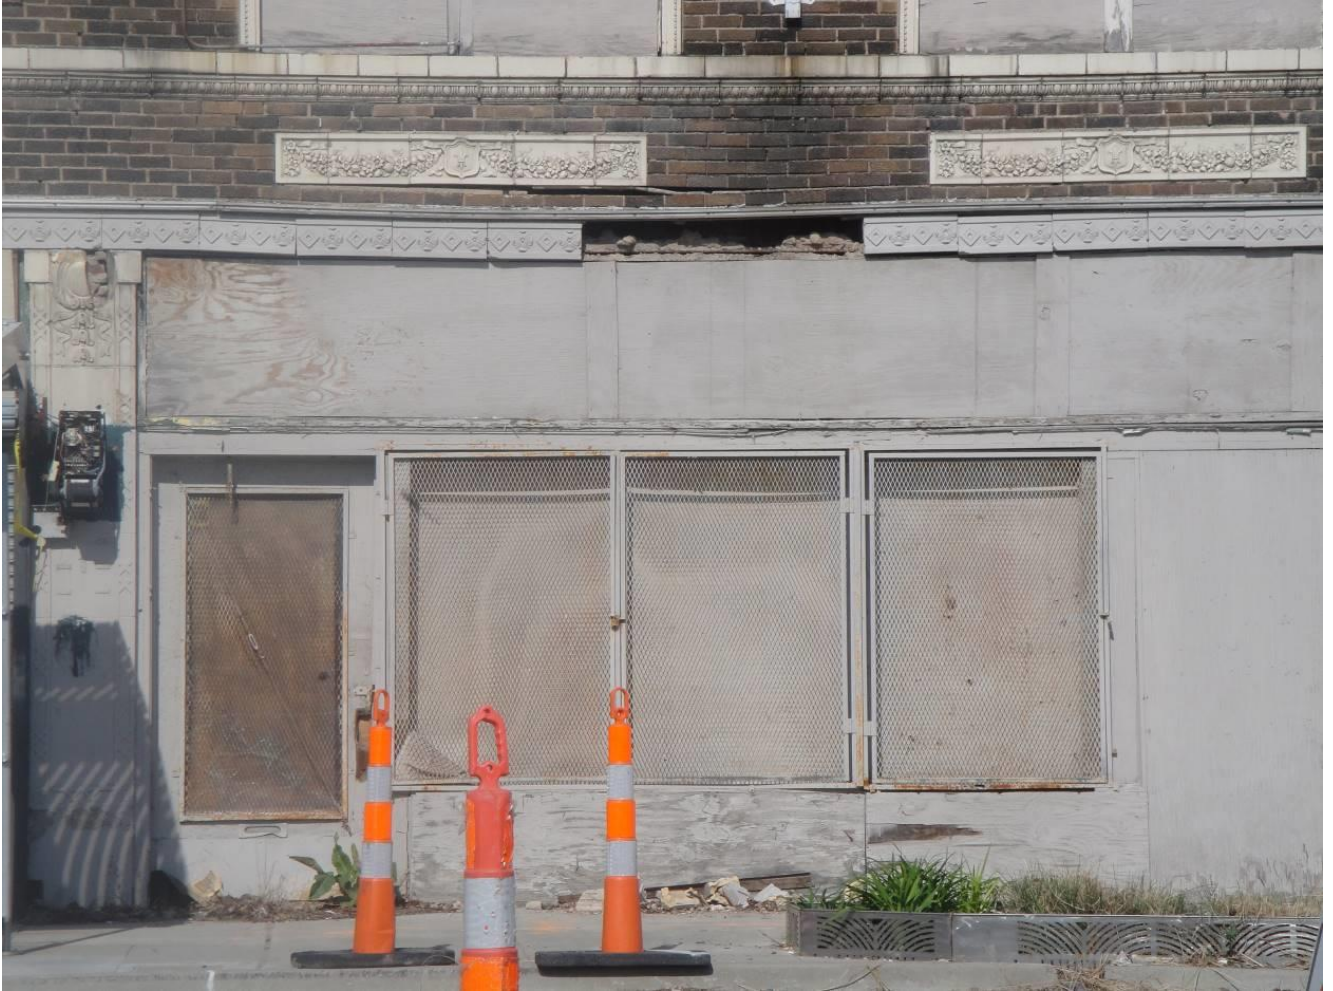
Photo 9 – Detail of the eastern façade of 2700 Troost. Note façade deterioration due to the lack of downspout.

This condition can cause further exterior and potentially interior damage and deterioration due to water infiltration. This can also add to the perception of an underutilized, vacant facility along the Troost Avenue Corridor.

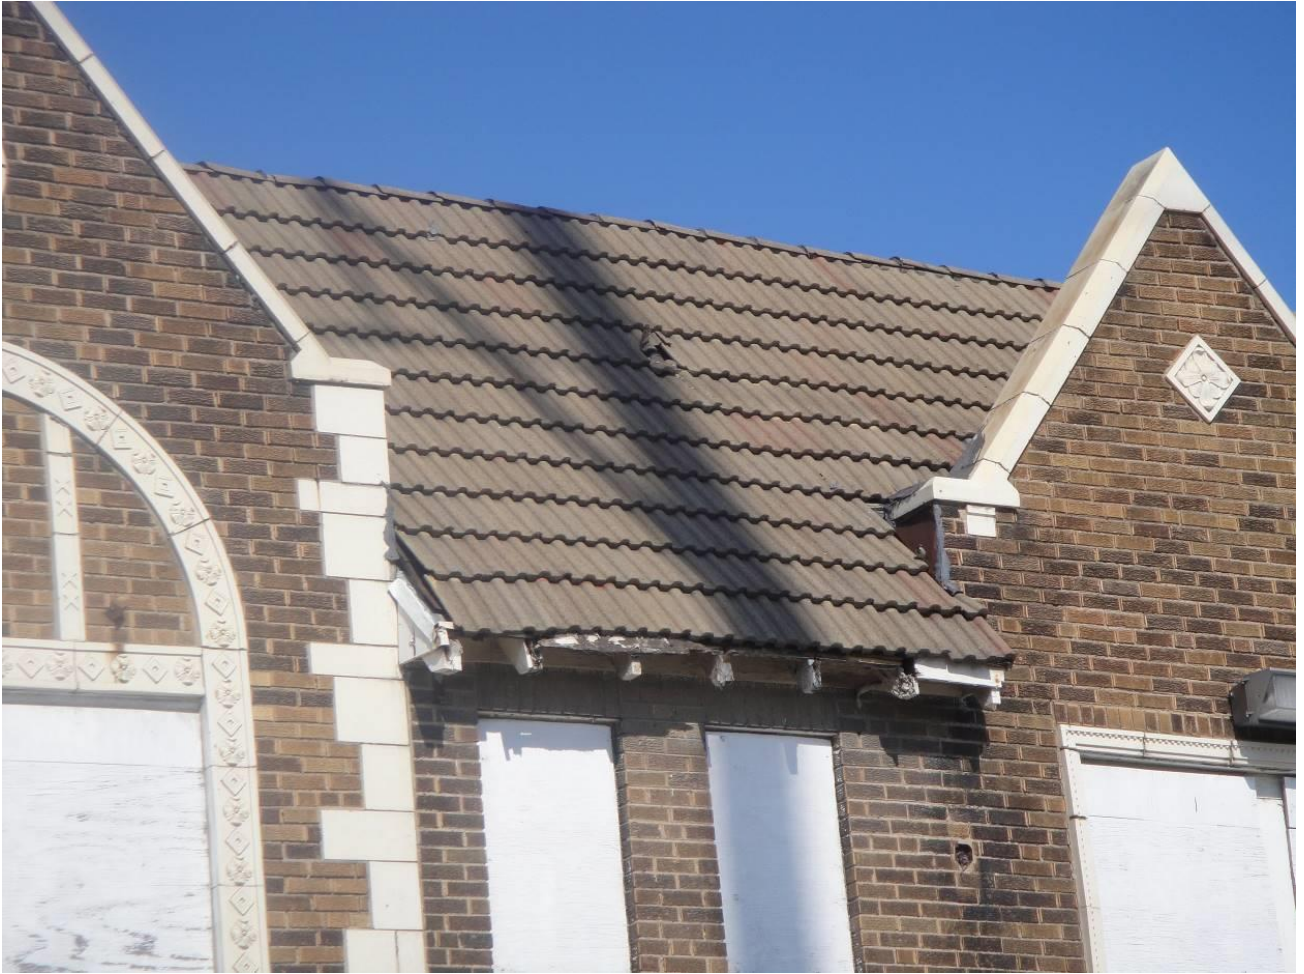
Photo 10 – View of the parapet detail along the eastern façade of the subject building. Note scattered, damaged roof materials. Roofing material appears to be original to facility. Also note lack of gutter and downspout systems to facilitate the discharge of excess rain-water away from the building structure. If deteriorated conditions persist, they could lead to water infiltration which would decrease value of property and deter potential tenants and shoppers, constituting an economic liability and contributing in the inability to pay reasonable taxes.
