**TIFFANY SQUARE EAST  
COMMUNITY IMPROVEMENT  
DISTRICT**

**Petition to Establish the District**

**October 29, 2021**

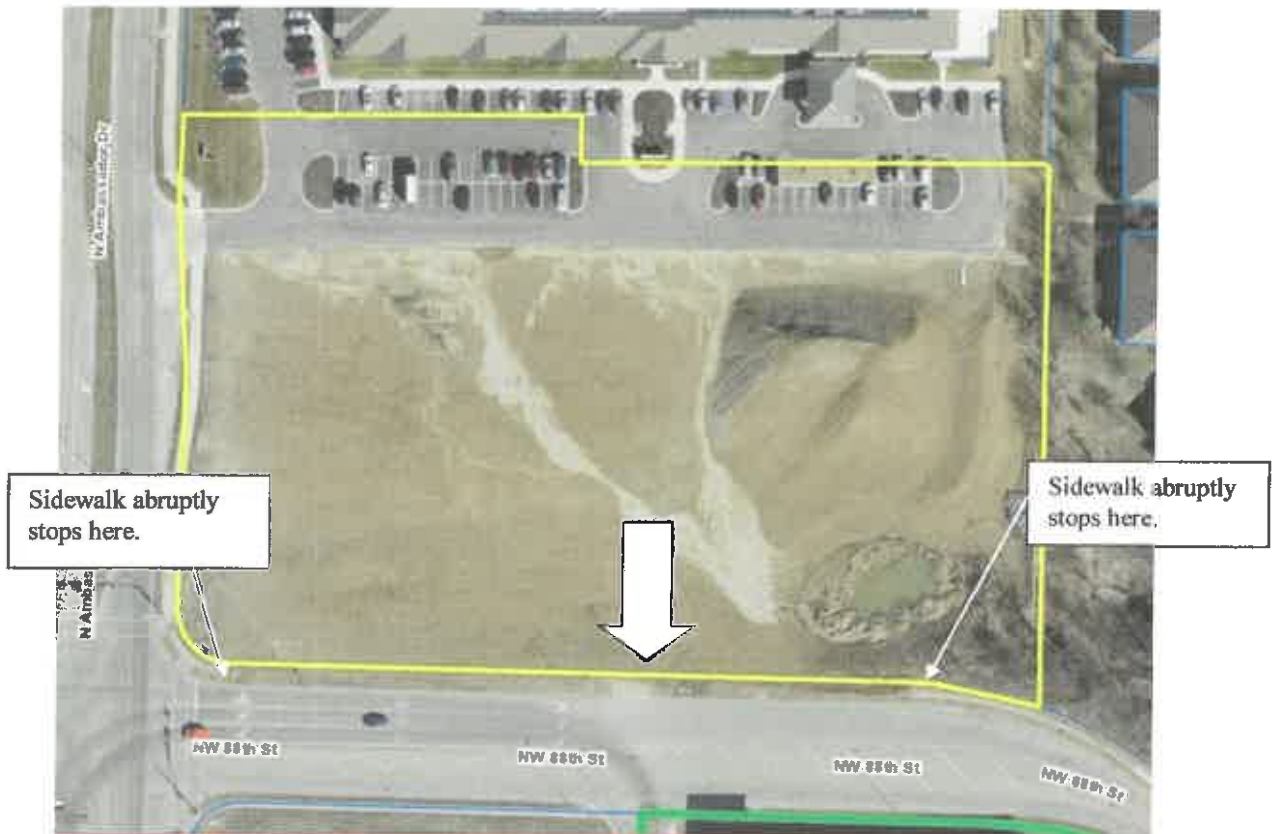
**Vehicular Access:** No vehicular access is currently available within the site. A proposed entry location off of NW 88<sup>th</sup> Street is planned as part of the Development Plan (see white arrow on Figure 11). This location will provide interior vehicular access to the overall property. Continued "right-in, right-out" access at the northwest corner of the property will continue and overall site accessibility will tie in at this location.

It is anticipated that total site infrastructure costs to construct vehicular and pedestrian accessibility improvements will be approximately \$2,050,000 for the entire site.

Figure 5 - Vehicular and Pedestrian Access.

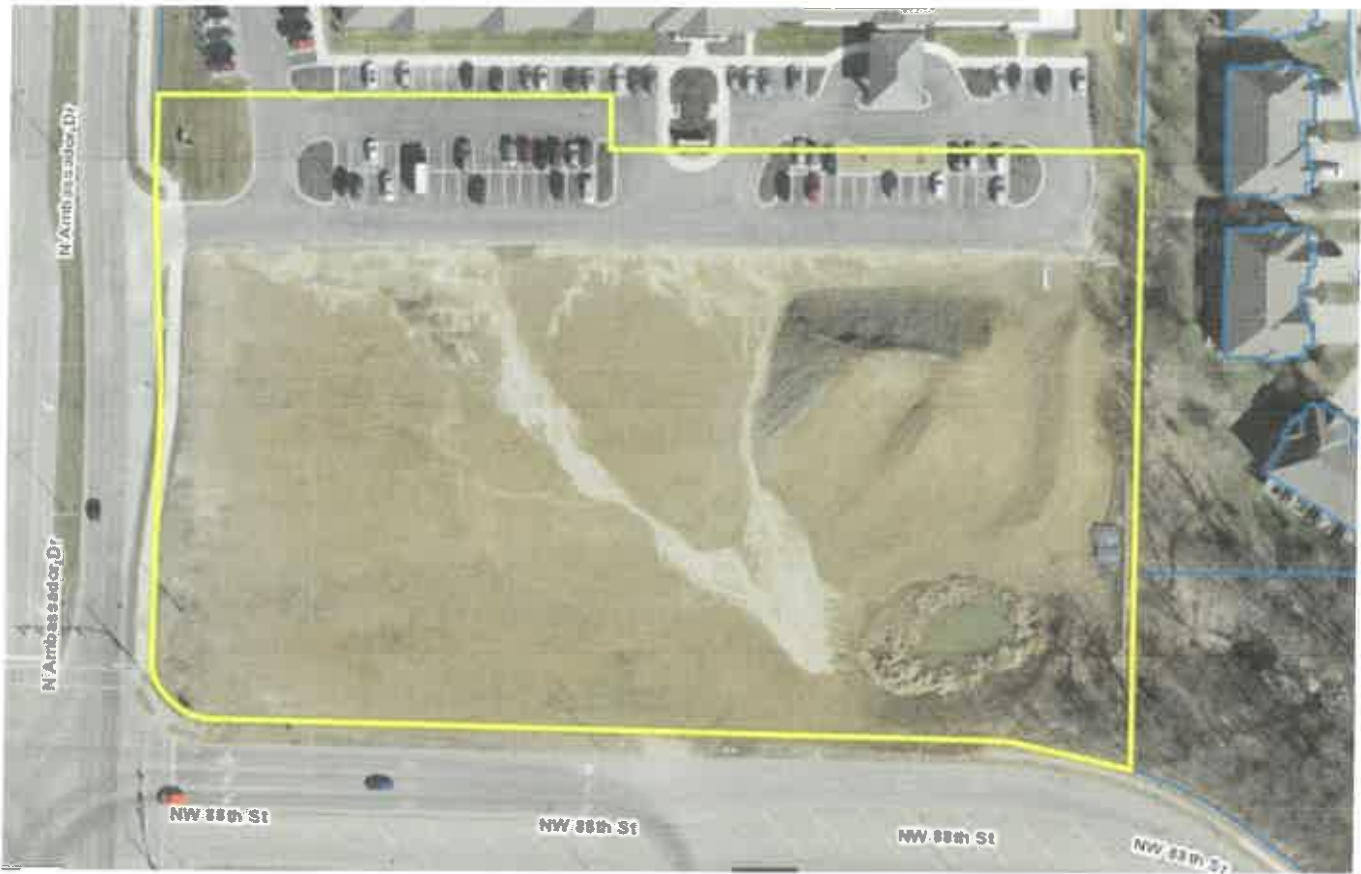
The majority of the site is currently a vacant, grass-covered tract which has been previously graded. The northern portion contains surface parking and drive isles for a previously constructed multi-family project to the north. This area contains approximately 55 parking spaces and associated drive lanes.

Figure 7 - Parcel map indicating existing conditions.

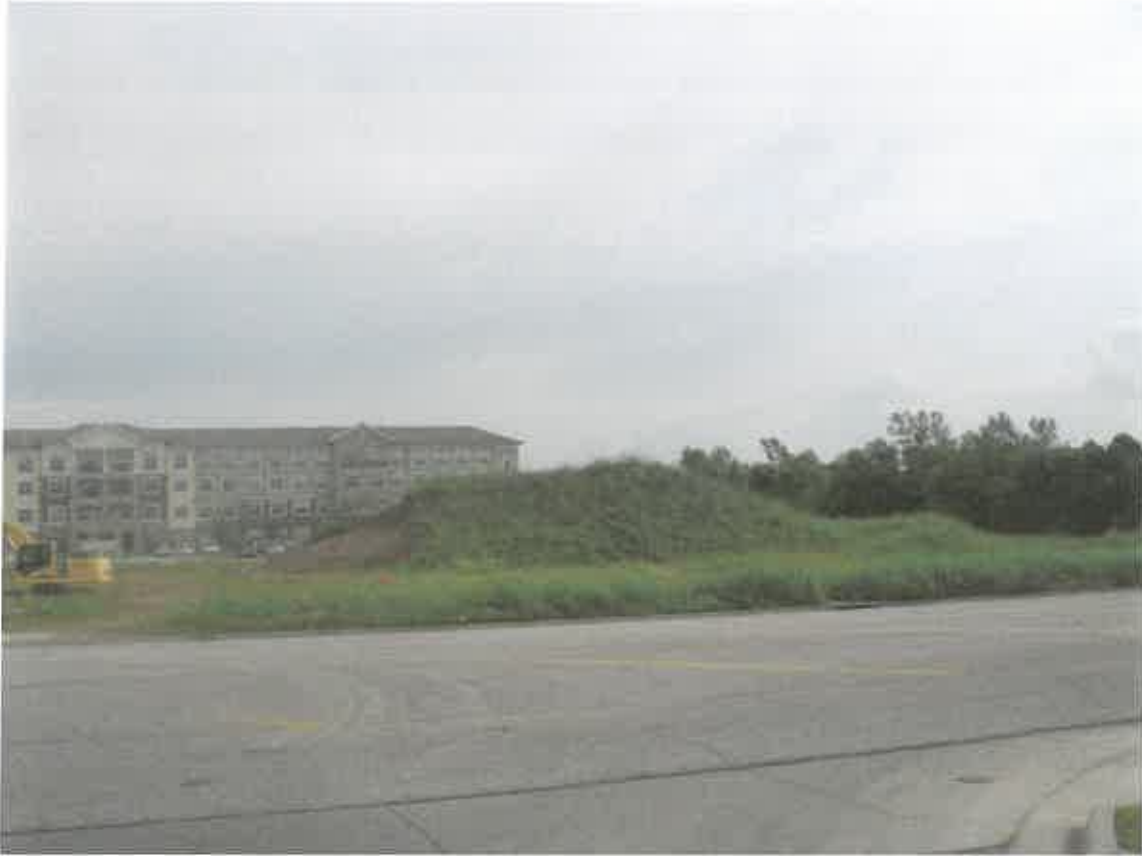
- **Expensive vehicular and pedestrian infrastructure.**  
As previously stated, it is anticipated that total site infrastructure costs to construct vehicular and pedestrian accessibility improvements will be approximately \$2,050,000 for the entire site.
- **Subsurface remediation and replacement of fill material.** As previously mentioned, the site has previously been utilized for construction staging for neighboring properties. Soil overburden material has been stored on site as the result of previous construction projects to the north. There is an existing large pile of soil overburden currently present on the eastern portion of the site (see following Photo 1).

Photo 1 - Existing overburden pile currently located on site.

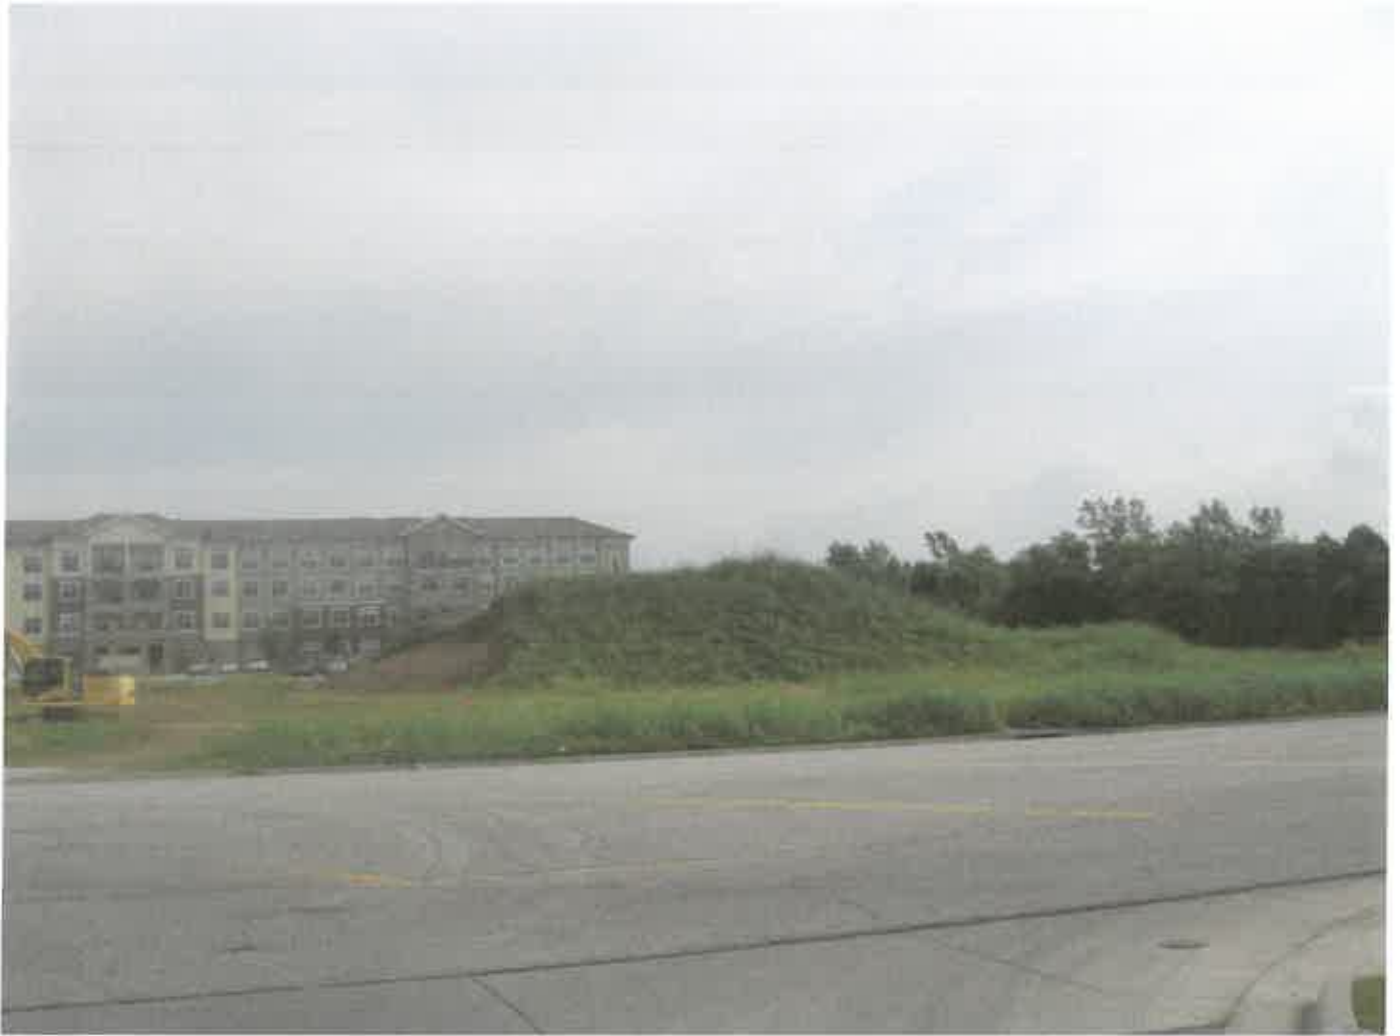
**Photo 3 - Overburden pile currently located on eastern portion of subject property, view from the south.**

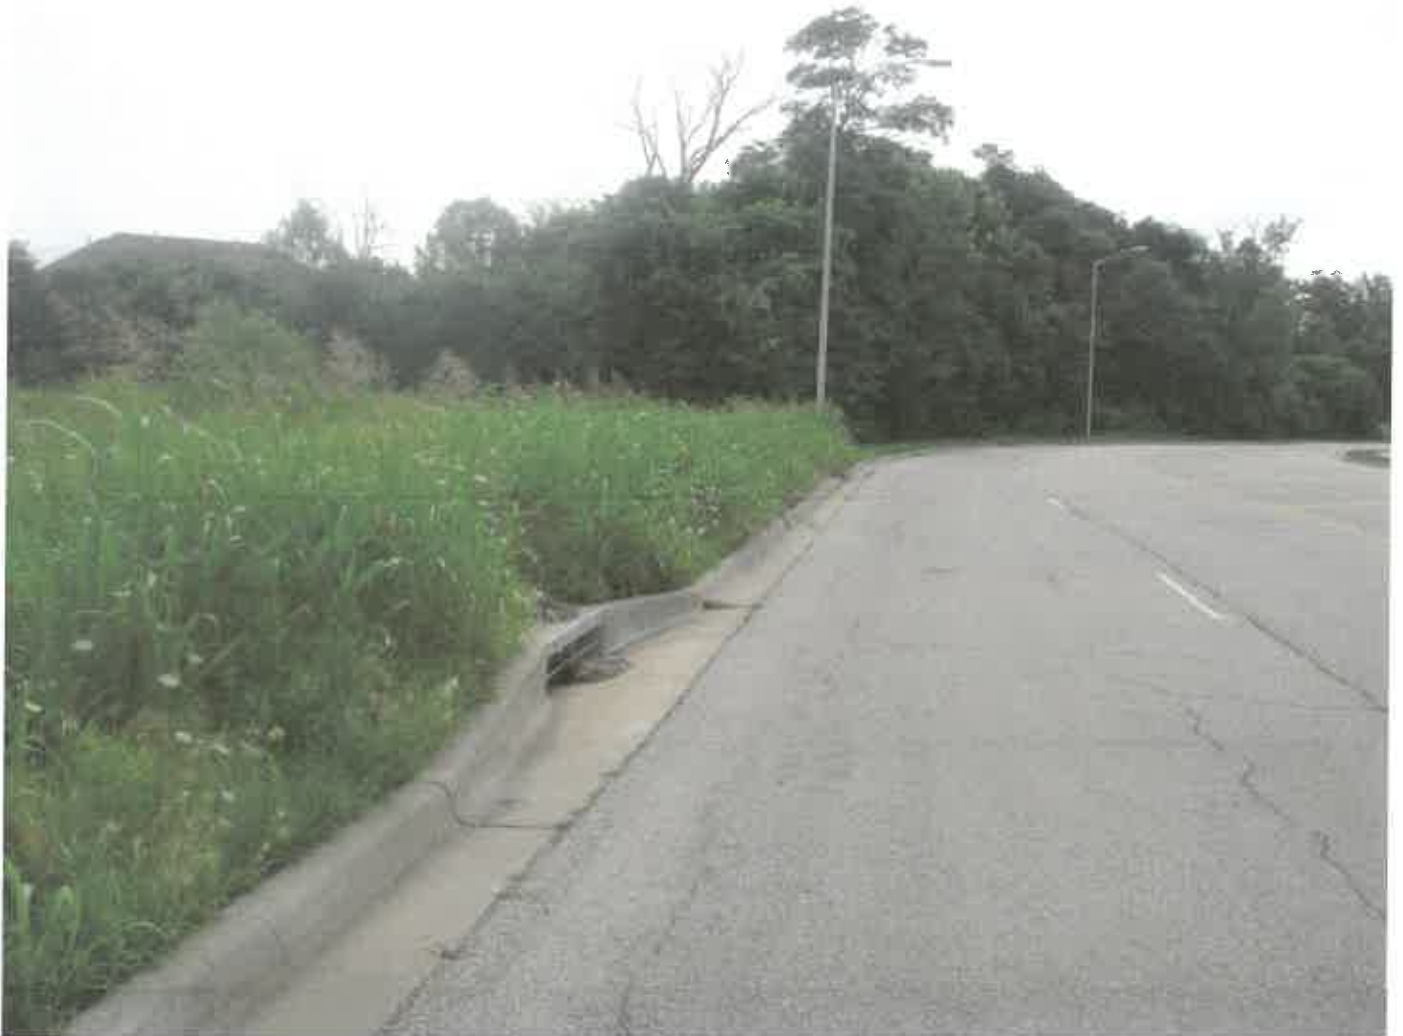
**Photo 4 - View east along NW 88<sup>th</sup> Street. Note storm-water inlet. Also note absence of sidewalk, pedestrian connectivity.**

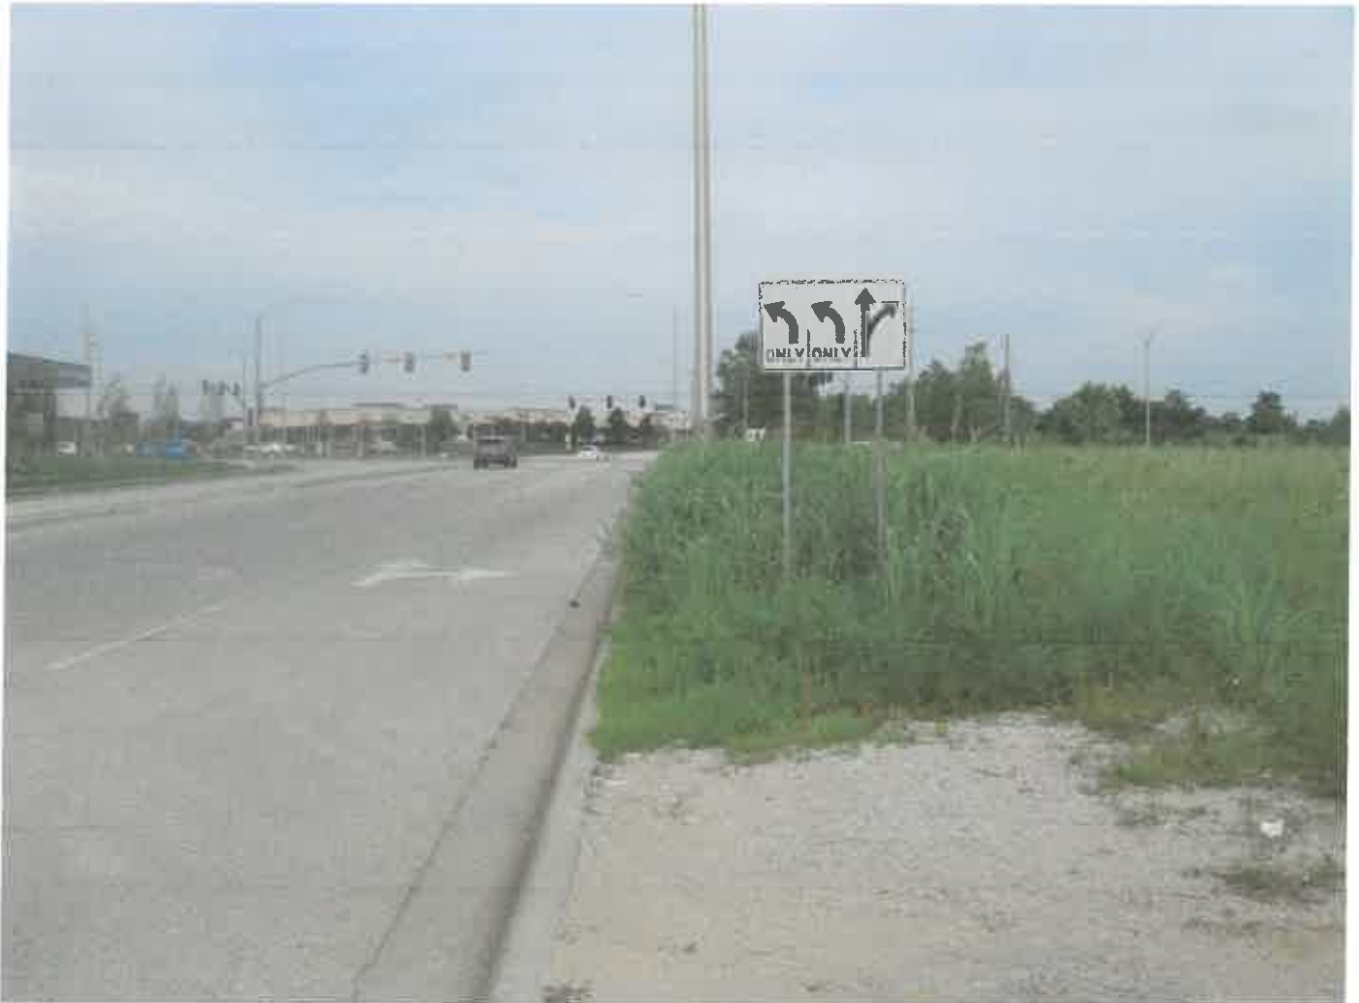
**Photo 5 - View west from same location. Note absence of sidewalk, pedestrian connectivity.**

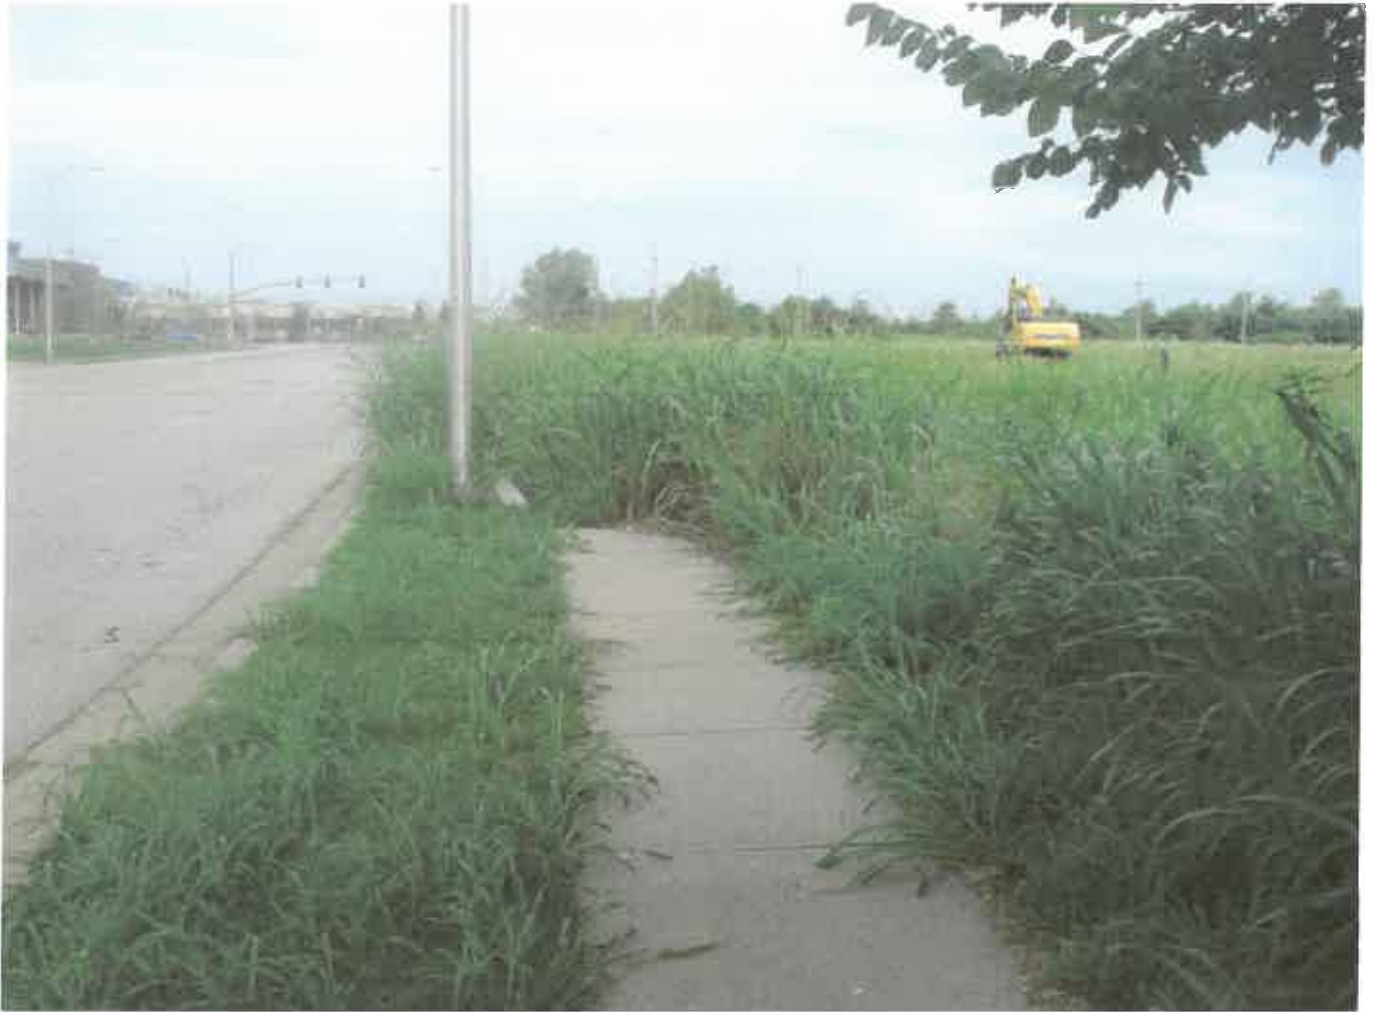
**Photo 6 - View west along NW 88<sup>th</sup> street at SWC of subject property. Note sidewalk/pedestrian access abruptly ends at this location.**

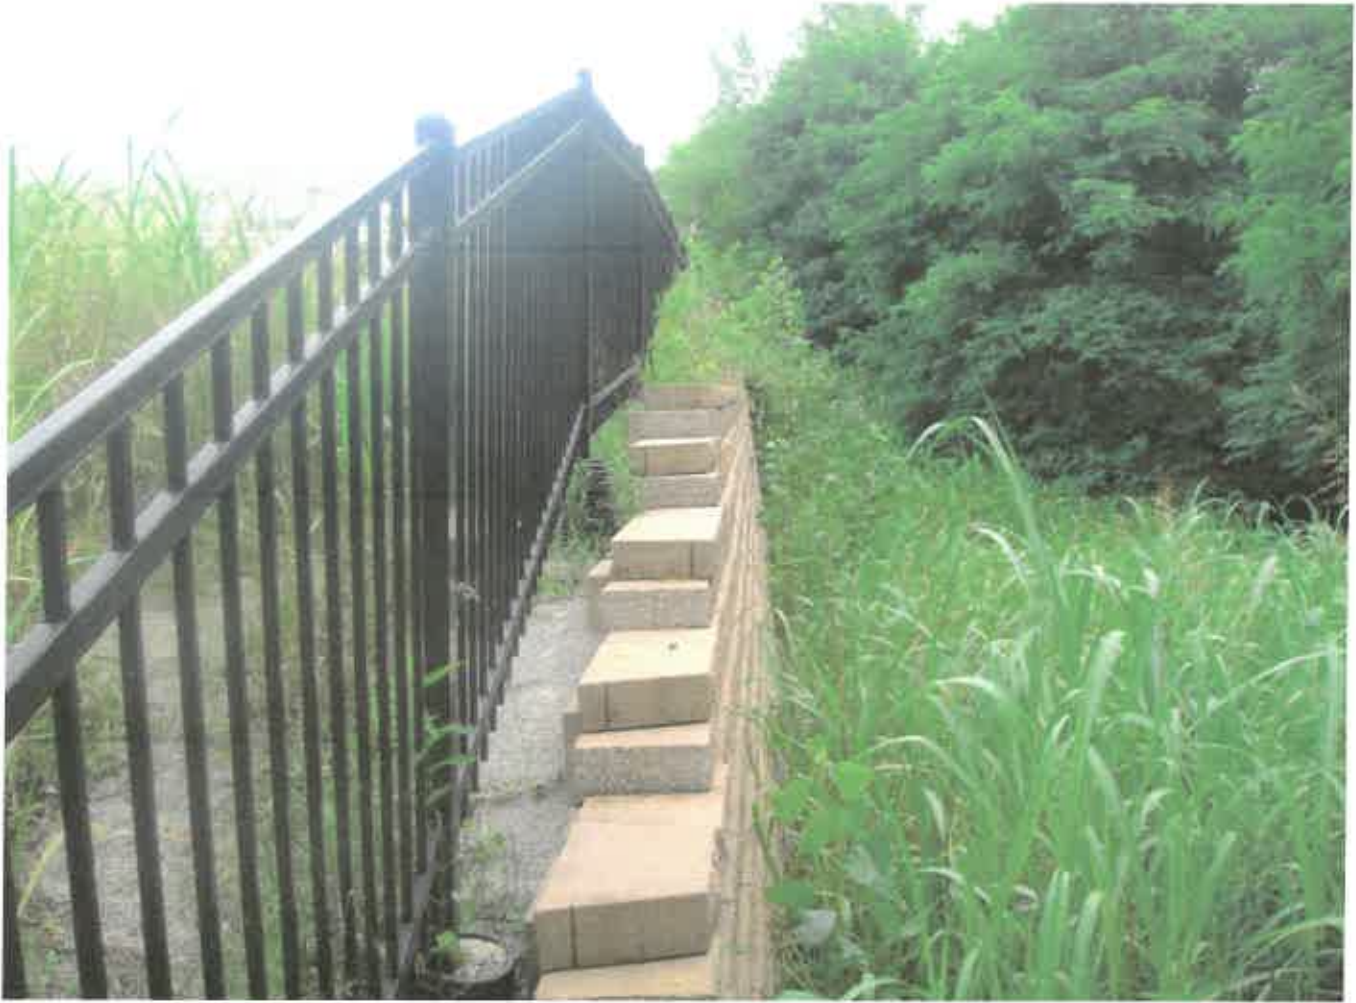
Photo 7 - Retaining wall along eastern property boundary. Wall is approximately 20' in height at this location.

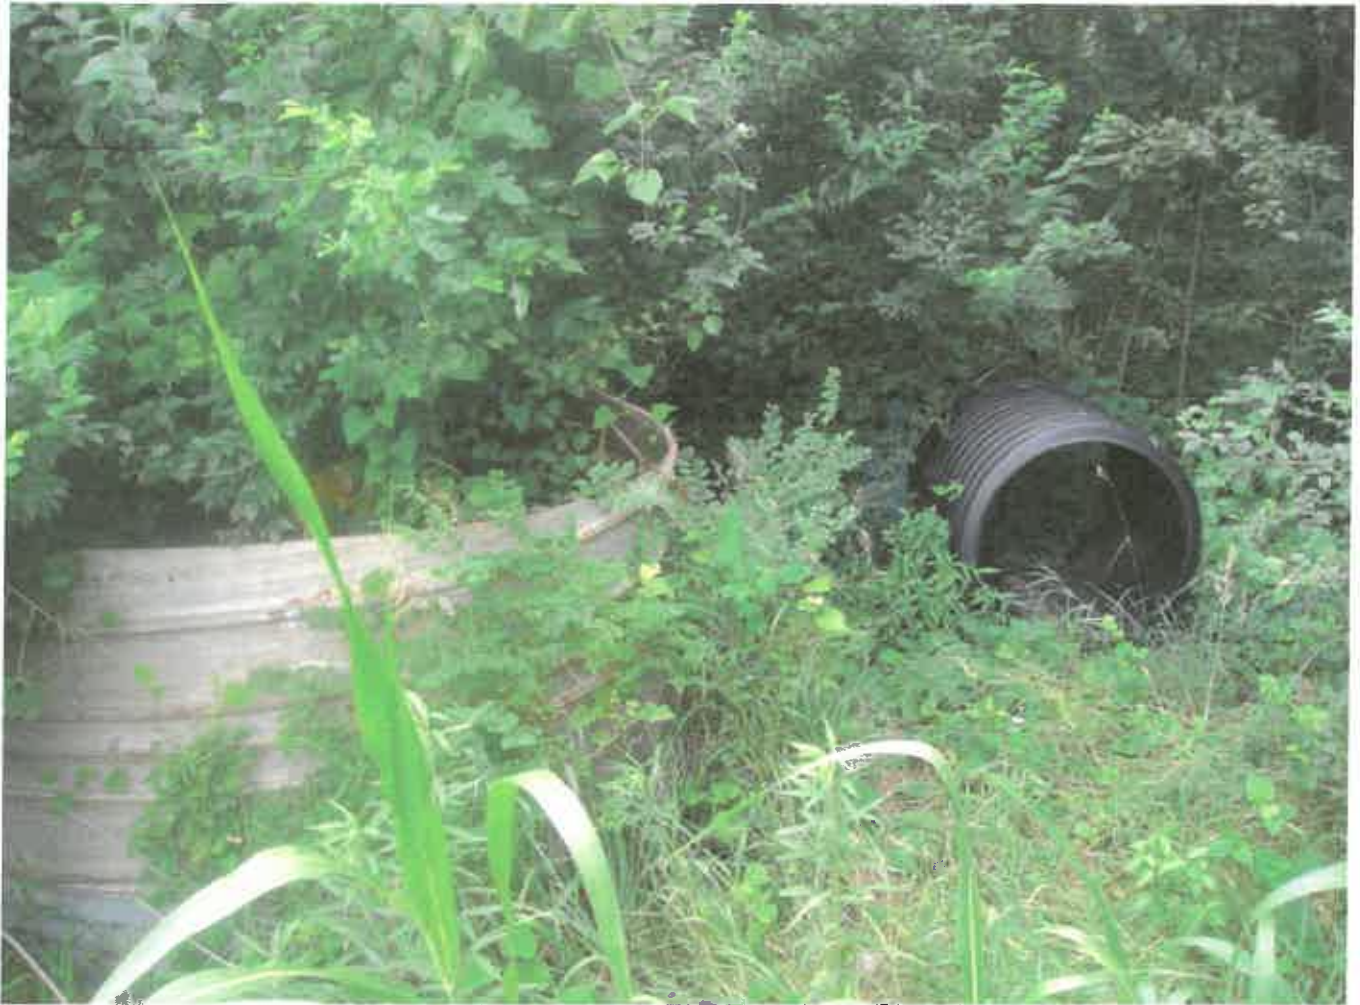
**Photo 8 - Excess storm water culvert left in this location.**

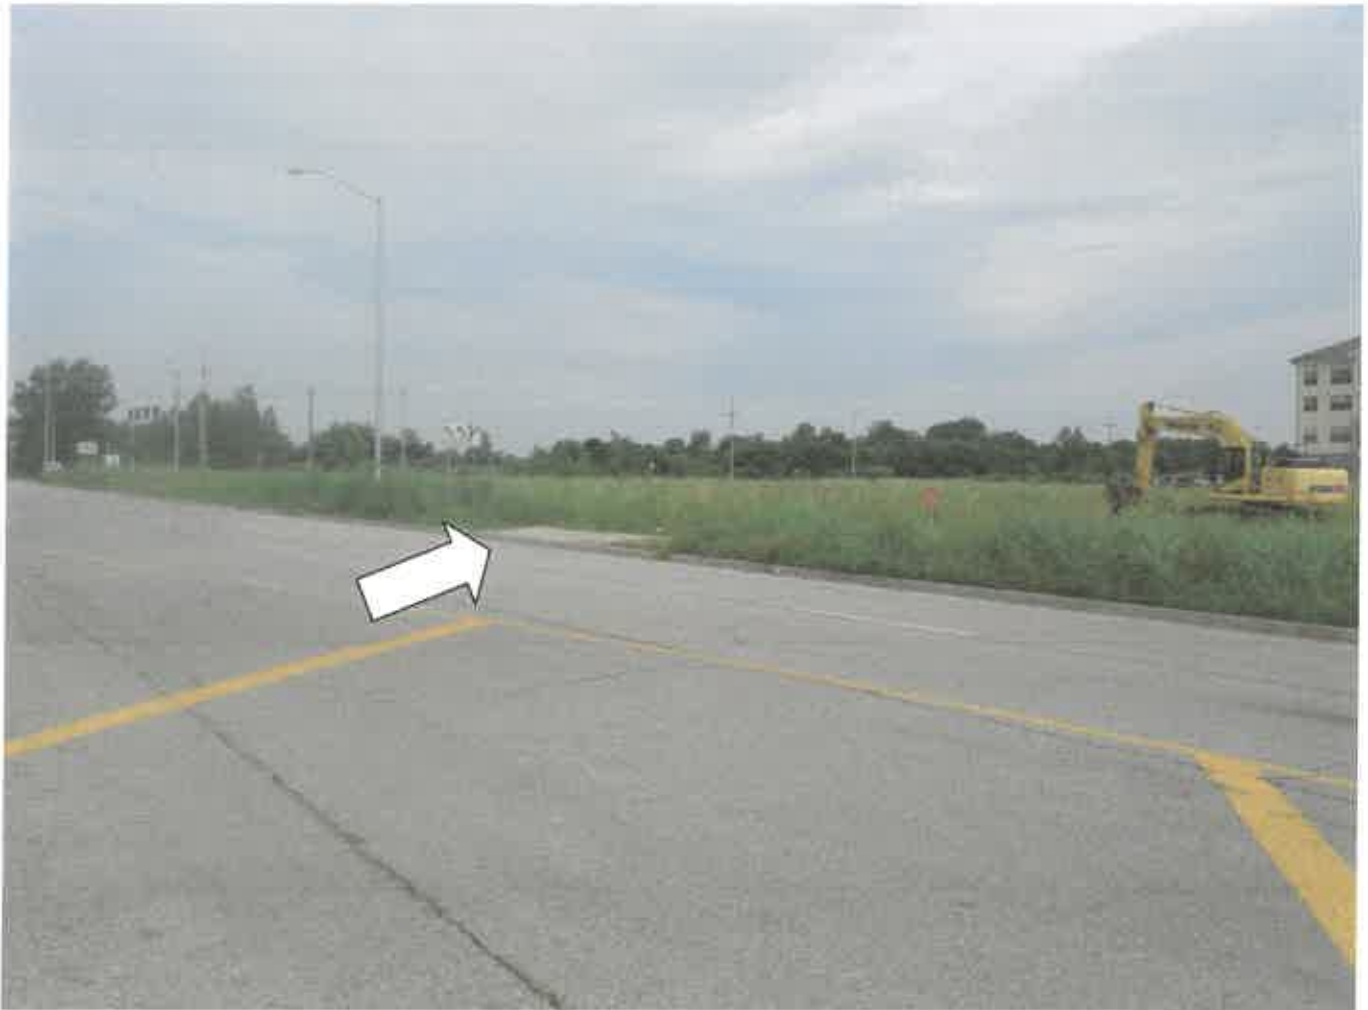
**Photo 9 - View of southern property boundary as it meets NW 88<sup>th</sup> Street. Arrow indicates where vehicular access will have to be constructed.**

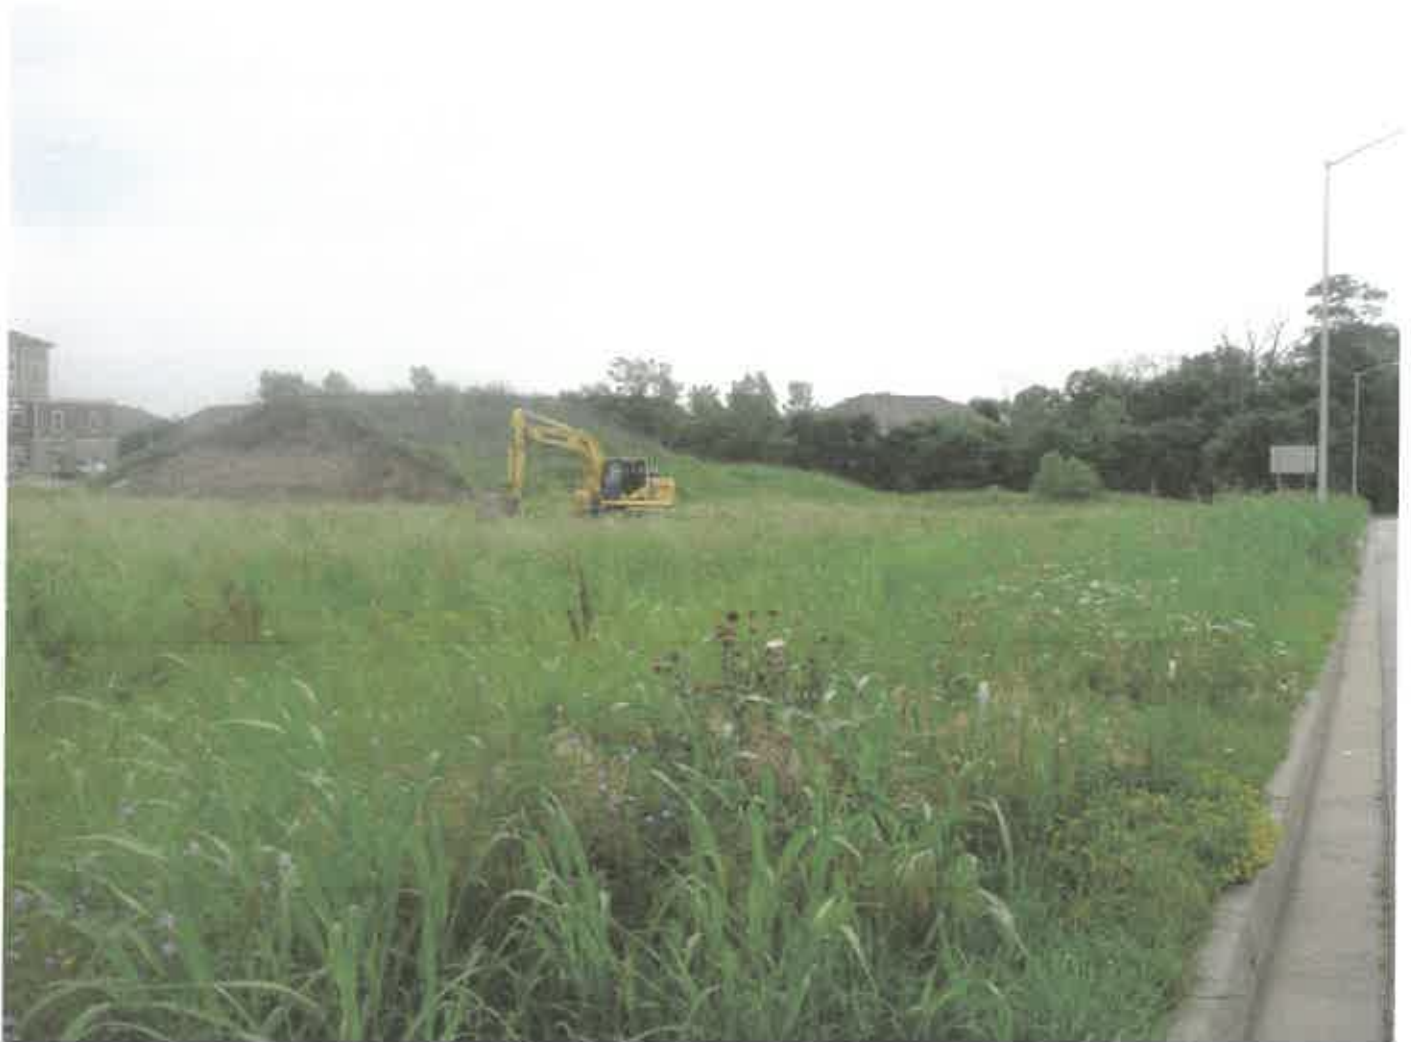
**Photo 12 - View east along NW 88<sup>th</sup> Street. Note overburden pile present on site.**

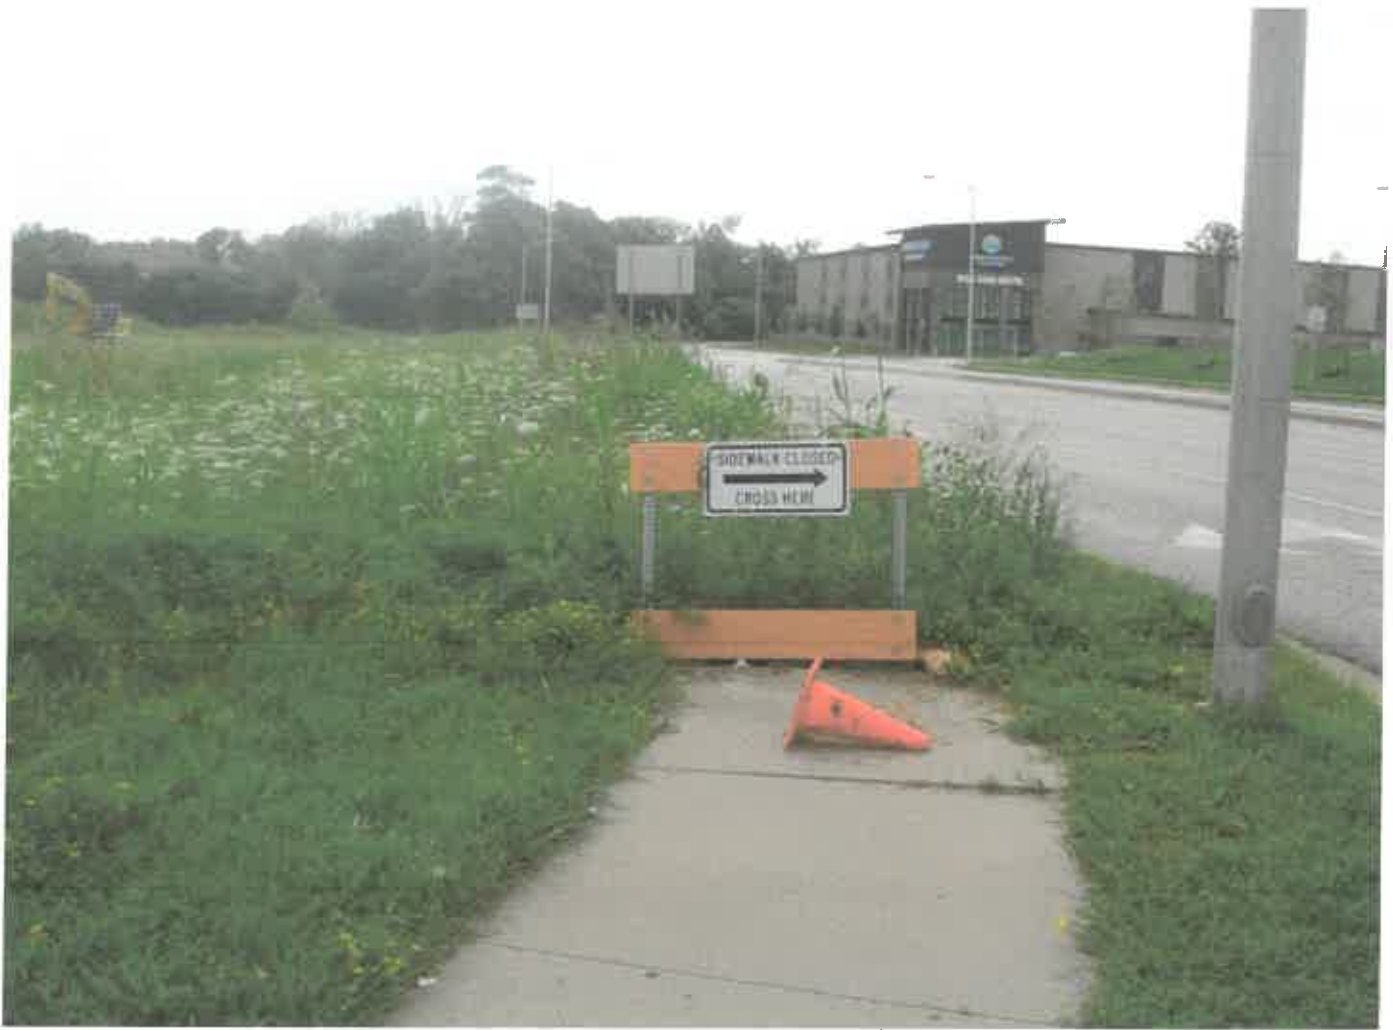
**Photo 17 - Southwest corner of subject property. Sidewalk/pedestrian access abruptly ends in this location. NW 88<sup>th</sup> Street in background.**
