AMENDED BLIGHT STUDY

WEST BOTTOMS STUDY AREA

FORESTER VIADUCT/BLUFF ROAD/W 12TH STREET/HICKORY STREET
KANSAS CITY, MISSOURI

NOVEMBER 17, 2023
RECORD No. 1800

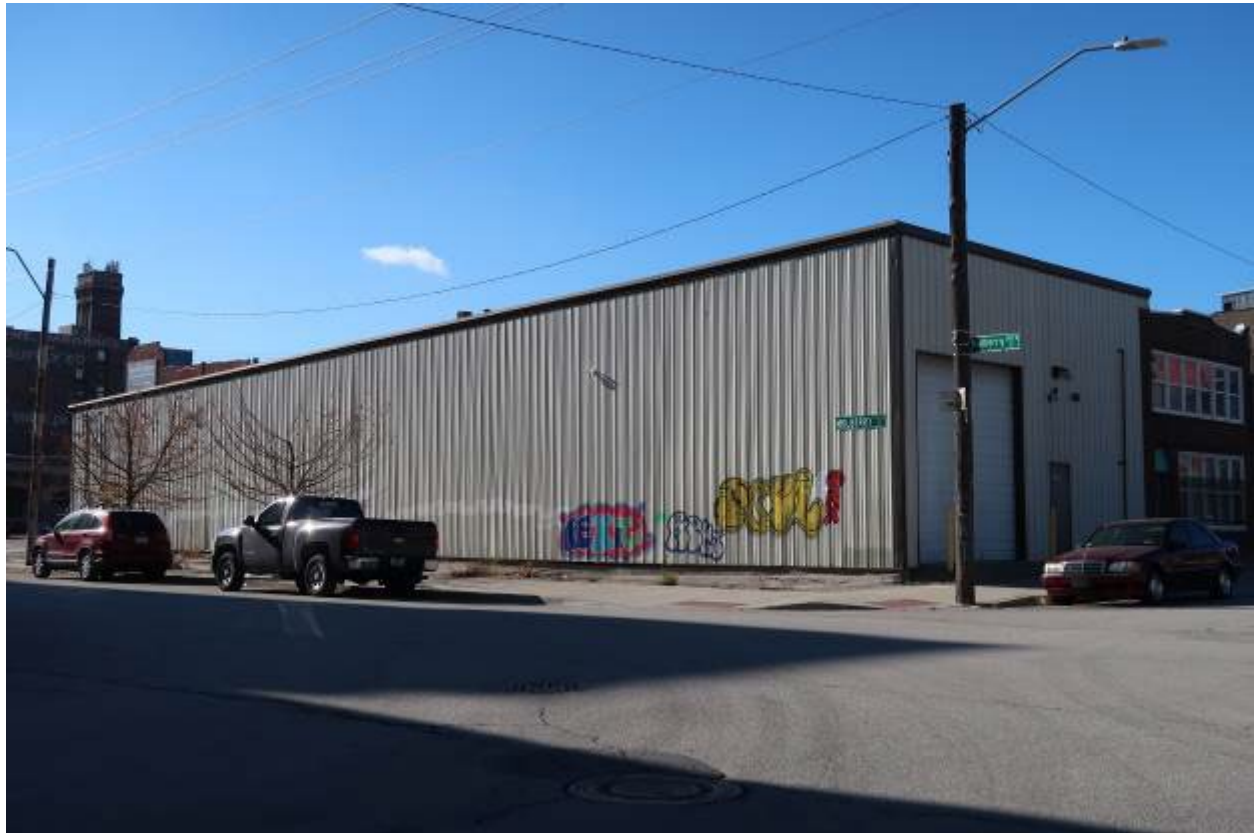
Looking Southwest At The East (Mulberry Street) & North Elevation Of 1301 Union Avenue

The exterior is in poor to fair condition. The foundation below the east elevation and the adjoining sidewalk are settling noticeably. The exterior walls have dents and have graffiti or whited out graffiti areas. The roof is newer. The structure lacks windows. Finished space is minimal. Elongated buildings are less functional. The structure would be a poor candidate for residential or commercial conversion.

Blight issues involving Deterioration Of Site Improvements observed at the subject tax parcel include deterioration of the exterior facades, the foundation settling along the east elevation, and functional obsolescence issues dealing with the elongated structure, lack of windows, and minimal finished space.

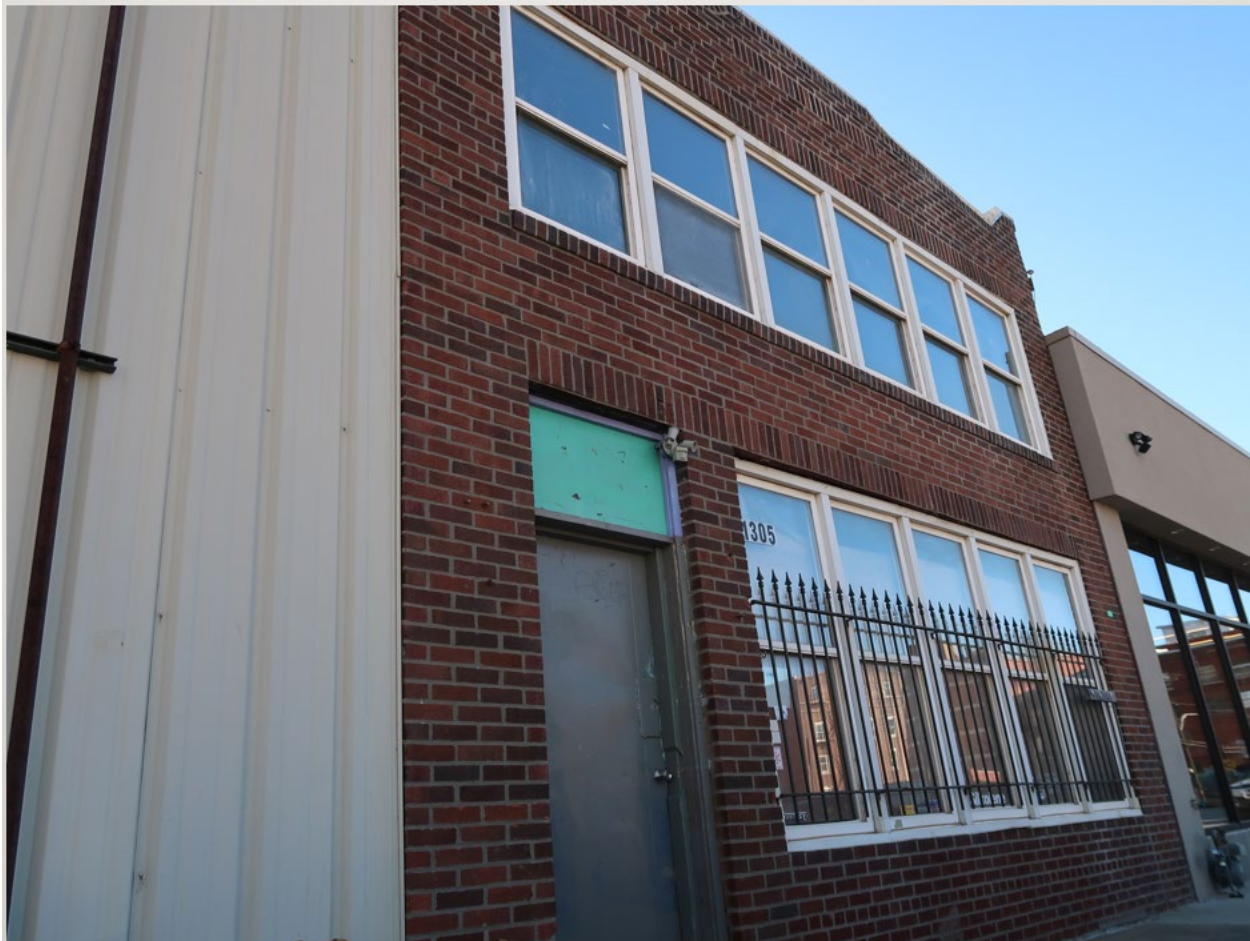
Looking Southwest At The Front (North) Elevation Of 1305 Union Avenue

The exterior is of fair quality and condition. The interior is of poor quality in poor to fair condition. The roof is newer. Windows along the front façade have unappealing security bars. The structure has no interior finish and is exposed concrete. The concrete floors are in poor condition. The interior floor is on multiple levels resulting in dysfunction. The front door is rusted and settling creates a one inch gap between the door bottom and the floor. The very elongated buildings has less functionality. The gas-fired furnace is newer. The structure would be a poor candidate for residential or commercial conversion.

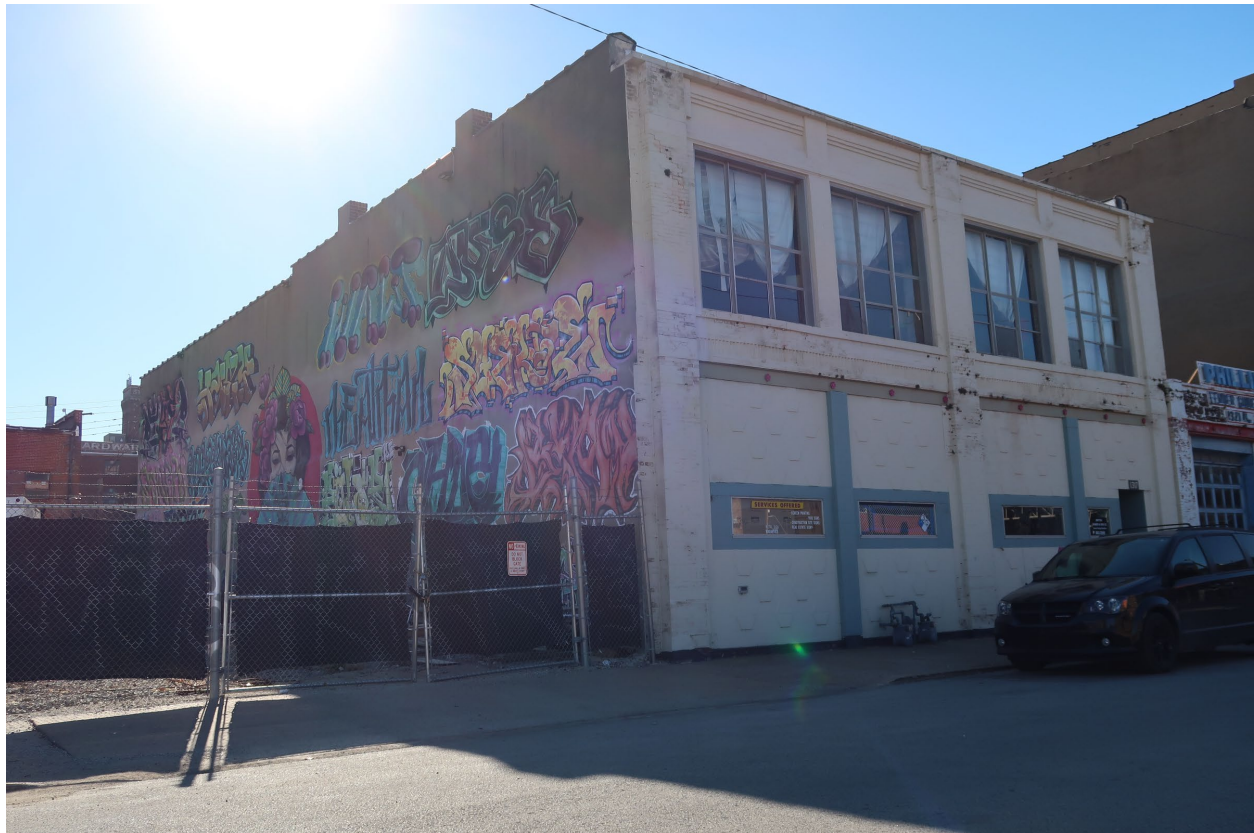
Looking Southwest At The Front (North) & East Elevations Of 1317 Union Ave. & Adjoining Storage Yard

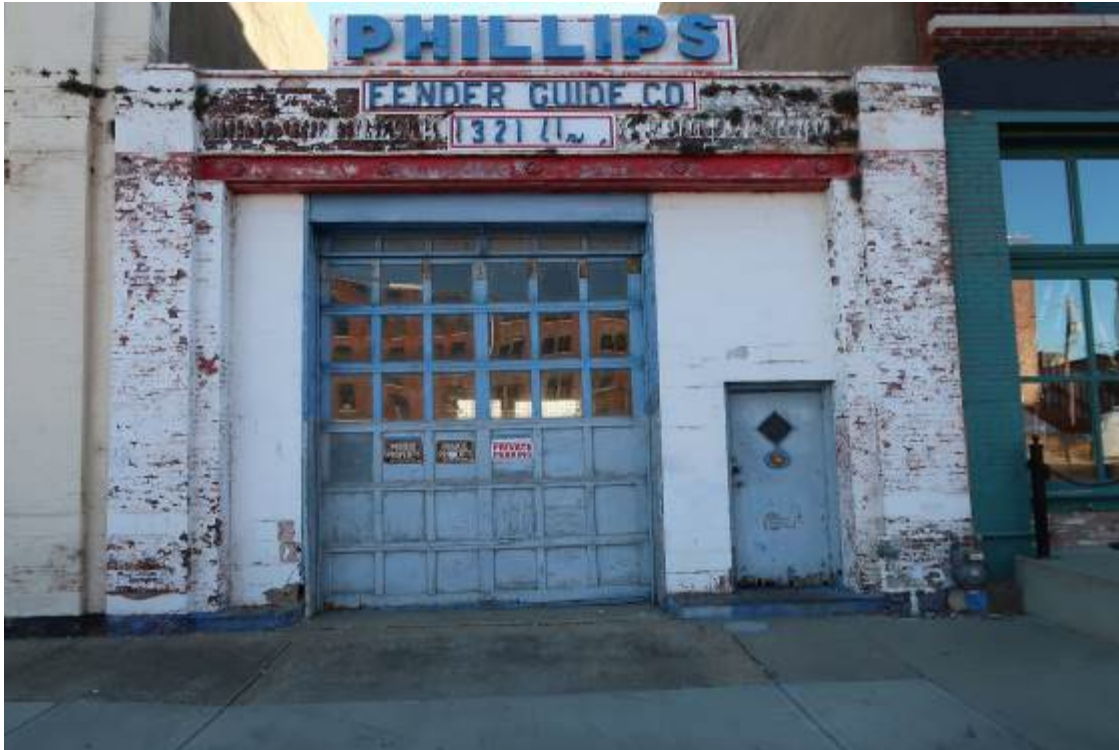
The Front Elevation Of The Westerly Adjoining Blighted Property
