AMENDED BLIGHT STUDY

WEST BOTTOMS STUDY AREA

FORESTER VIADUCT/BLUFF ROAD/W 12TH STREET/HICKORY STREET
KANSAS CITY, MISSOURI

NOVEMBER 17, 2023
RECORD No. 1800

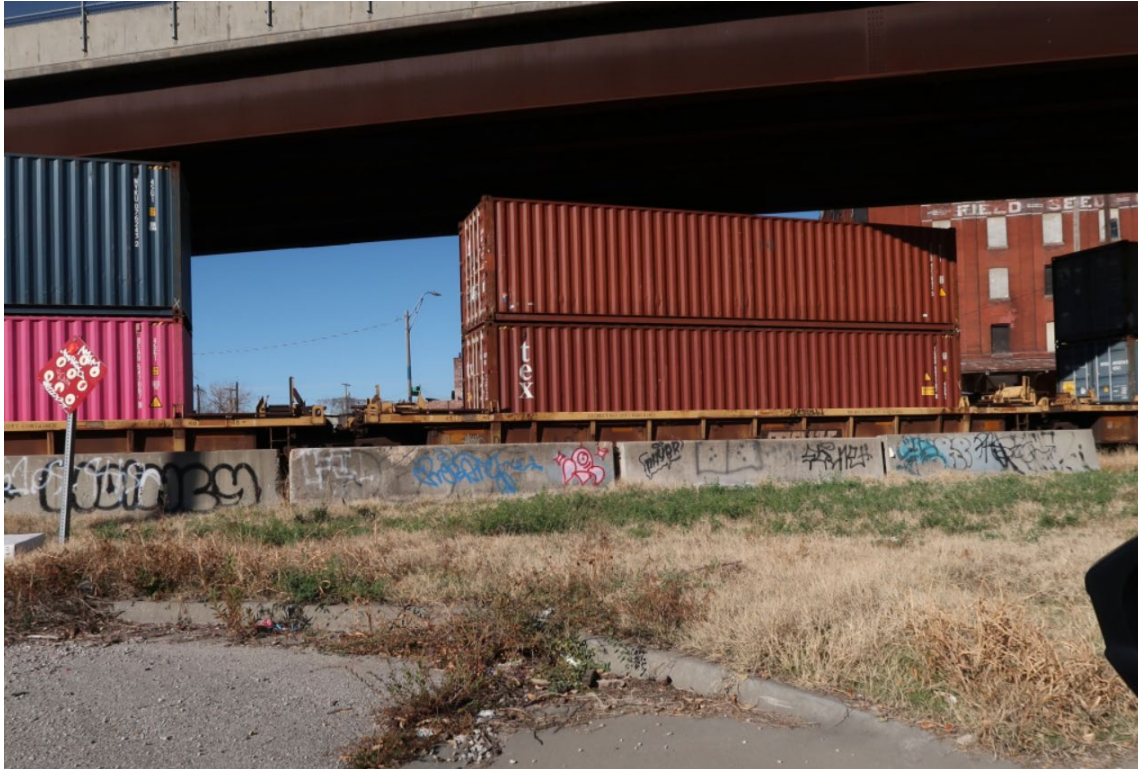
Blight issues involving Insanitary Or Unsafe Conditions observed at the subject tax parcel include trash and illegal dumping as well as the presence of the active railroad tracks bisecting the tax parcel.

Blight issues involving Endangerment By Fire Or Other Causes observed at the subject tax parcel include crime (graffiti) and the endangerment caused by the active railroad tracks bisecting the property.

Active Railroad Bisecting Tax Parcel

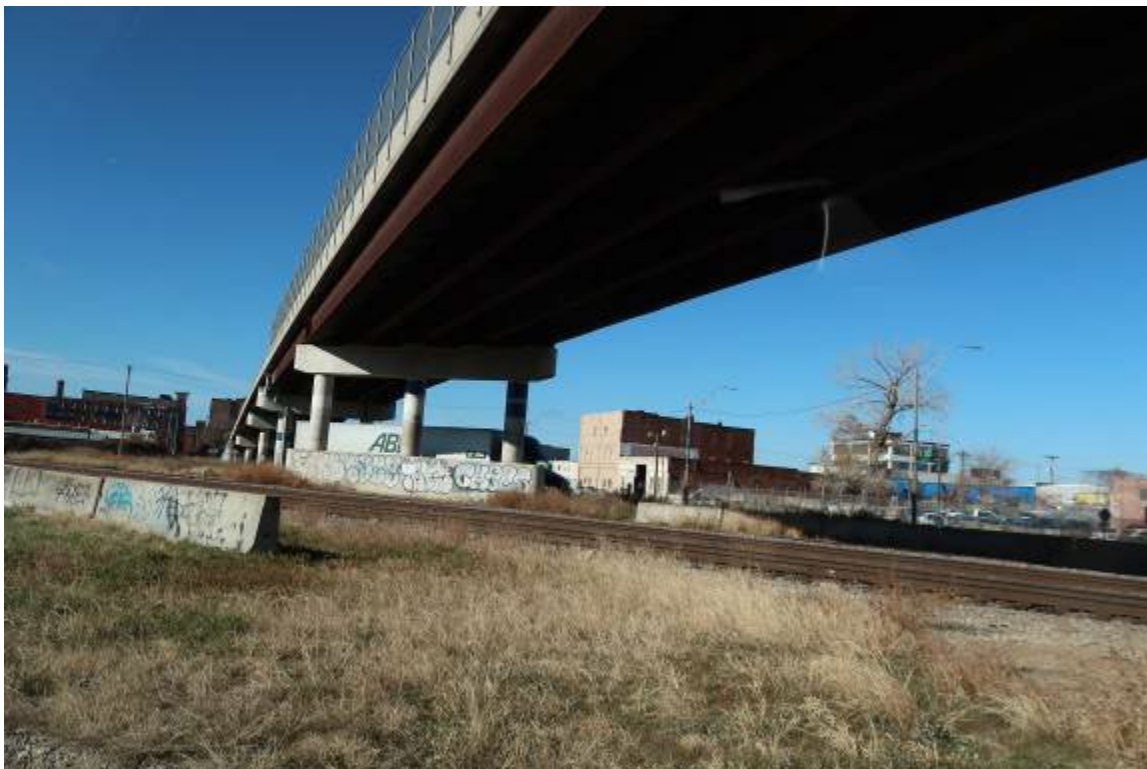
Graffiti & Forester Viaduct & Active Railroad

912 Santa Fe Street has remained unimproved and unused due to the presence of the active rail line and the Forester Viaduct. The active (unguarded) rail line is a safety concern in this center city location while illegal dumping, trash, and crime negatively impact this parcel. The subject tax parcel suffers from multiple blighting components.

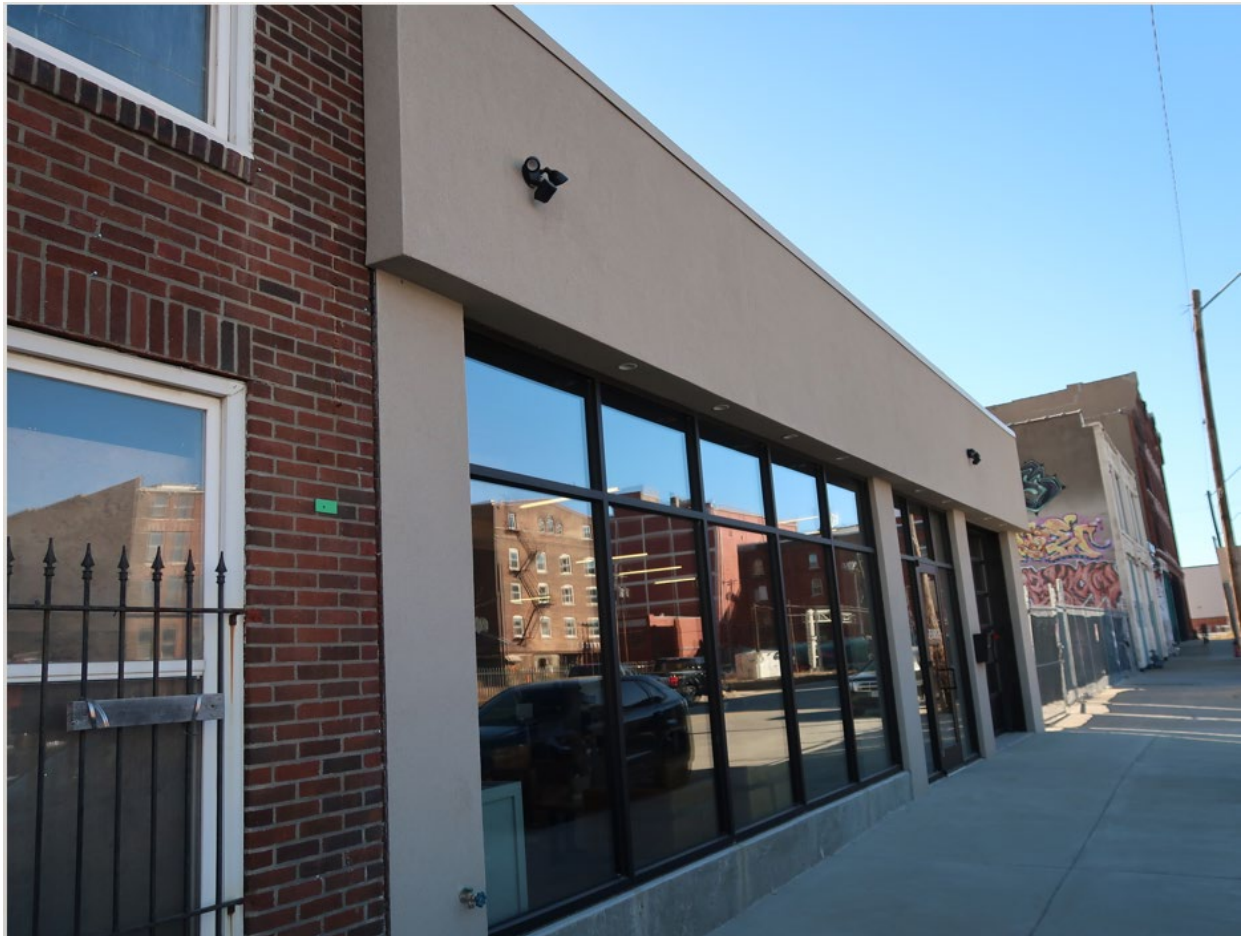
Looking Southwest At The Front (North) Elevation Of 1309 Union Avenue

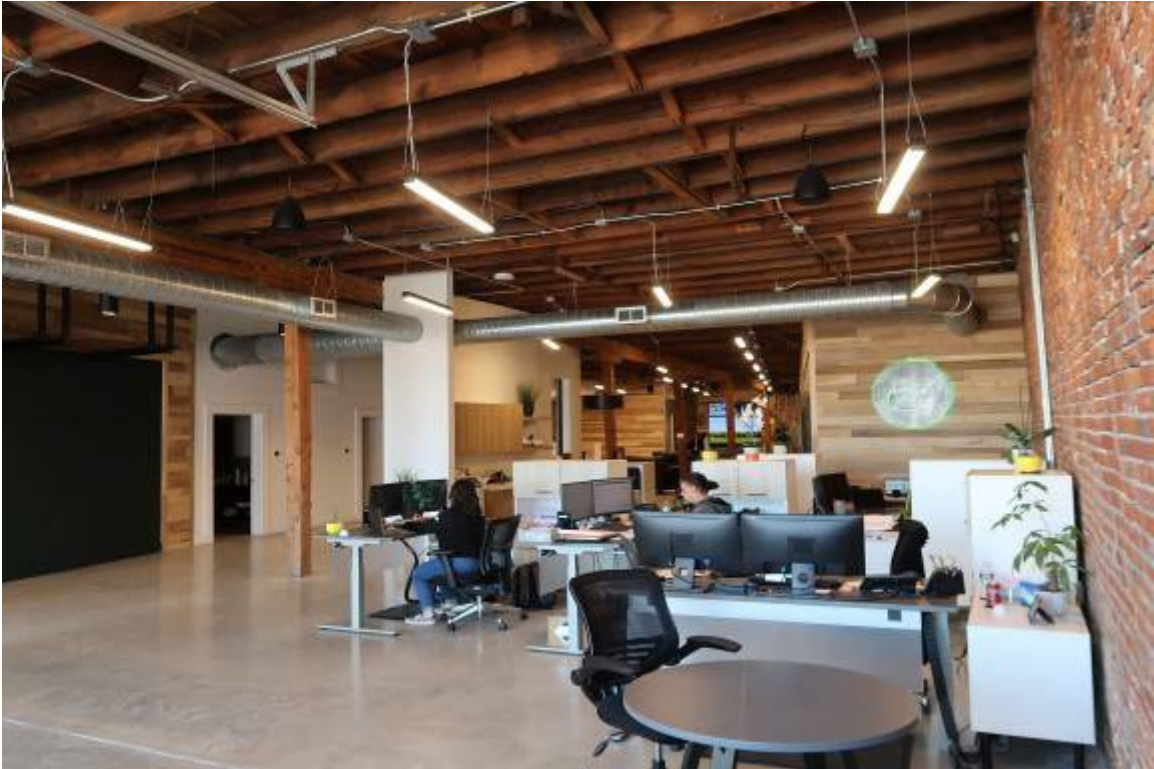
Interior Office Conversion Finish

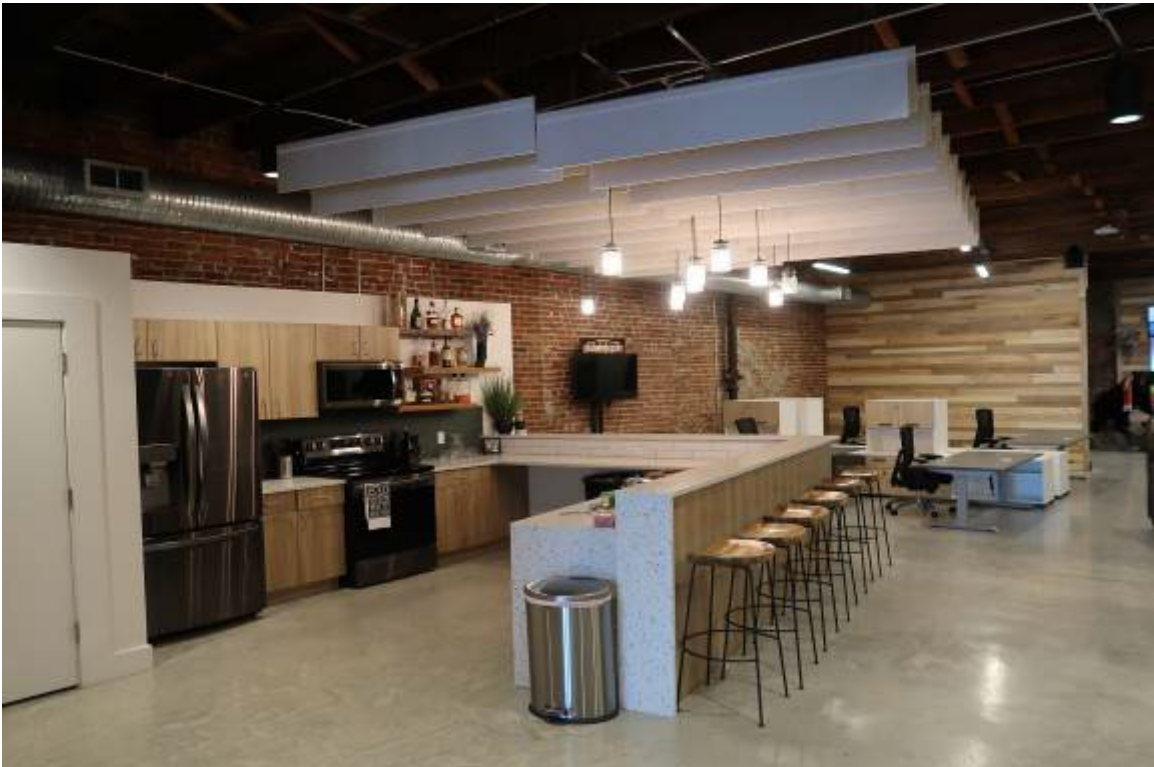
Interior Office Conversion Finish

1306 Union Avenue does not appear to have any blighting components except the unsightly rear elevation (physical deterioration) and the lack of no off-street parking provision.

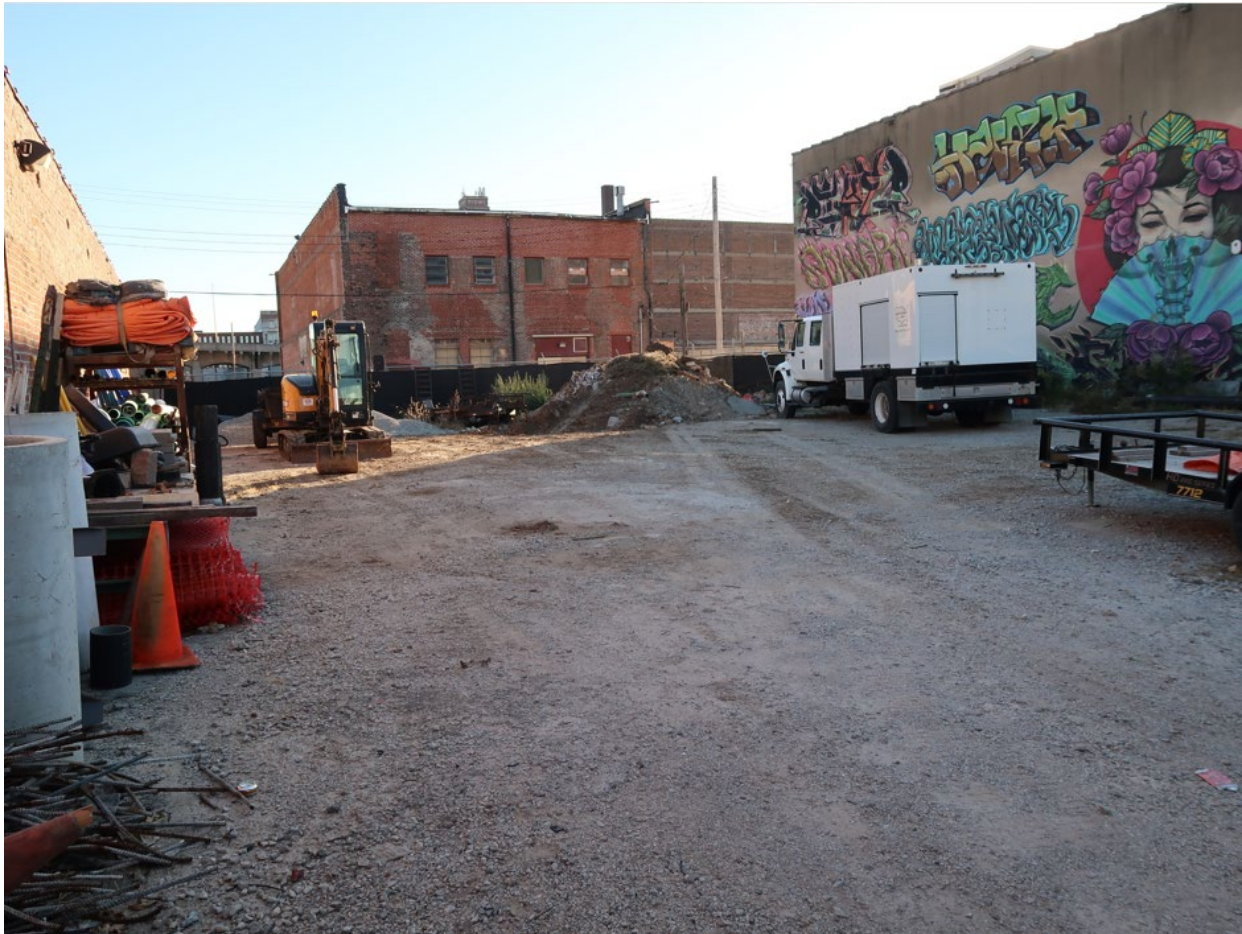
Looking South Across 1311 Union Avenue

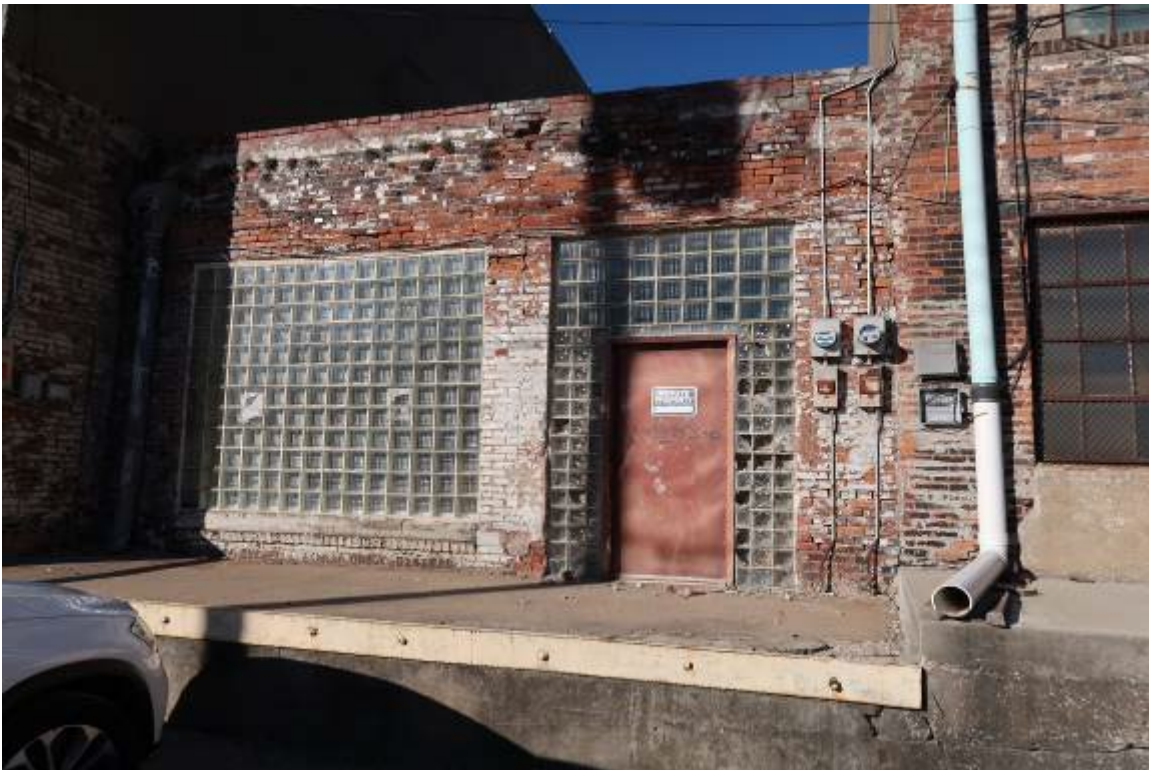
The Rear Elevation Of The Westerly Adjoining Blighted Property

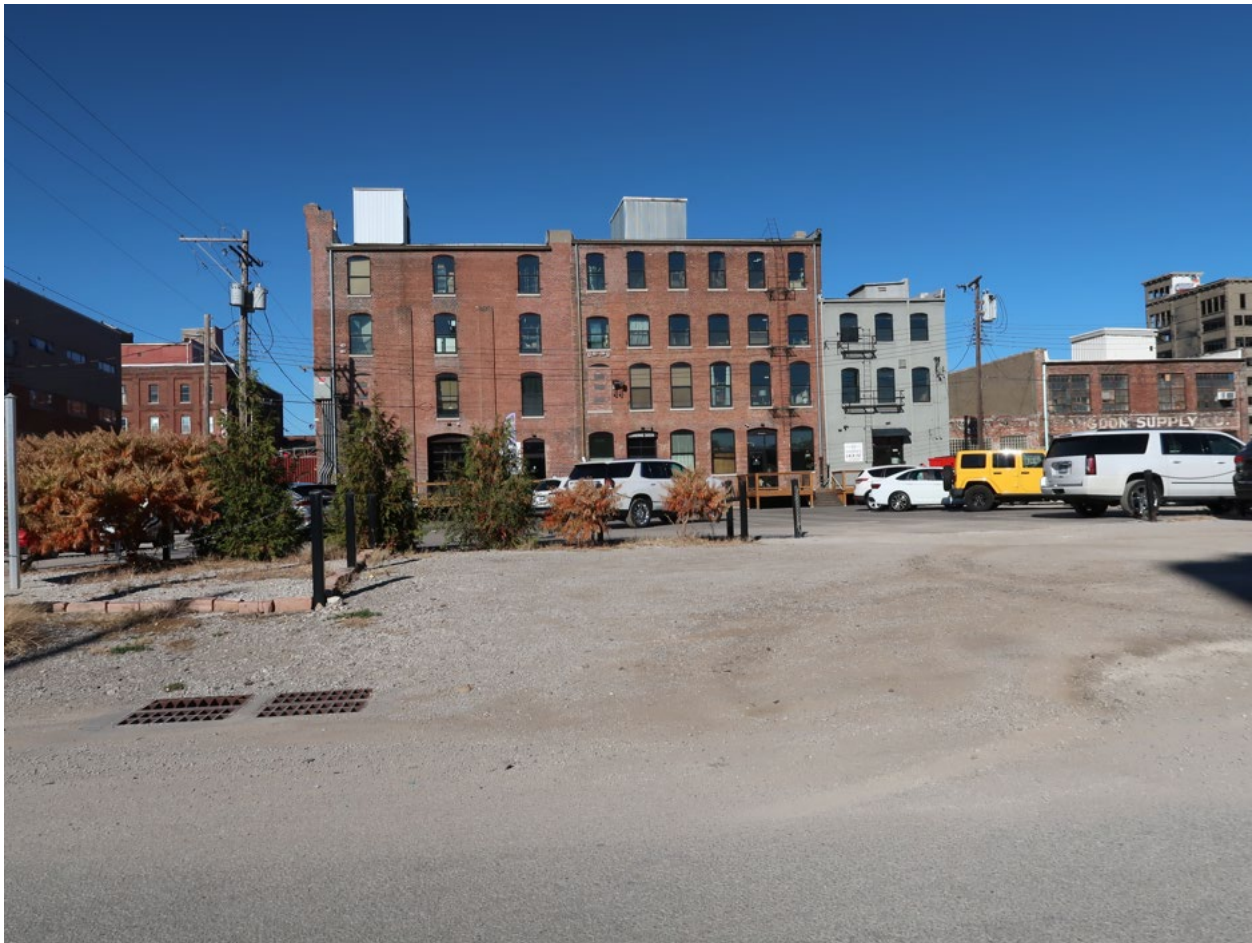
Looking North From E 11th Street Across The Dirt Access To 1027 Hickory Street

Gravel parking/storage lots in the urban setting can be a nuisance (dust in the air, dirt on adjoining sidewalks and streets). Pedestrian sidewalks and curbs along Hickory Street are in poor condition creating safety concern. Pedestrian sidewalks and curbs are lacking along E 11th Street.

Roadways lacking safe pedestrian walkways or with deteriorated provisions are safety concerns. Parking lots with gravel access create safety concerns.

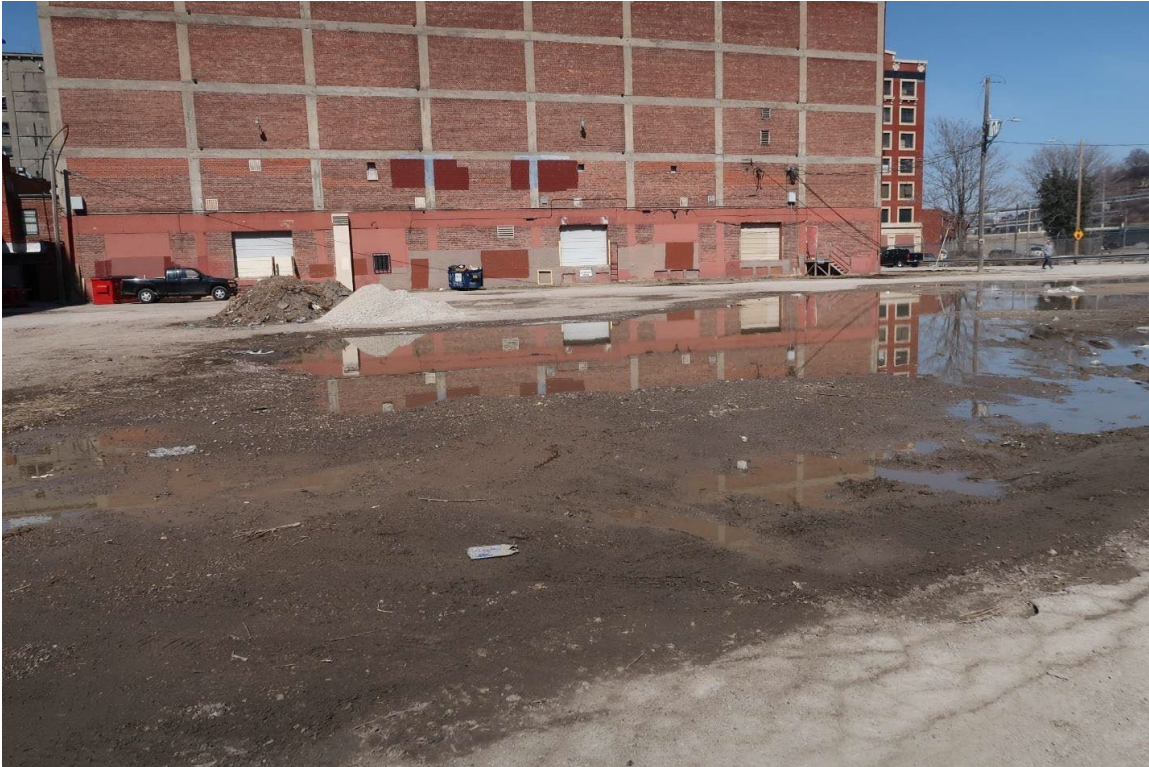
Dirt Parking Lot At 1015 Mulberry Street – 2022

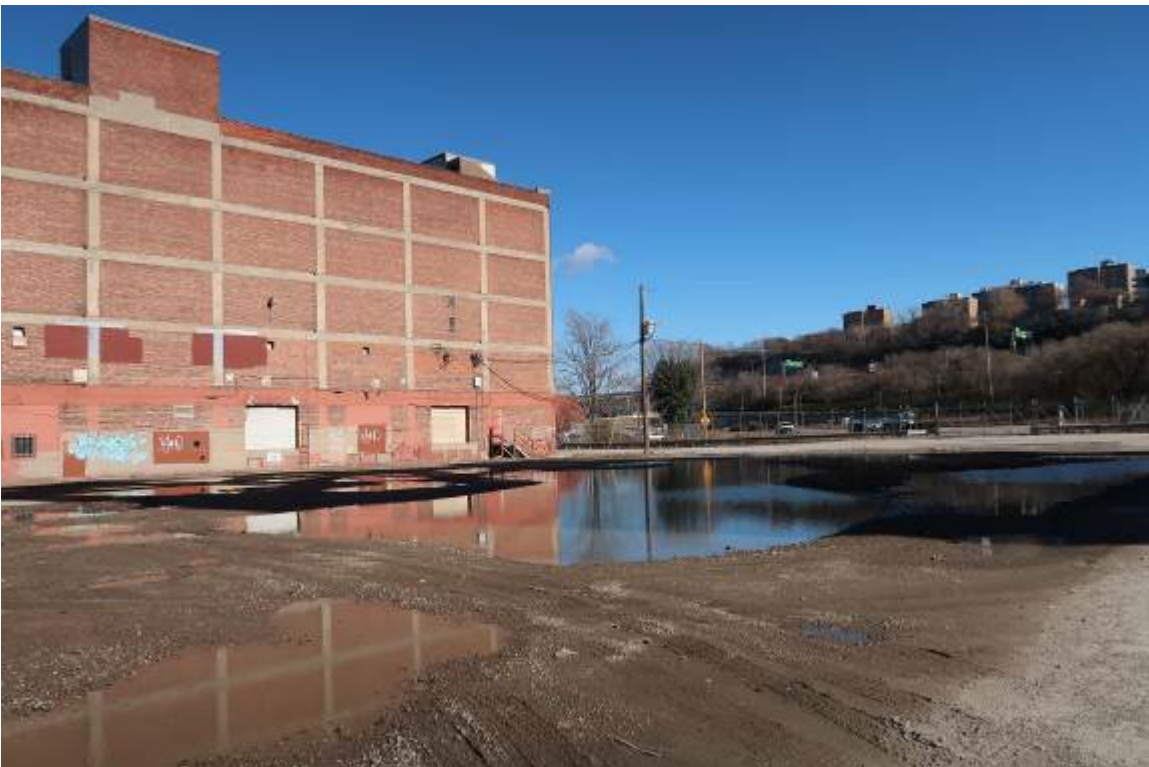
Dirt Lot Parking At 1015 Mulberry Street – 2023

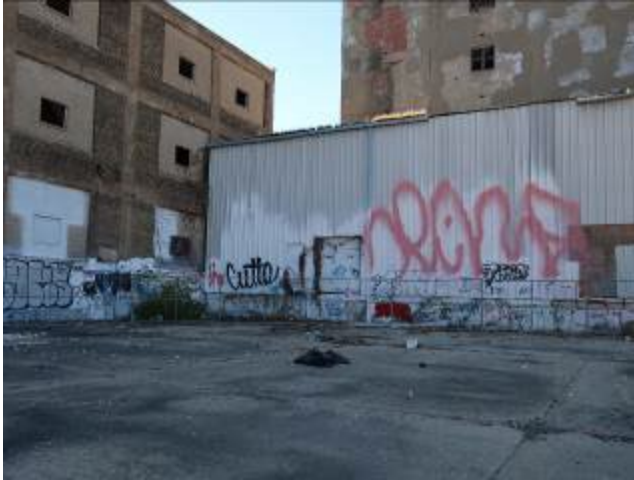
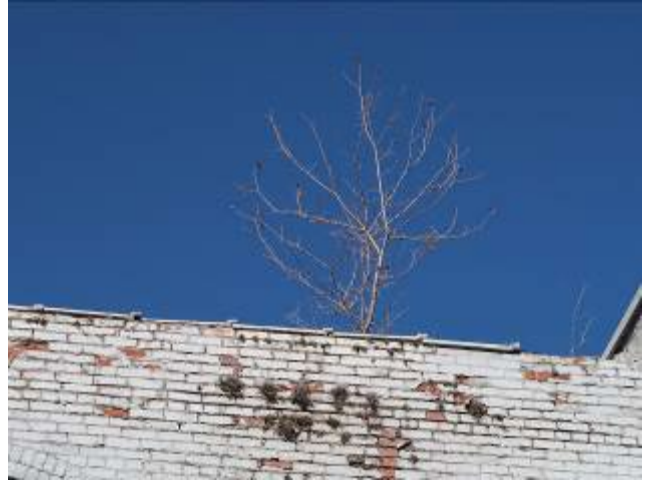
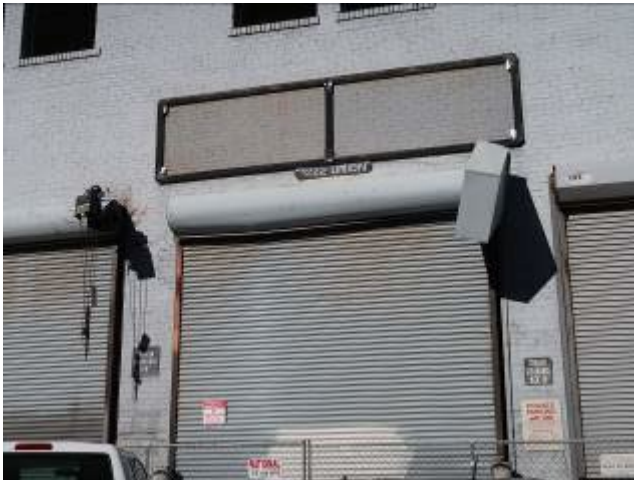
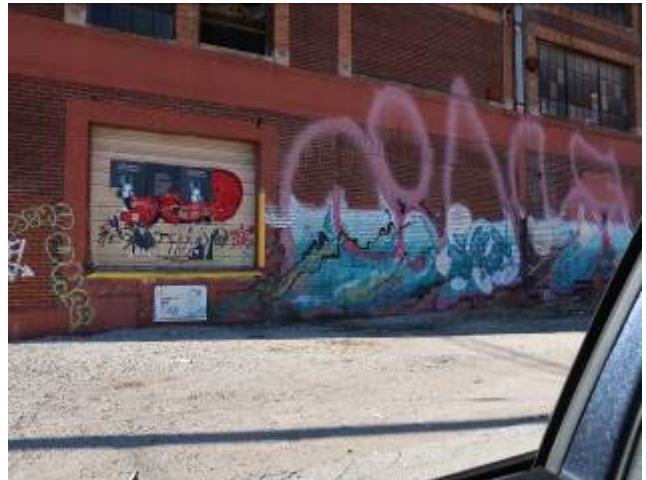
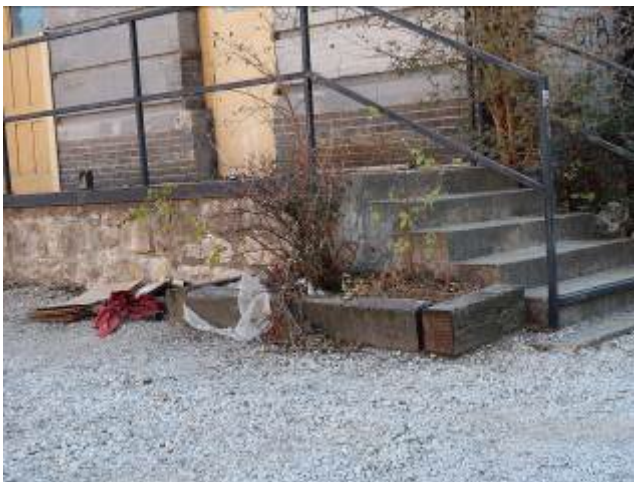
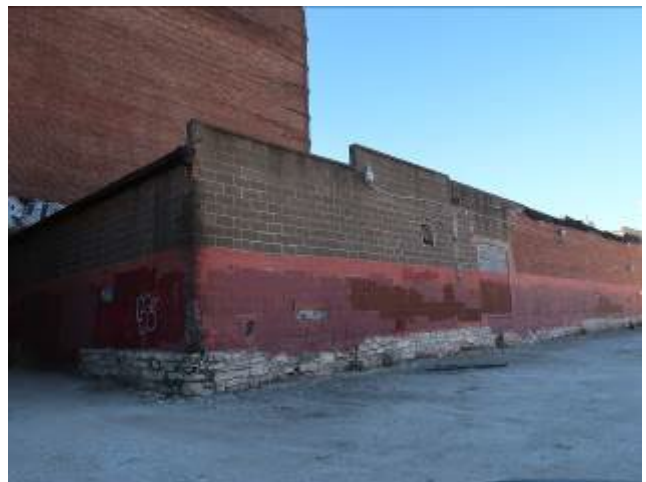
Other Current Blight Photographs

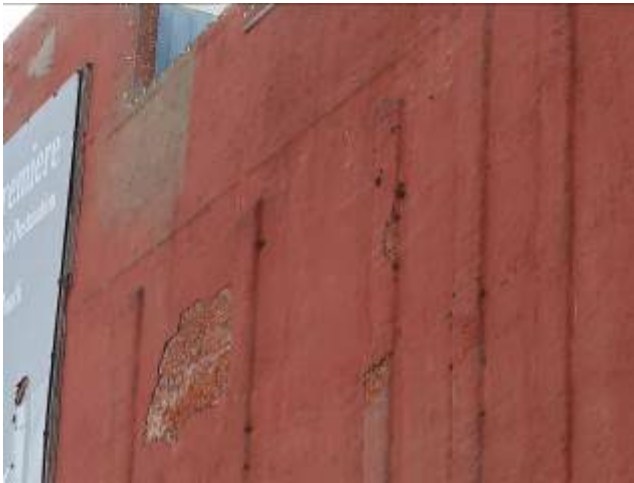
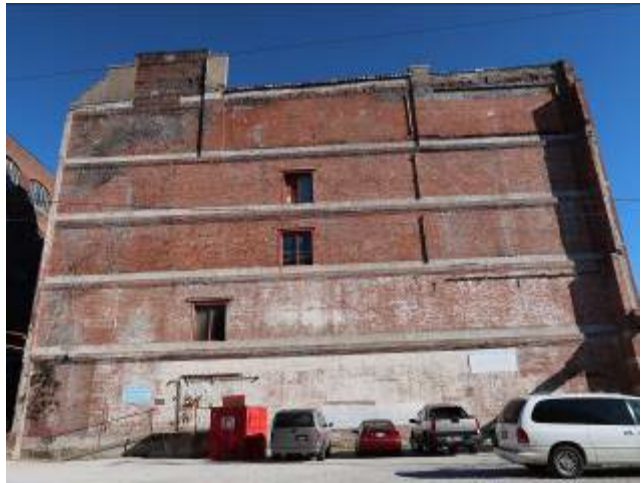
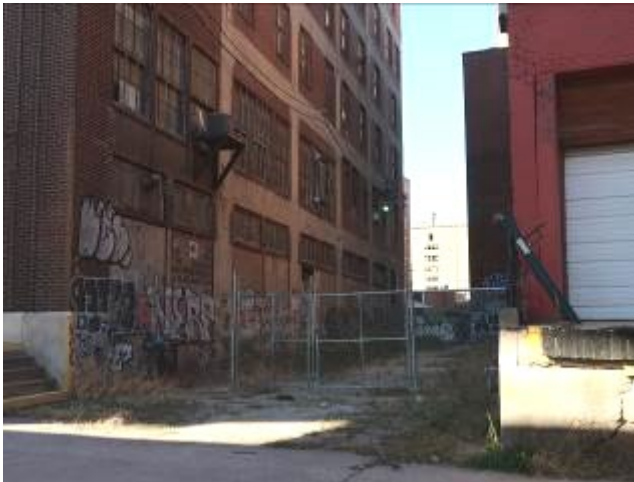
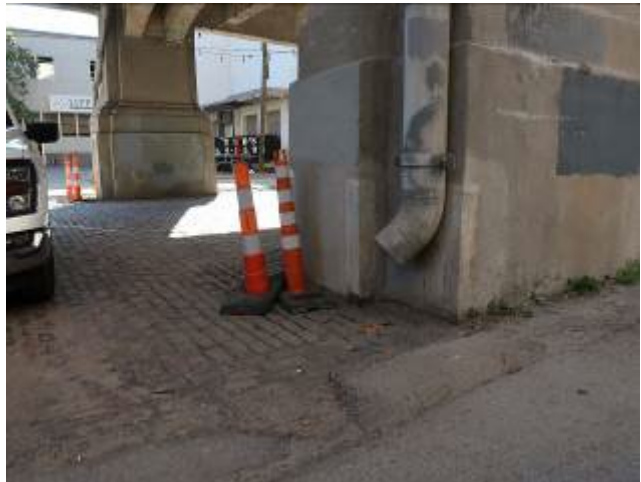
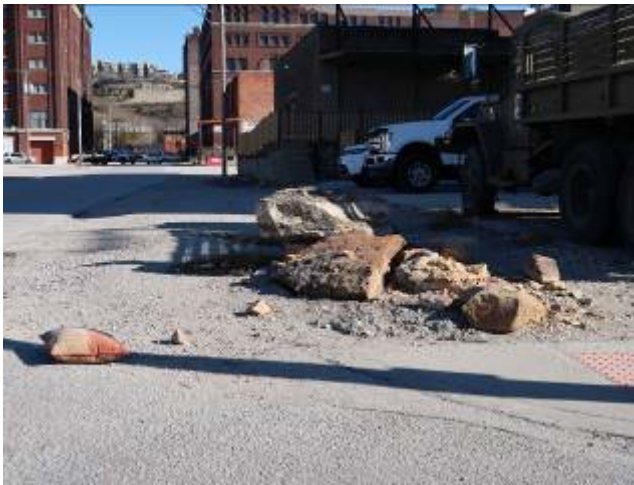
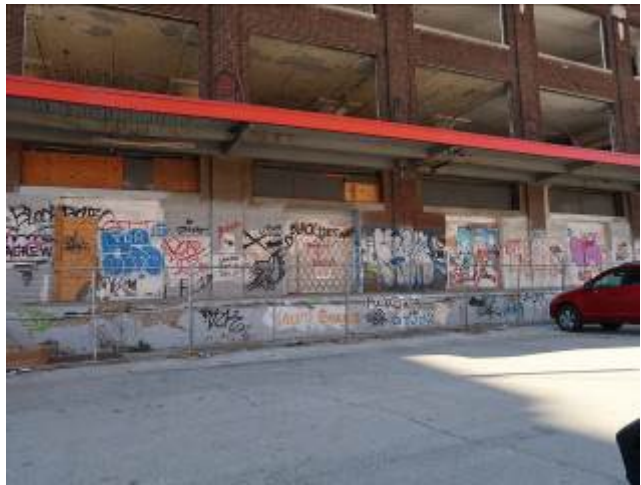
Other Current Blight Photographs
